ON-SITE INADVERTENT AIR BAG DEPLOYMENT INVESTIGATION

CALSPAN CASE NO: CA04-039

VEHICLE – 2004 CADILLAC CTS

**ON-SITE INADVERTENT AIR BAG DEPLOYMENT INVESTIGATION
CALSPAN CASE NO: CA04-039**

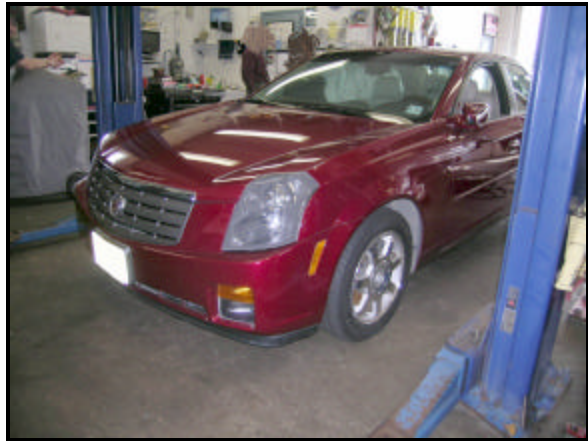
Figure 1: Front left view of the Cadillac.

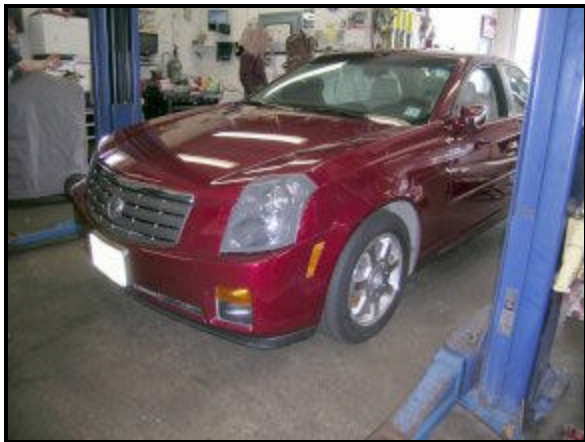
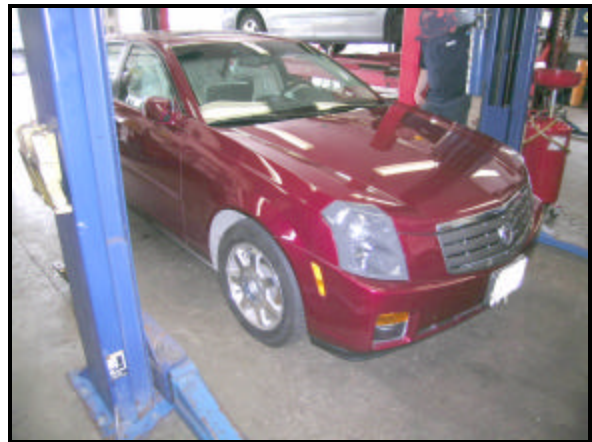
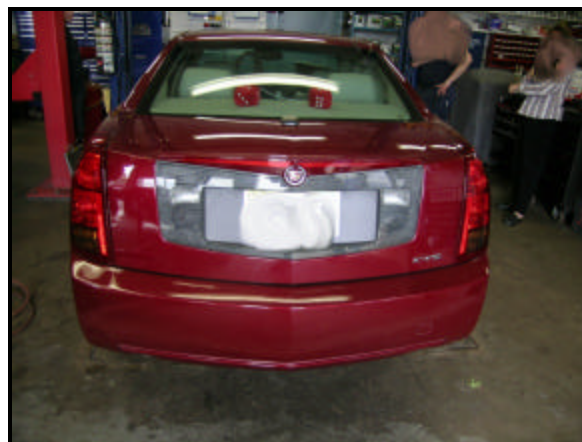
Figures 3, 4 and 5 are the front left, front right and back views of the vehicle. The inspection of the vehicle's exterior was unremarkable. There was no crash type damage.

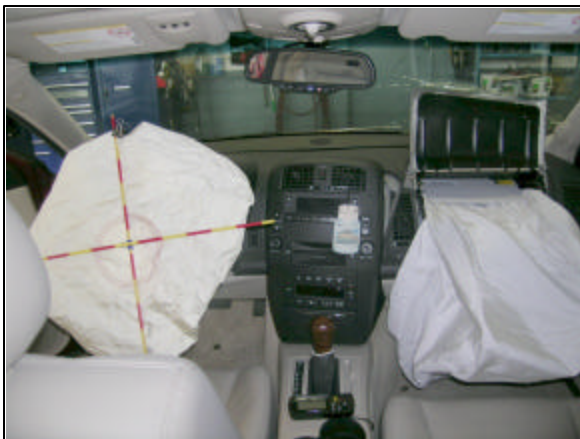
Figure 6 is a view of the front interior. All the interior damage to the Cadillac was related the deployment of the multiple air bags. The right aspect of the windshield was fractured by the rotation of the front right passenger air bag module cover flap.

Figure 6: View of the front interior.

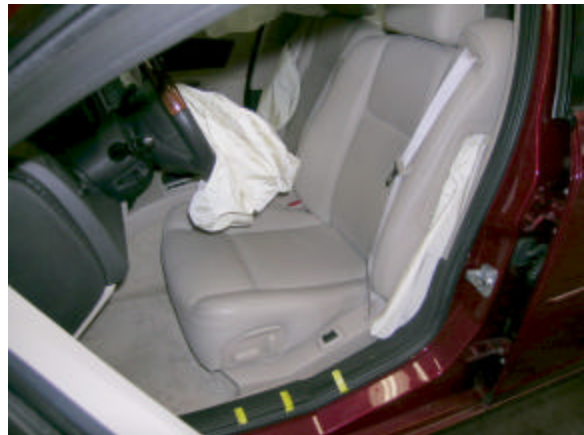
The power driver seat, **Figure 7**, was located in a mid-track position. The seat position was programmed into memory and was adjusted for the subject driver. The seat position measured 12.7 cm (5.0 in) forward of the full rear position. The total seat track travel measured 22.9 cm (9.0 in). The seat back recline angle measured 20 degrees. In this position, the horizontal distance from the center of the driver air bag module to the seat back measured 50.8 cm (20.0 in).

Figure 7: Driver's interior view.

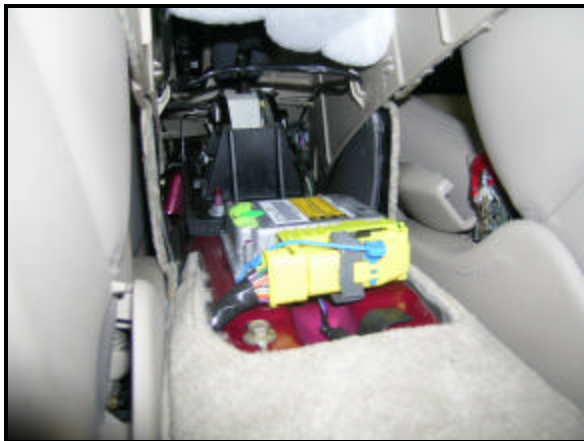
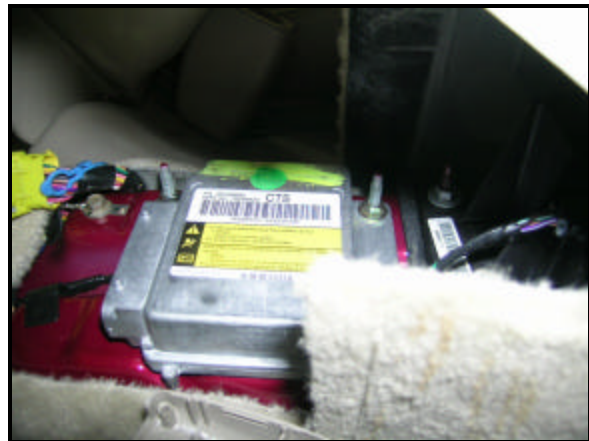
- Step Four involved visually examining the SDM. The SDM was located on the center tunnel under the console, **Figures 8 and 9**. The module and its electrical connector were found intact and undamaged. An examination of the connector and the module's mating pins was unremarkable. The mounting location of the module on the center tunnel was elevated relative to its surrounding and was unlikely to have been contaminated by water or other fluids. The following nomenclature identified the module:

Figure 8: Longitudinal view of the SDM.

Figure 9 Right lateral view of the SDM.

None of the diagnostic procedures conducted during the course of the vehicle inspection yielded any information that indicated the Cadillac had a pre-existing problem within the air bag system. The root cause of the inadvertent deployment could not determined.
