**CALSPAN ON-SITE CHILD AIR BAG RELATED FATALITY CRASH  
INVESTIGATION**

**CALSPAN CASE NO: CA04-046**

**VEHICLE: 1994 DODGE CARAVAN**

**CRASH DATE: OCTOBER 2004**

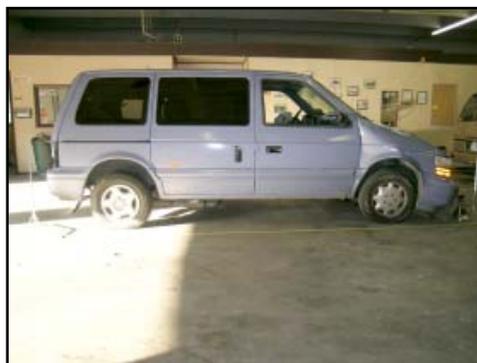
**Figure 1. Subject vehicle 1994 Dodge**

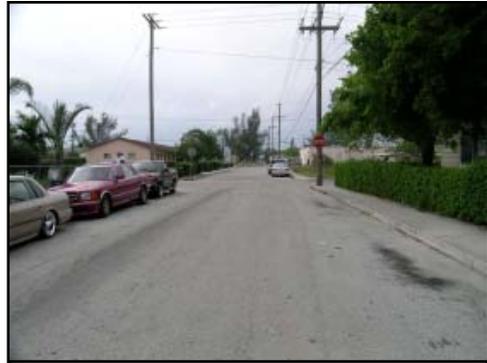
The 38-year-old female driver was operating the 1994 Dodge Caravan in a westerly direction approaching the four-leg intersection (**Figure 2**). A 34-year-old female was operating the 1996 Ford Windstar northbound approaching the intersection from the Caravan's left. The east/westbound legs of the intersection were controlled by stops signs; however, the stop sign that was located on the east leg was stolen two-days prior to the crash and was not replaced. The driver of the Dodge proceeded into the intersection as though it was an uncontrolled intersection for her path of travel. As she detected the approaching Ford, the driver of the Caravan applied a braking force prior to impact. There was no pre-crash evidence (i.e. skid marks) present at the crash site

**Figure 2. Pre-crash trajectory of the Dodge. Note: Stop sign was not present at the time of the crash.**

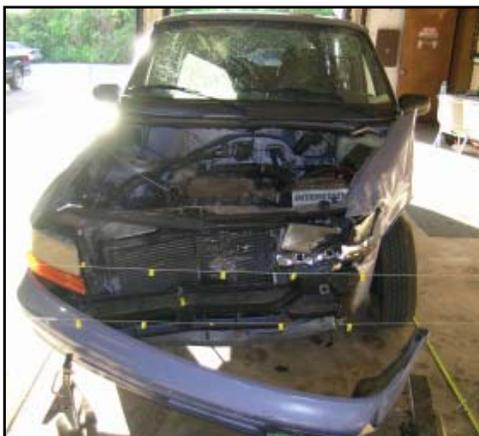
The 1994 Dodge Caravan sustained moderate severity frontal damage as result of the initial impact with the Ford (**Figure 3**). The damaged components included the hood, bumper fascia and bumper beam, left headlamp assembly, upper radiator support, and the front fenders. Additionally, the front structure of the vehicle was shifted to the right. The left frame rail was displaced 14 cm (5.5") to the right while the right rail was displaced 17 cm (6.5"). Maximum crush was 15 cm (5.9"), and was located at the left corner of the bumper beam. The direct contact damage began 10 cm (3.9) right of the vehicle's centerline and extended 89 cm (35.2") to the left bumper corner. A crush profile was documented along the full width of the deformed bumper beam which measured 130 cm (51.25"). The crush profile consisted of six equidistant crush measurements that were as follows: C1 = 11 cm (4.3"), C2 = 12 cm (4.7"), C3 = 15 cm (5.9"), C4 = 12 cm (4.7"), C5 = 4 cm (1.6"), C6 = 2 cm (0.8"). The Collision Deformation Classification (CDC) for this impact was 71-FYEW-1 with an incremented shift value of 60 added to the 11 o'clock direction of force.

**Figure 3. Frontal damage to the 1994 Dodge Caravan.**

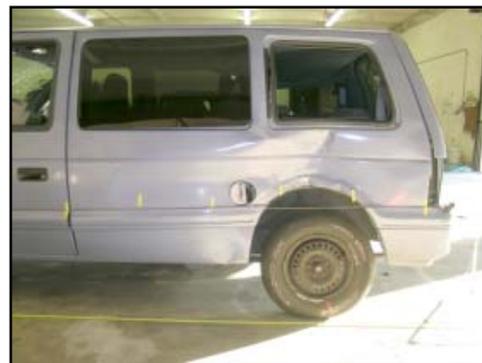
**Figure 4. Left rear damage from the secondary impact.**

The secondary side slap impact with the Ford resulted in minor damage to left rear aspect of the Dodge (**Figure 4**). The direct contact damage began 15 cm (5.75") aft of the left rear axle and extended 67 cm (26.25") forward. The maximum crush measured 15 cm (5.75") and was located 8 cm (3.25") forward of the left rear axle position on the wheel opening. The crush profile for this impact was as follows: C1 = 0 cm, C2 = 5 cm (2"), C3 = 11 cm (4.4"), C4 = 6 cm (2.25"), C5 = 2 cm (0.75"), C6 = 0 cm. The CDC for this impact was 09-LZEW-2.

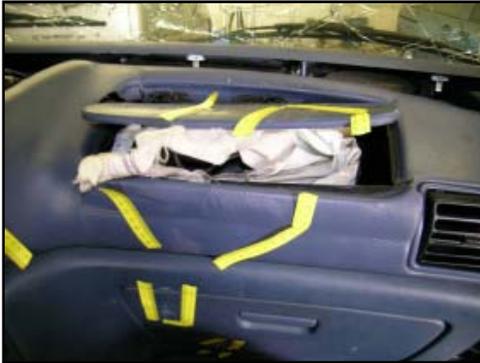
The front right child passenger contacted the glove box door with her lower extremities. A fabric transfer was present on the lower left aspect that extended 31-34 cm (12.25-13.5") right of center and 34-41 cm (13.5-16") below the top of the upper Instrument Panel (IP). A scuff mark was present below the transfer that extended 29-31 cm (11.5-12.25") left of center and 47-50 cm (18.5-19.5") below the referenced IP. A patterned scuffmark/fabric transfer was present on the upper mid panel at the protrusion of the right instrument panel. The contact point was located 11-14 cm (4.25-5.5") right of center and 10-15 cm (4-6") below the top surface of the IP. A white scuff mark was present on the upper left aspect of the glove box door that extended onto the mid instrument panel. This contact point was located 27-30 cm (10.75-11.75") right of center and 14-23 cm (5.5-9") below the top surface of the instrument panel. The vertical face of the mid-to-upper instrument panel at the locations of the corners of the air bag module opening was split. The left tear was 7 cm (2.75") in length and the right tear was 7 cm (2.6") in length. These splits occurred by the air bag as it expanded against the module and the out-of-position child passenger. Additionally, this panel contained vertically oriented scuff marks and tissue transfers from contact with the front right passenger. A triangular area of tissue and scuff marks was present on the mid panel immediately below the air bag module. This contact occupied an area that was 15 cm (5.75") horizontally and 8 cm (3.25") vertically.

The air bag cover flap was bowed 6mm (0.25") at the leading edge from contact with the child passenger during the initial deployment phase. A single strand of hair was noted on

the center aspect of the leading edge of the cover flap. Diagonally oriented tissue transfers were noted to the leading edge of the cover flap and located 19-26 cm (7.5-10.25") right of the left edge of the flap, extending 4 cm (1.75") forward of the leading edge.

**Figure 5. Occupant contact points to the air bag module cover, mid panel, and the glove box door.**

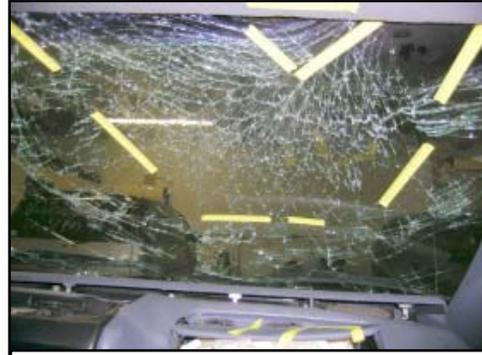
The child passenger was displaced vertically, contacting and fracturing the upper aspect of the windshield with her head. The windshield was cracked and bowed outward over a large area that extended from the rear view mirror to the right A-pillar. This contact extended onto the windshield header which was deformed. These areas were evidenced by hair which was removed by the investigating officer. A white air bag transfer was noted on the windshield 21-43 cm (8.25-17") right of center and 17 cm (6.5") above the top of the instrument panel.

**Figure 6. Front right passenger contacts to the windshield.**

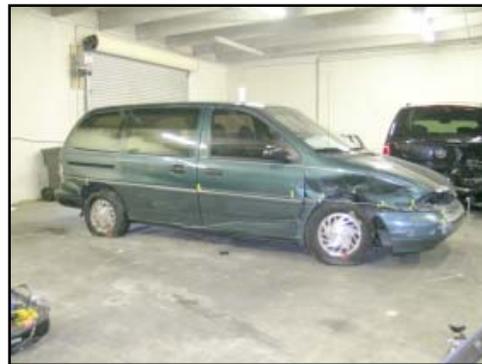
The 1996 Ford Windstar sustained moderate severity damage to the right side from the impacts with the Dodge (**Figure 7**). The initial impact involved the right side with the direct contact damage beginning 29 cm (11.5") forward of the rear axle and extended 371 cm (146.0") forward to the right front bumper corner. The maximum crush was 19 cm (7.6") and was located on the fender 45 cm (17.75") forward of the left A-pillar. The crush profile was documented at the mid-level and was as follows: C1 = 0 cm, C2 = 5 cm

**Figure 7. Overall view of the right side damage.**

(1.9”), C3 = 19 cm (7.6”), C4 = 18 cm (7.1”), C5 = 16 cm (6.3”), C6 = 8 cm (3.25”). The CDC for this impact was 02-RFEW-2.

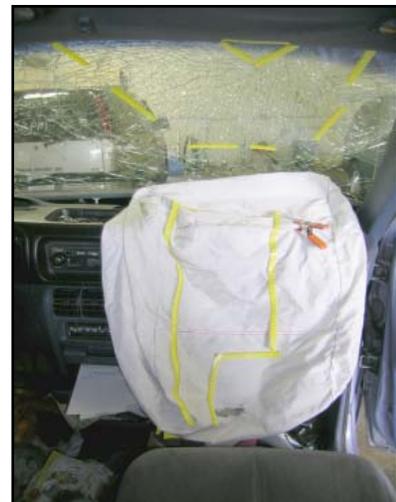
The right front air bag membrane measured 48 cm (19”) in width and 55 cm (21.5”) in height (**Figure 8**). The bag was tethered by two 32 cm (12.5”) wide band tethers that were sewn to the face of the membrane and spaced 28 cm (11”) apart. The air bag membrane was cut from the module by the investigating police officer prior to this SCI investigation. The bag was repositioned by the SCI investigator for proper documentation. Blue fabric

**Figure 8. Front right air bag and contact evidence.**

transfers from the front right passenger were present on the face of the membrane. These

blue clothing transfers began 11 cm (4.3”) below the top seam and extended 44 cm (17.3”) to the bottom seam. Tissue transfers were present within the lower aspect of this fabric transfer. The tissue transfers began at the bottom seam and extended 20 cm (8”) to the lower tether and were 5 cm (2”) wide at the lower aspect and 18 cm (7”) wide at the tether. The sun visors of the Dodge were equipped with air bag warning labels on the inner sides.
