Child Safety Seat Fatality/ Vehicle to Objects
Dynamic Science, Inc. / Case Number: DS05001
1990 Chevrolet 1500 pickup
Colorado
January, 2005

1. Report No. DS05001	2. Government Accession No.		3. Recipient Catalog No.	
4. Title and Subtitle Child Safety Seat On Site Investigation			5. Report Date July 21, 2005

Dynamic Science, Inc.
Crash Investigation
Case Number: DS05001

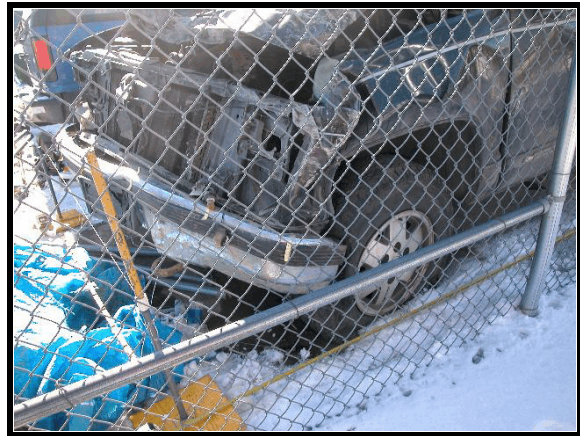
Figure 1. Front left, Chevrolet K1500

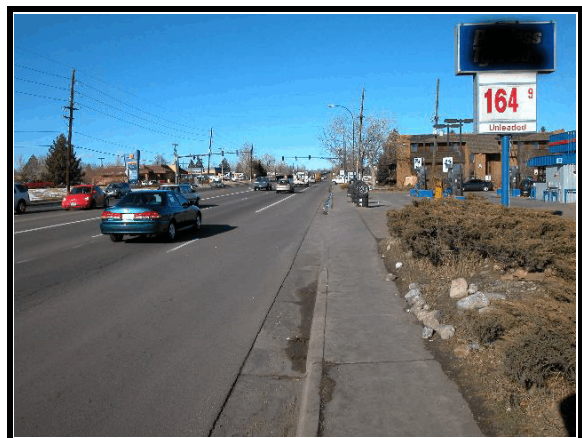
Figure 2. Area of roadway departure (north)

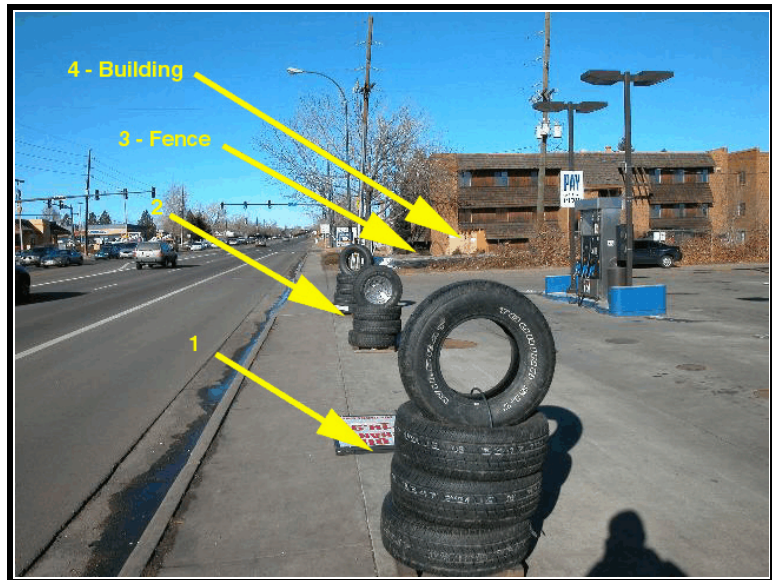
There was no damage from the curb impact. The impacts to the tire display and the chain link fence were generally insignificant. The frontal contact with the tire displays and fence was masked by the subsequent building impact. There were scratches found down both sides from contact with the fence. The impact with the building was essentially a two stage event. The initial contact was

Figure 3. View showing four impacts

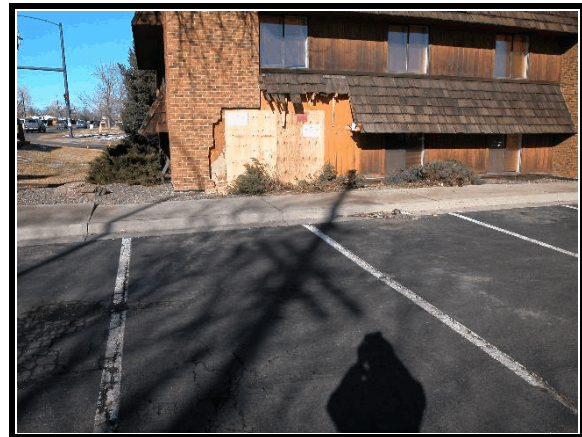
Figure 4. Impact with building

with the front bumper and grille. This stiff part of the vehicle penetrated the building. There was 87.0 cm (34.2 in) of direct contact found on the bumper from the building impact, but the entire front end was involved. As the vehicle continued forward the upper cab area of the vehicle engaged a slanted roof portion of the building above the original penetration point. This resulted in significant deformation and intrusion along the windshield header with the front header being pushed rearward into the rear header. The upper cab was cut away during extrication. At a minimum there was 60.0 cm (23.6 in) of crush near the center. A CDC of 12FDAW8¹ was assigned to describe the resultant damage to the bumper level and the damage to the cab. As the vehicle penetrated the building, the camper shell was forced off the vehicle and came to rest to the right of the vehicle next to the building. As the vehicle penetrated the building, it likely dropped down to the frame level as the tires went from the ground level to the office level.

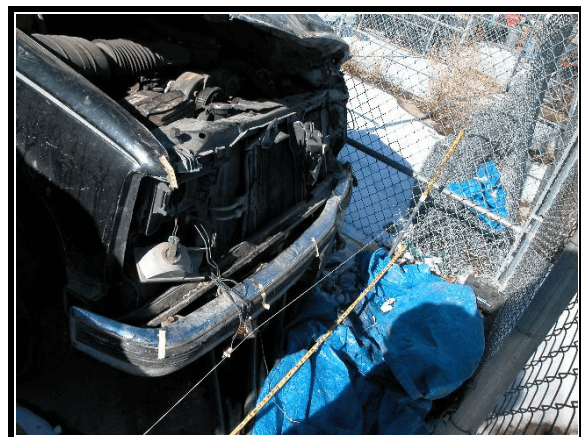
Figure 5. Front right, Chevrolet K1500

Damage Description: There was no damage from the initial curb impact. The impacts to the tire displays and the chain link fence were generally insignificant. The frontal contact with the tire display and fence was masked by the subsequent building impact. There were scratches found down both sides from contact with the fence and building.

A field L of 184.0 cm (72.4 in) was assigned at the bumper level. The residual crush measured along the bumper was as follows: C1=40.0 (15.7 in), C2 =25.0 cm (9.8 in), C3=14.0 cm (5.5 in), C4=4.0 cm (1.6 in), C5=2.0 cm (0.8 in), C6=6.0 cm (2.3 in).

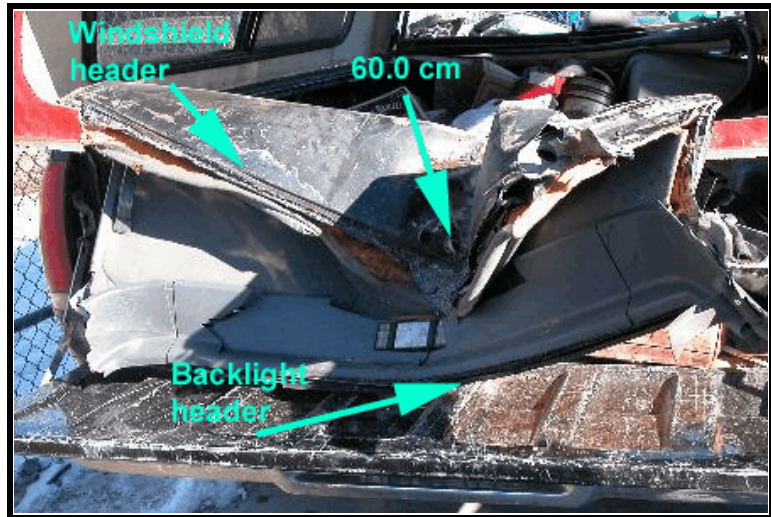
The 1990 Chevrolet K1500 sustained major interior damage as a result of passenger compartment intrusion. There was longitudinal intrusion by both A pillars, the windshield header, and the roof. This intrusion included all three seat positions. The extent of the intrusion is uncertain, the upper cab had been cut away during extrication. At a minimum there was 60.0 cm (23.6 in) of crush near the center which actually pushed the front header into contact with the backlight header. There was 17.0 cm (6.7 in) of lateral intrusion through the right door. The instrument panel was cracked and deformed due to intrusion. The steering wheel was covered in blood. There was blood pooling on the driver's seat back. There were blood spatters and smears on the seat and on the left side of the booster seat. The glove box was separated from the instrument panel. The speedometer was broken and the speed was fixed at 24 km/h (15 mph).

Figure 6. Damage to upper portion of the cab

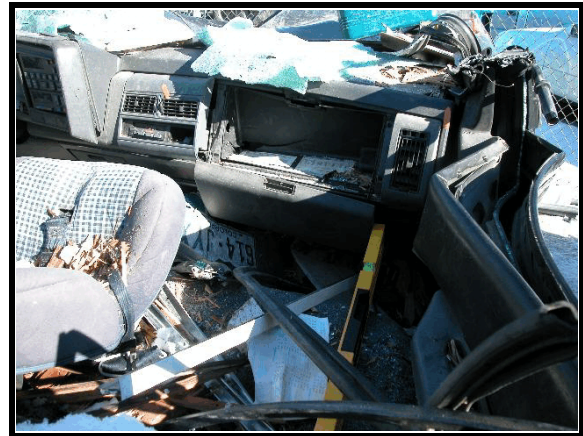
Figure 7. Right door intrusion

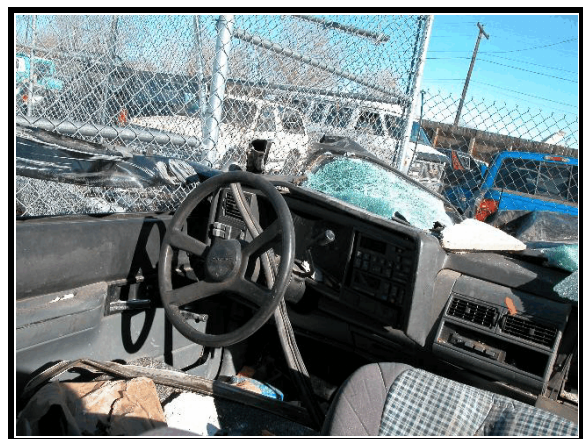
The 1990 Chevrolet K1500 was configured with manual 3-point lap and shoulder belts at the two outboard positions and a manual lap belt at the middle seat position with a locking latch plate. Both outboard seat belts were configured with sewn-on latch plates and emergency locking retractors. The driver's belt showed evidence of loading and had been cut off the driver during his extrication. The front right seat belt showed evidence of loading. The lap belt in the middle seat position was being used in conjunction with the high back booster seat. There were load marks to the lap belt indicating usage in this crash.

Figure 8. Driver's seated position

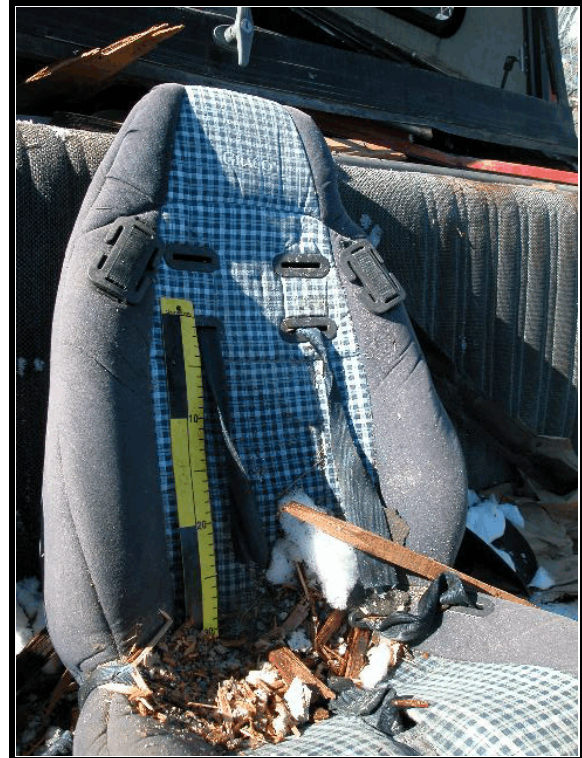
The child safety seat was being used with the integral 5-point harness. The harness was routed through the bottom set of slots. There were load marks to the shoulder portions of the harness. The harness was cut off the child during extrication. The child seat was anchored to the vehicle using the available lap belt. There were load marks to the lap belt indicating usage in this crash. There was 20.0 cm (7.9 in) of tip distance at the top and 19.0 cm (7.5 in) tip distance at the bottom of the child seat. The distance from the interior of the child seat back to the center instrument panel was 87.0 cm (34.3 in).

Figure 9. Graco high back booster seat

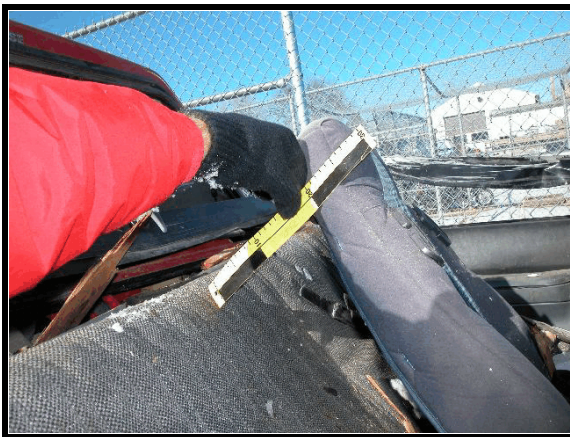
Figure 11. Top tip distance

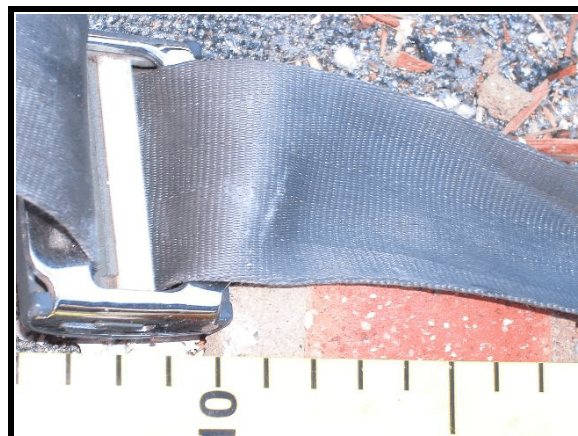
Figure 10. Load marks to middle seat lap belt

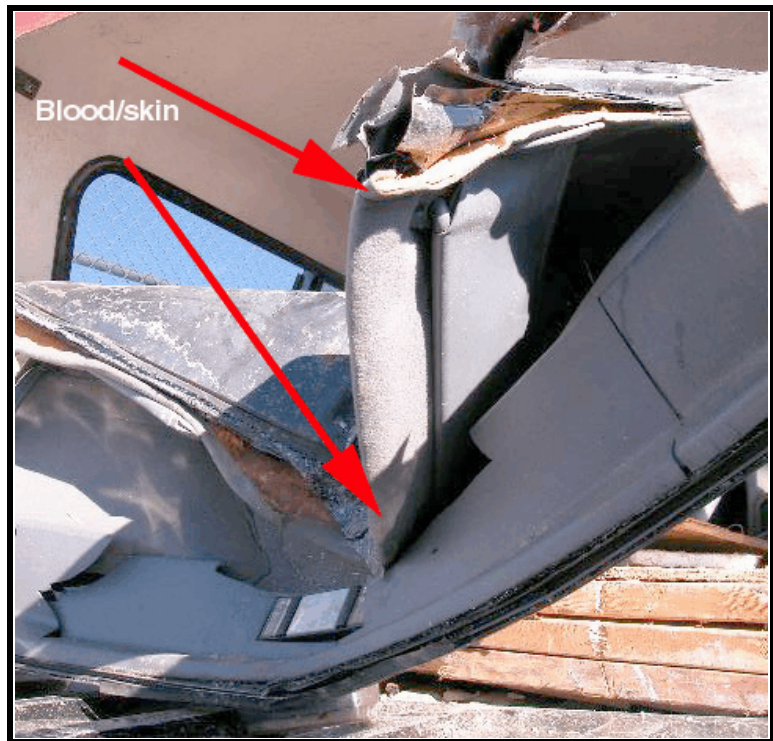
The 35-year-old male driver (178 cm/70 in, 88 kg/195 lbs) was seated facing forward. He was wearing the available lap and shoulder belt. It appears that he was likely unconscious. It is also likely that he was still seated in a generally upright fashion, but with his head rotated downward to some degree. During the first three relatively minor impacts, the driver likely remained generally in place. There may have been some bouncing involved but very little longitudinal deceleration. At impact with the office building, the driver initiated a forward trajectory. He loaded the lap and shoulder belt. As the vehicle continued forward, the upper portion of the cab struck the overhanging roof structure. The windshield fractured and the windshield header intruded into the passenger compartment. Some portion of the header and windshield engaged the driver's face causing the nasal and maxilla fractures, the orbit fracture and the lacerations to forehead, left eyelid, nose, and lips.

Figure 12. Inside portion of left windshield header. Arrows indicate areas of blood/tissue transfer.
