REMOTE ADVANCED OCCUPANT PROTECTION SYSTEM INVESTIGATION

CASE NUMBER - IN-05-002
LOCATION - Ohio
VEHICLE - 2004 PONTIAC GRAND PRIX
CRASH DATE - April 2004

Submitted:
June 23, 2006
Revised:
03/07/2008

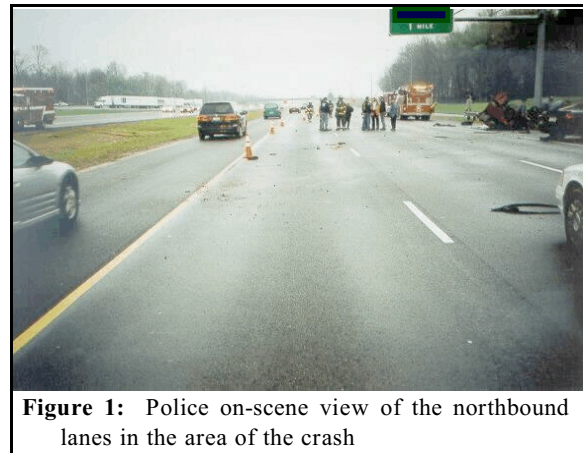
Figure 1: Police on-scene view of the northbound lanes in the area of the crash

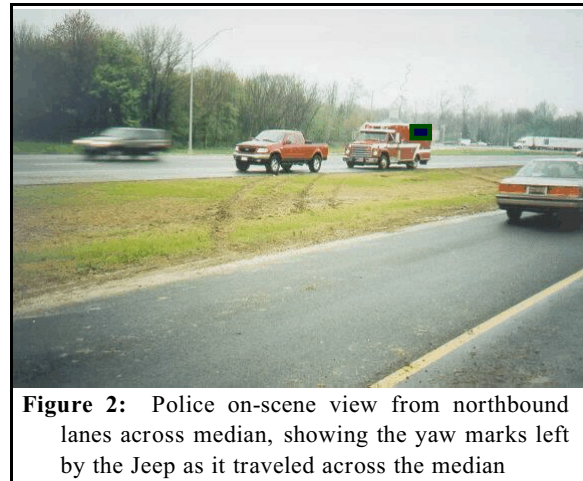
the left (east) side of the southbound roadway, into the median. The Jeep traveled through the median with counterclockwise yaw motion and entered the northbound lanes, heading approximately eastward (**Figure 2**). The case vehicle's front impacted the Jeep's right side (event #2), causing the case vehicle's driver and front right passenger air bags to deploy. The damage on the case vehicle suggests that the case vehicle driver probably steered right immediately prior to the impact. The case vehicle was redirected and it ran off the right (east) edge of the northbound roadway, where its front impacted a steel W-beam guardrail (event #3). The case vehicle came to rest with its front against the guardrail, heading east. The impact with the case vehicle caused the Jeep to roll left two quarter-rolls (event #4) and it slid, upside down, off the right (east) edge of the northbound roadway. The Jeep came to rest, on its roof, with its right side near the guardrail, heading south. The Mercury's left side was struck (event #5) by an unknown loose object or debris set in motion by the previous events. The Mercury's driver did not stop, but came forward to the police the following day. The tractor-trailer rig was brought to a controlled stop on the inside shoulder of the southbound roadway.

Figure 2: Police on-scene view from northbound lanes across median, showing the yaw marks left by the Jeep as it traveled across the median

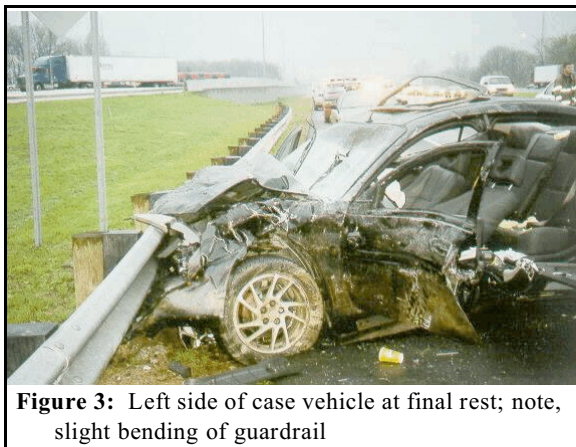
Figure 3: Left side of case vehicle at final rest; note, slight bending of guardrail

The case vehicle sustained very heavy frontal damage from two overlapping impacts, the first with the Jeep and the second with a steel W-beam guardrail (**Figure 3**). All of the frontal structures were crushed rearward against the engine and front tires, and the wheelbase was probably shortened on both sides. The hood was crushed and folded and probably impacted the windshield. The right front area is not visible in the available photographs. The available photographs show that the left front door was pried open, with the left B-pillar cut at the top and bottom and the left rear door removed. The laminated windshield was shattered across its entire width with a large slit in the center. All the other glazing except the right front door window was disintegrated, but some of this glazing damage probably occurred during extrication efforts (**Figure 4**). There was direct contact damage along the left fender, left A-pillar and roof rail, and left front door. This left side damage suggests that the case vehicle driver probably steered right immediately prior to the first impact, such that the case vehicle's left side engaged the Jeep's right side during the first impact. The left front tire appears to be deflated, with the right front tire not visible and the two rear tires inflated.

No reconstruction was attempted for the case vehicle's second impact (with the guard rail) because the extent of deformation attributable to the second impact cannot be estimated from the available photographs. The guardrail shows some slight deformation (see **Figure 3**) and this contractor estimates that the second impact was of low severity (12-23 km.p.h. [9-14 m.p.h.]) for the case vehicle.

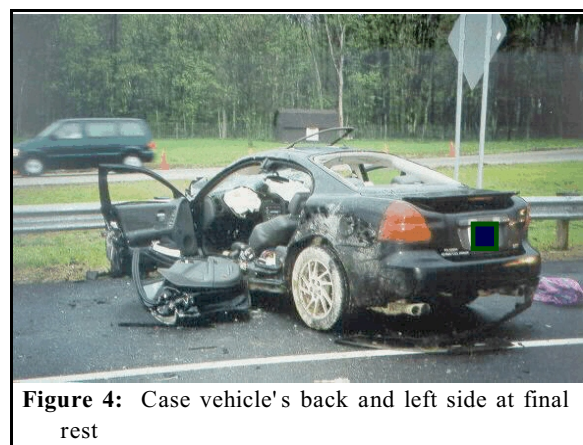
Figure 4: Case vehicle's back and left side at final rest

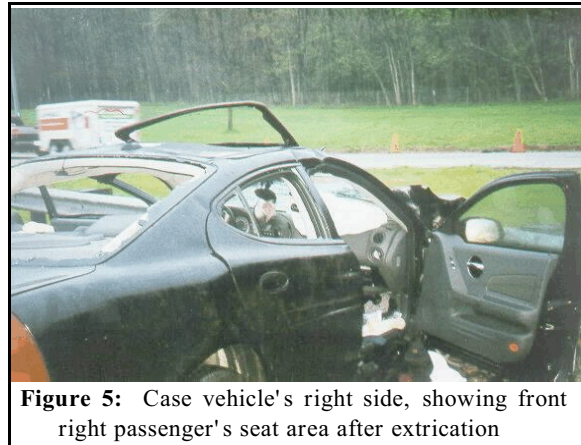
Figure 5: Case vehicle's right side, showing front right passenger's seat area after extrication

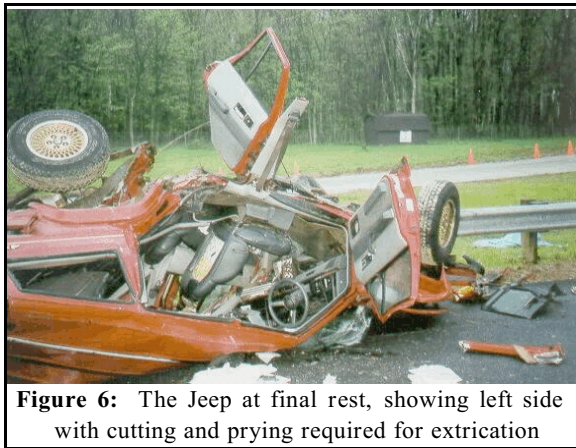
The Jeep sustained very heavy damage on the right side from its impact with the case vehicle. It then rolled two quarter-rolls to the left, onto its roof, resulting in substantial distortion to the greenhouse area. It came to rest upside down and rescue personnel performed major cutting and prying to extricate the driver. The available photographs show the Jeep at final rest (upside down, **Figure 6**) and at a tow yard (set upright, **Figure 7**).

Figure 6: The Jeep at final rest, showing left side with cutting and prying required for extrication

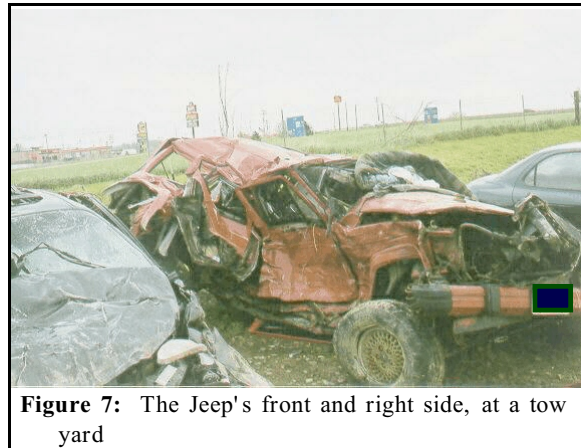
Figure 7: The Jeep's front and right side, at a tow yard

The CDC for the Jeep's first impact (event #1, with the tractor-trailer rig) is unknown because the impact area is obscured by subsequent damage. The CDC for the Jeep's most severe impact (event #2, with the case vehicle) was estimated from the available photographs as **03-RDAW-3 (80 degrees)**. The CDC for the Jeep's rollover (event #4) was estimated as **00-TDDO-3 (non-horizontal)**.

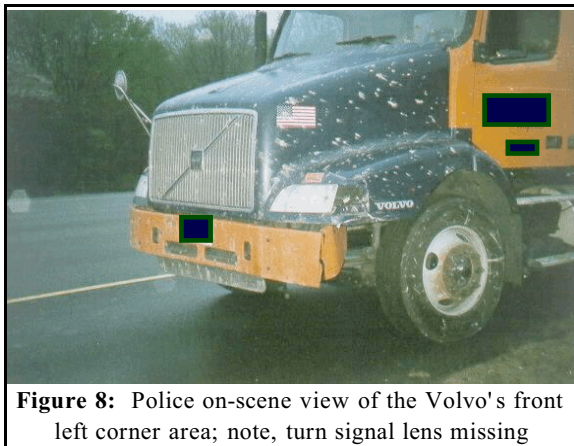
The Volvo truck-tractor sustained relatively minor damage at the apex of its front left corner (Figures 8 and 9). The part of the front bumper that folds around onto the left side was broken at the crease of its fold and was pushed inward. The left turn signal lens was shattered but the left headlamp was intact, and there was some scraping on the left fender immediately below the turn signal assembly. The TDC for the Volvo truck-tractor, estimated from the available photos, is 12-FLES-1 (0 degrees).

Figure 8: Police on-scene view of the Volvo's front left corner area; note, turn signal lens missing

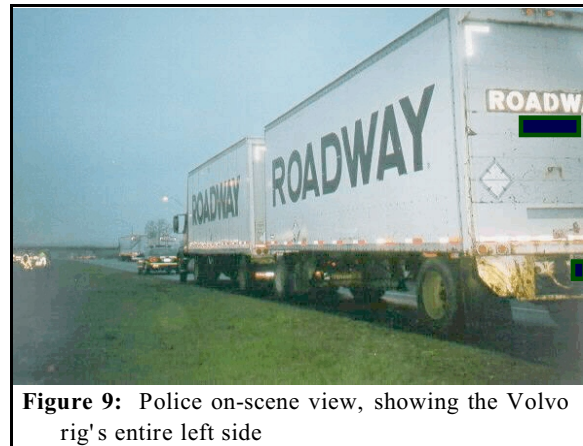
Figure 9: Police on-scene view, showing the Volvo rig's entire left side

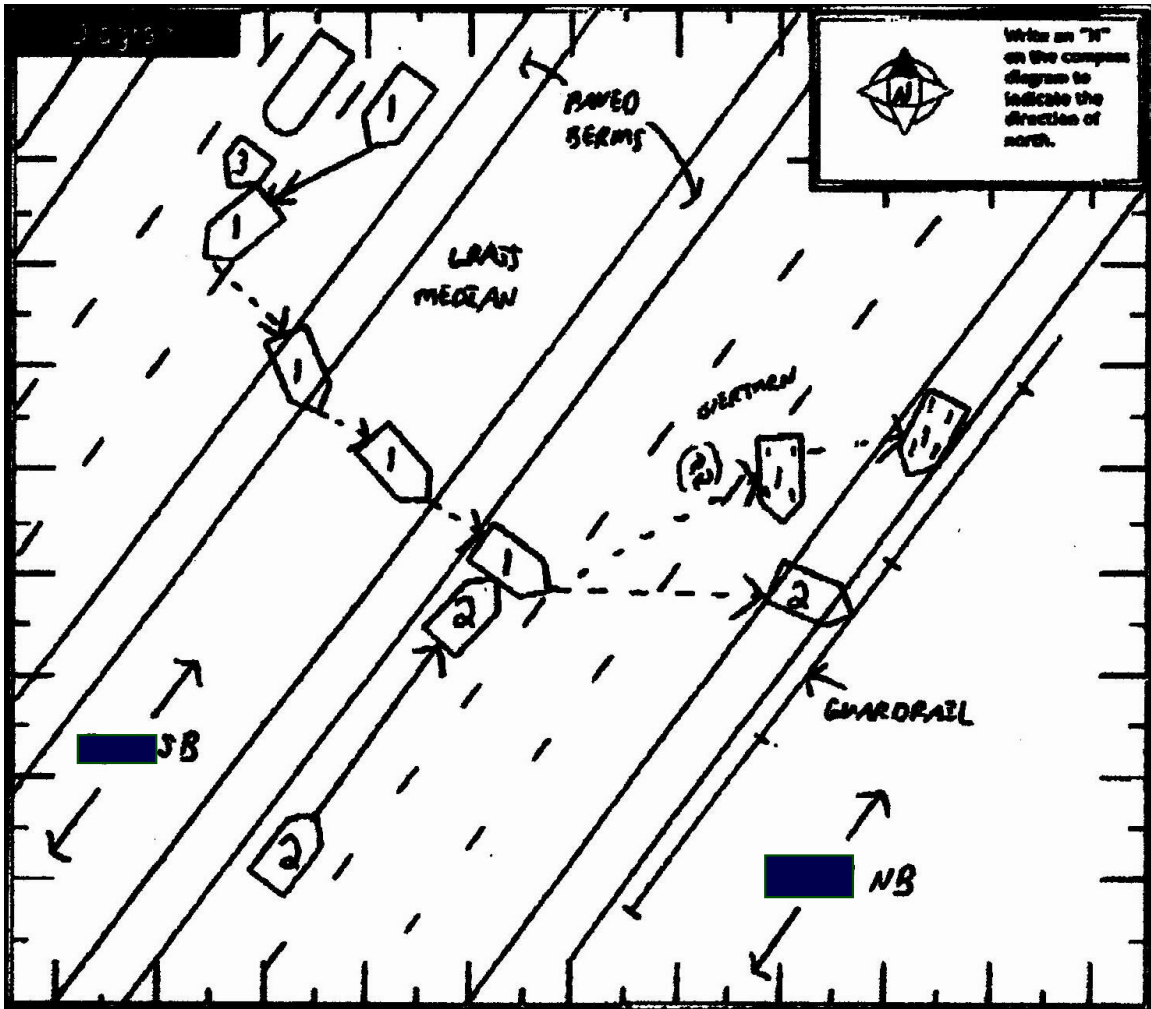
Copied from the police crash report. The case vehicle is V2 in this drawing. V1 is the Jeep and V3 is the Volvo tractor-trailer rig. The Mercury Sable (third other vehicle) is not depicted in this drawing.
