## ON-SITE SCHOOL BUS INVESTIGATION

CASE NUMBER - IN-05-015

VEHICLE - 1991 CARPENTER (ON A FORD B700 CHASSIS) SCHOOL BUS

CRASH DATE - March 2005

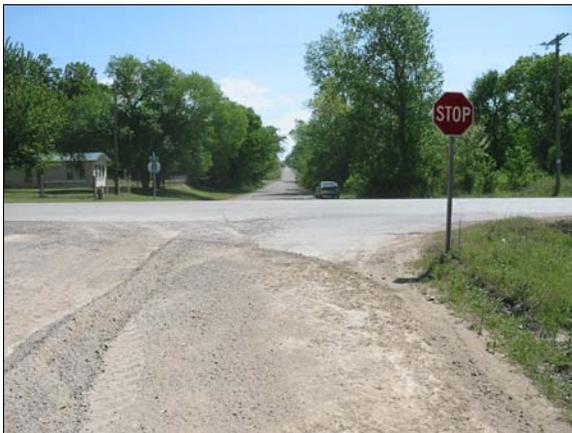
**Pre-Crash:** The case vehicle was traveling east in the eastbound lane and was stopped at the stop sign (**Figure 1**). The case vehicle’s driver was intending to proceed through the intersection and continue eastbound. The Chevrolet was traveling north in the northbound lane (**Figure 2**). The Chevrolet’s driver was intending to continue eastbound. Witnesses in the case vehicle stated that the driver looked both ways before pulling into the intersection. The police crash report concluded that the bus driver did not see the approaching Chevrolet due to a vision obstruction caused by the bus’s right “A” pillar and side view mirror. Observations made from the driver’s seat during the vehicle inspection indicated that the police conclusion is a plausible. The case vehicle’s driver made no pre-crash avoidance maneuver. The evidence and the police crash report indicate the Chevrolet steered right in an attempt to avoid the crash. The crash occurred in the four-leg intersection of the two trafficways (**Figure 3**).

**Figure 1:** Approach of case vehicle eastbound to intersection

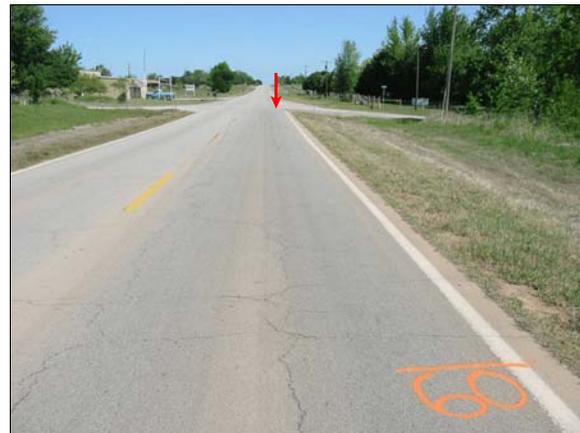
**Figure 2:** Approach of Chevrolet northbound to impact (arrow)

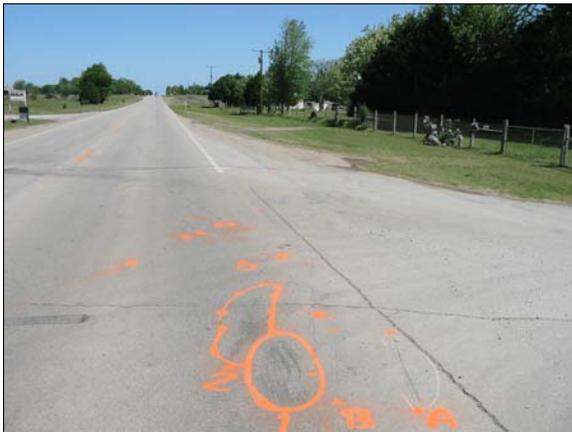
**Figure 3:** Location of impact from Chevrolet’s approach

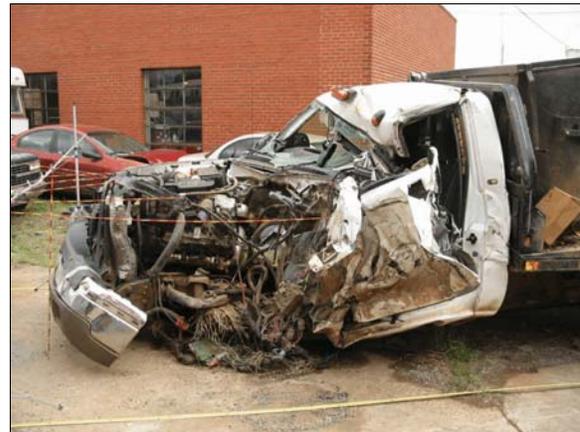
**Figure 4:** Left side view of crush to front of Chevrolet and collapse of driver’s side of cab, each increment on rods is 5 cm (2in)

**Crash:** The front left of the Chevrolet (**Figure 4**) impacted the front portion of the case vehicle’s right fender and front bumper corner (**Figure 5** below). There was a mismatch between the height of the Chevrolet’s front bumper and the side and front bumper of the case vehicle. The bumper and left frame member of the Chevrolet sustained only minor engagement as the Chevrolet underrode the case vehicle’s right frame member and front right bumper corner. The Chevrolet’s

left fender was heavily engaged and crushed rearward. There was also major engagement to the cowl, which collapsed the driver's passenger compartment (**Figure 4** above). The case vehicle rotated counterclockwise and the Chevrolet deflected to the right. The left front door of the Chevrolet (**Figure 6** below) engaged the case vehicle's right front wheel. The left side of the Chevrolet (**Figure 7** below) engaged the case vehicle's cowl and side view mirror (**Figure 8** below). The stock trailer's gooseneck impacted the case vehicle's bi-fold door and roof (**Figure 8** below) and the trailer impacted the right rear side of the case vehicle (**Figures 9 and 10** below).

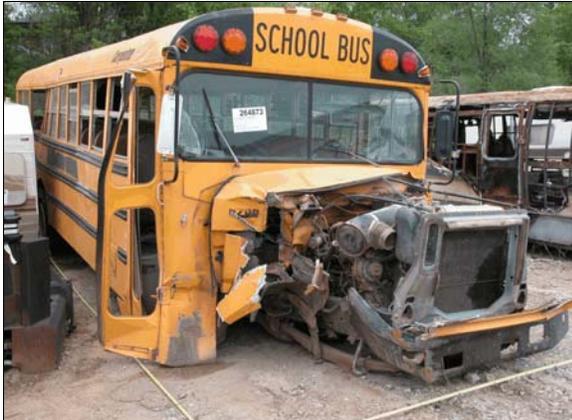
**Figure 5:** Damage to right front of case vehicle from due to impact with the Chevrolet

**Exterior Damage:** The case vehicle's initial impact with the Chevrolet involved the right corner of the front bumper, right fender, and the hood. In addition, the right front wheel, cowl and right side view mirror assembly were directly damaged by contact with the left side of the Chevrolet. The stock trailer's gooseneck impacted and damaged the top of the front section of the bi-fold door and the roof. The front wheel assembly was knocked off the case vehicle by the impact. The direct damage from the initial impact began at the right front bumper corner and extended rearward approximately 151 centimeters (59 inches). The impact shattered the case vehicle's fiberglass fenders and hood, and the engine compartment was shifted to the left. In addition, there was approximately 23 centimeters (9 inches) of leftward shift of both frame rails. The side-slap impact by the Chevrolet's stock trailer directly damaged the side and roof of the case vehicle forward and rearward of the right rear wheel. The direct damage began approximately 167 centimeters (65.7 inches) forward of the right rear axle and extended rearward 304 centimeters (119 inches). Induced damage involved the engine compartment, cowl, windshield, right side and roof of the case vehicle.

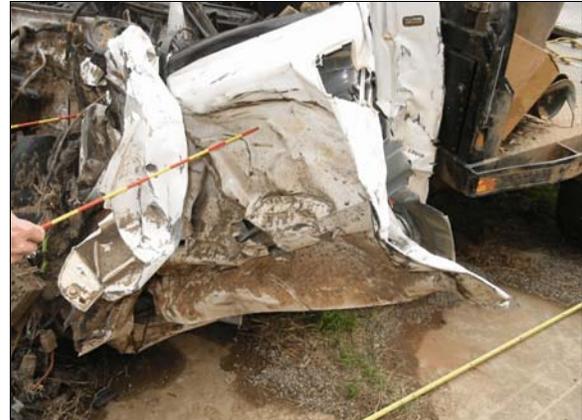
**Figure 6:** Impression of case vehicle's right front wheel in Chevrolet's driver door

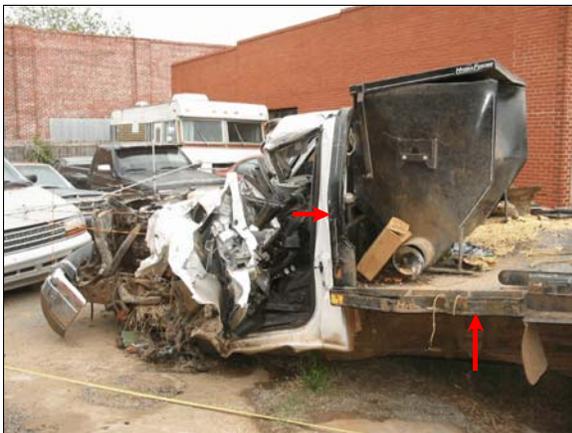
**Figure 7:** Damage to left side of Chevrolet from engagement with cowl and door of case vehicle, arrows show yellow paint transfer

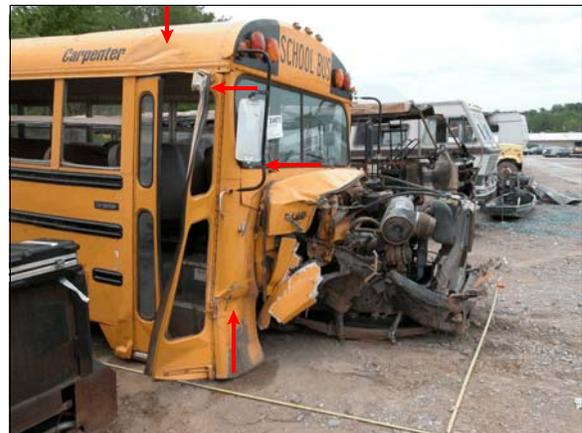
**Figure 8:** Overview of damage to cowl, side view mirror, bi-fold door and roof due to impact with Chevrolet and trailer

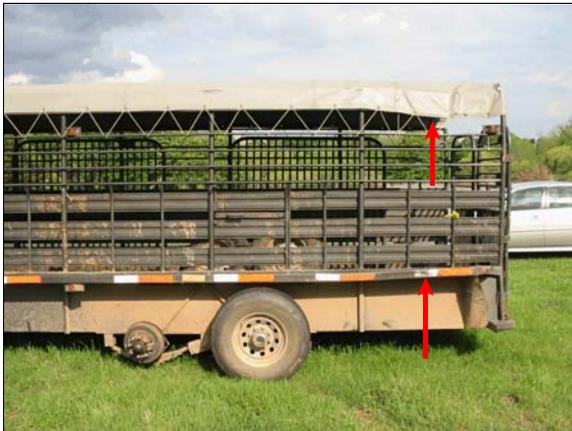
**Figure 9:** Damage to left side of stock trailer due to impact with the right side of the case vehicle

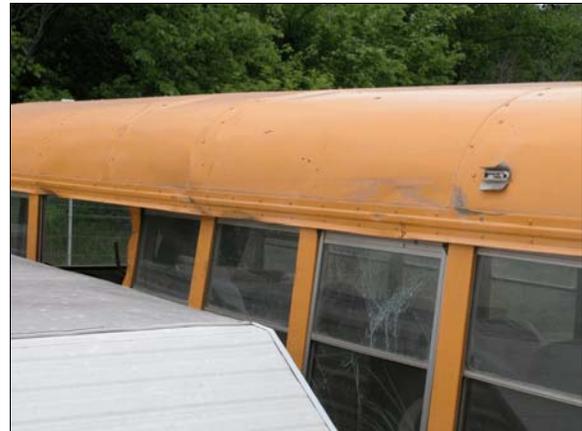
**Figure 10:** Damage to right rear side and roof of case vehicle due to impact with the left rear side of the stock trailer

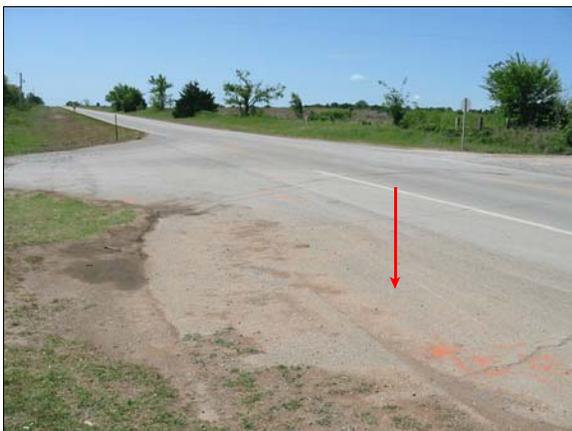
**Post-Crash:** As a result of the impact, the case vehicle rotated counterclockwise approximately 240 degrees and came to final rest on the east side of the roadway heading slightly southwest (**Figure 11**). The Chevrolet deflected to the right and traveled off the east side of the roadway and traveled approximately 156 meters (512 feet) and came to rest on the east side of the roadway heading slightly northwest (**Figure 12**).

**Figure 11:** View to southwest through case vehicle's area of final rest (arrow) back to impact area

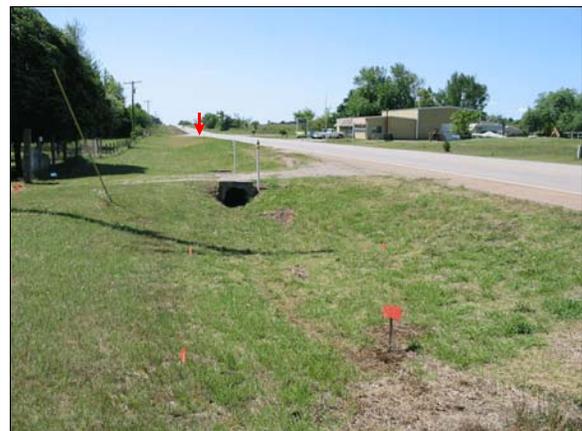
**Figure 12:** View to southwest through Chevrolet's area of final rest (orange flags), arrow shows impact area

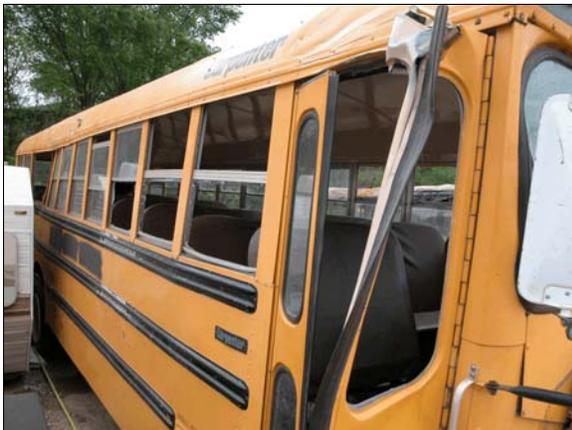
**Case Vehicle Bi-Fold Door Damage Analysis:** The front section of the bi-fold door was directly damaged and the door was twisted (**Figure 13** and **Figure 14**). The undeformed width of each of the two door sections was 33 centimeters. The top of the front door section was crushed to a width of 28 centimeters and both windows were broken out. In addition, the piano hinge on the front door section was jammed by the deformation of the cowl (**Figure 14**), and an approximate 20 centimeter (7.9 inches) section of the door actuating rod had been removed by the rescue crew to facilitate opening the door. Much of the twisting deformation of this section of the door was done as the door was forced open by the rescue crew. The rear section of the door had only minor induced damage and was free to open. It was determined by the evidence in the vehicle and an interview with rescue personnel that there was no involvement of the bi-fold door in the fatal injury to the passenger seated in the 1st row, left seat center position. The evidence in the case vehicle indicated that her fatal injury was not related to interaction with the bi-fold door, but was due to head impact to the lower window frame and window sill immediately rear of the bi-fold door (**Figures 15** and **16** below). The passenger was thrown into the door well during the crash, but she was not physically pinned by the damaged bi-fold door. The passenger was determined to have expired from her injuries prior to efforts to remove her from the vehicle.

**Figure 13:** Overview of damage to top of front section of the bi-fold door

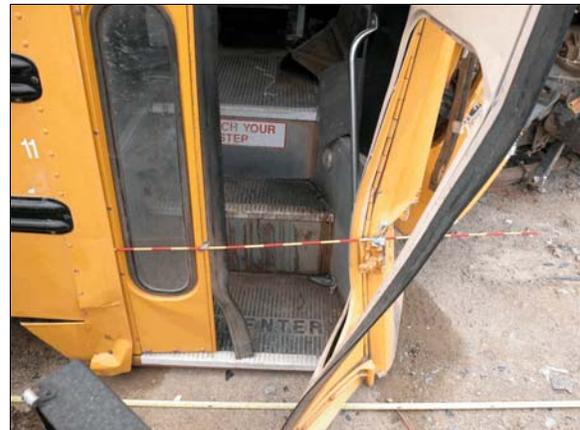
**Figure 14:** Overview of damage to front section of bi-fold door and deformation of door piano hinge

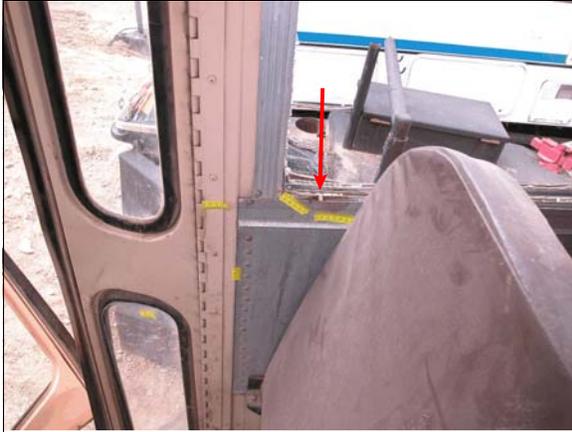
**Figure 15:** Overview of head contact (arrow) from passenger seated in 1st row, left seat center

Her head impacted the window frame, glazing and window sill immediately behind the bi-fold door (**Figures 15 and 16** above) causing blunt head trauma and contusions to her face and head. Her torso also impacted the window frame, glazing and side surface in the right first row seat area (**Figures 17** above and **Figure 18**). She was subsequently thrown into the stair well as the case vehicle rotated counterclockwise and came to final rest against the bi-fold doors.

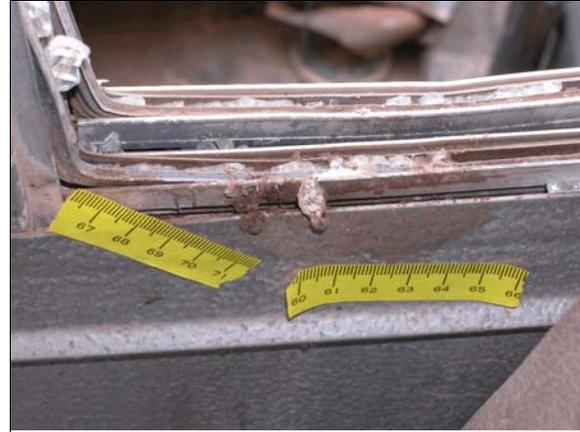
**Figure 16:** Close view of head contact to window frame and side surface immediately rear of bi-fold door

**Vehicle Interior:** Inspection of the case vehicle's interior revealed occupant contact evidence on the right side window frame and window sill immediately rear of the bi-fold door. This area was just in front of the cushion barrier located between the right first seat row and the door well. The occupant contact evidence on the window frame and window sill consisted of tissue, blood and a few strands of hair. In addition, there was a large deposit of blood on the steps in the door well. Immediately behind the cushion barrier in the right first seat row was evidence of a hard occupant impact to the window frame and side surface. This impact was of sufficient severity that it bowed the window frame and side surface outward (**Figure 17** and **Figure 18** below). The window glazing was also broken. The source of both of these areas of damage was contact by the fatally injured passenger who was seated in 1st row, left seat center. Evidence of occupant contact was also found in the right second passenger seat area. A 15-year-old female passenger was seated in the window seat in this position. The side window was broken, the window frame was bent outward and the side surface appeared to have been impacted. In addition, the right portion of the seat back in front of this position appeared slightly deformed.

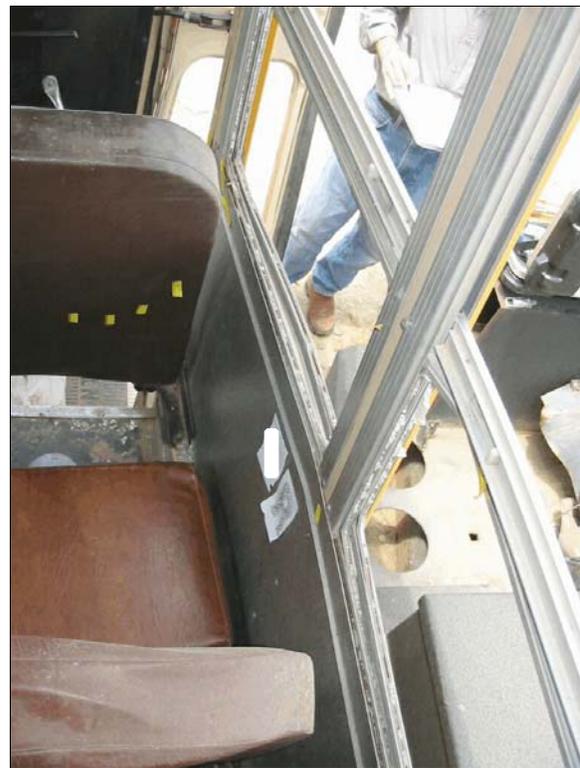
**Figure 17:** Damage to right side from impact by passenger seated in 1st row, left seat center

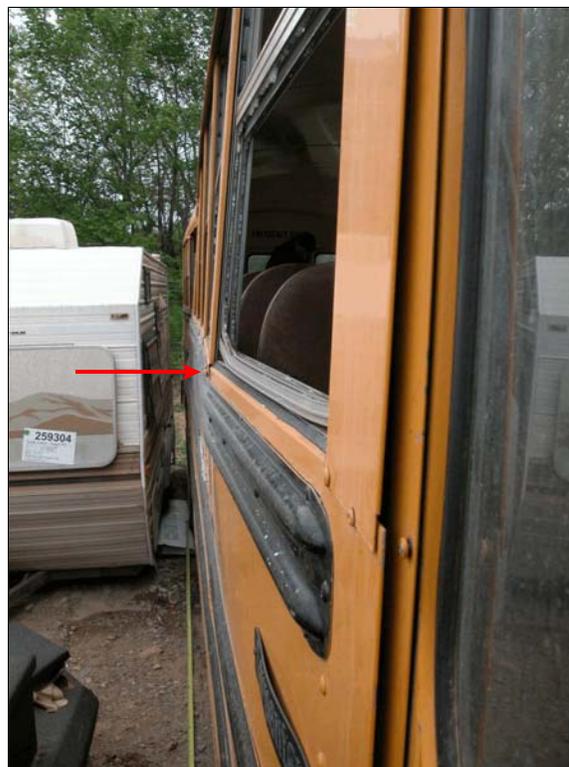
**Figure 18:** Outward buckle of right side of case vehicle (arrow) due to interior impact by passenger seated in the 1st row, left seat center

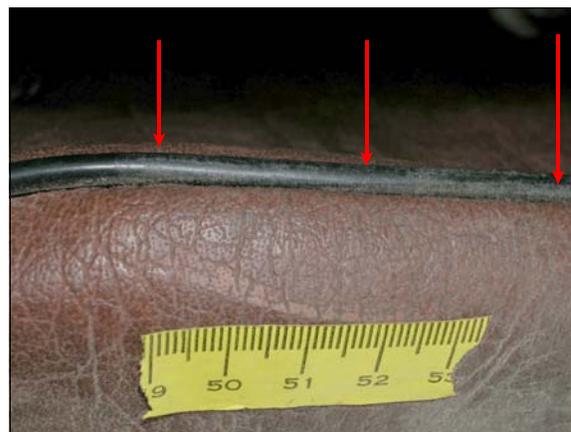
The evidence observed at the vehicle inspection indicated the driver was restrained by her manual lap belt. There was an abrasion on the seat cushion and piping on the left side of her seat (**Figure 19**) consistent with loading by the lap belt, and the seat frame and metal safety belt buckle anchor (**Figure 20** below) were bent to the right consistent with loading by a restrained driver during the crash. In addition, there were blood stains on the lap belt consistent with the lap belt being out of its retractor in the crash. The driver also reported belt pattern bruising on her hips and abdomen.

**Figure 19:** Safety belt abrasion on left side of driver's seat cushion and seat cushion piping (arrows)

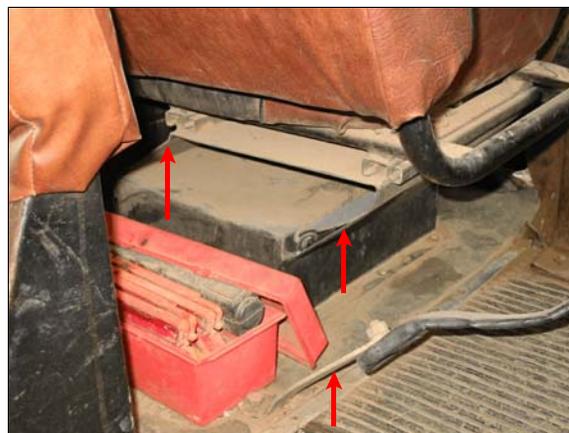
**Figure 20:** Base of case vehicle driver’s seat and safety belt anchor shifted to the right

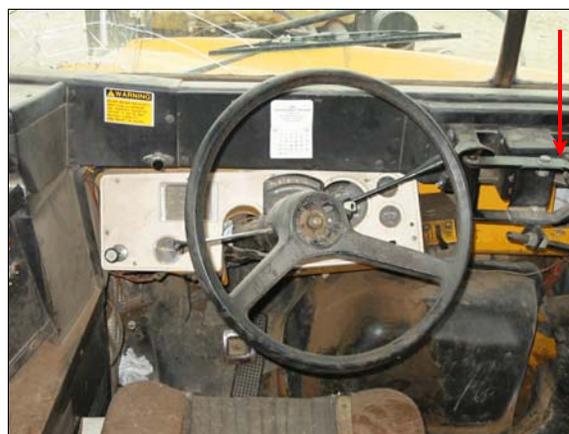
**Figure 21:** Case vehicle’s left instrument panel and steering wheel, arrow shows door control lever

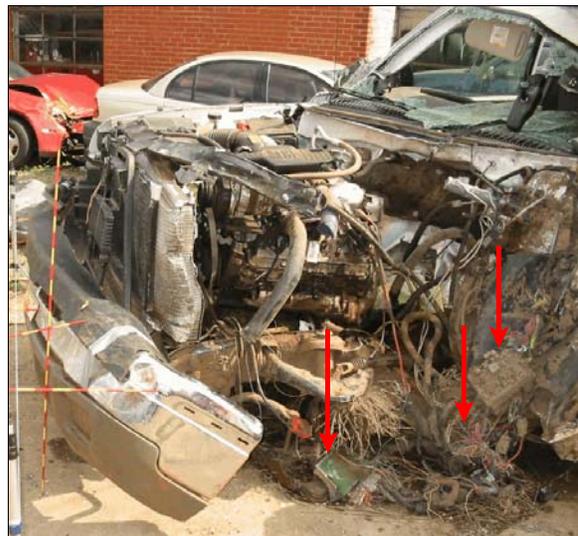
Neither the driver nor front right passenger air bags deployed in this crash. This contractor believes that due to the underride, which resulted in minimal bumper crush and no engagement of the vehicle's frame, the crash pulse was elongated and the electrical system was disrupted cutting power to the air bag system before deployment threshold was reached.

**Figure 22:** Arrows show Chevrolet's destroyed electrical wiring and electrical components
