Certified Advanced 208 Compliant Vehicle Investigation / Vehicle to vehicle
Dynamic Science, Inc. / Case Number: DS05021
2005 Lexus RX330
California
September 2005

1. Report No. DS05021		2. Government Accession No.		3. Recipient Catalog No.	
4. Title and Subtitle Certified Advanced 208 Compliant Vehicle Investigation				5. Report Date April 17, 2006

This on site investigation focused on the air bag system in a Certified Advanced 208-Compliant (CAC) vehicle (2005 Lexus RX330). The multi-stage air bags were certified by the manufacturer to meet the advanced air bag requirement of Federal Motor Vehicle Safety Standard (FMVSS) No. 208. The Lexus RX330 sport utility vehicle was being driven by a 19-year-old female. The Lexus was struck on the left front by a 1992 Honda Accord in an intersection crash. The impact resulted in sufficient longitudinal deceleration of the Lexus to command the deployment of the frontal air bag system, including the driver's knee air bag. The Lexus was redirected to the right and struck a concrete curb with its front right tire. There were no reported injuries. Both vehicles were towed from the scene due to damage.

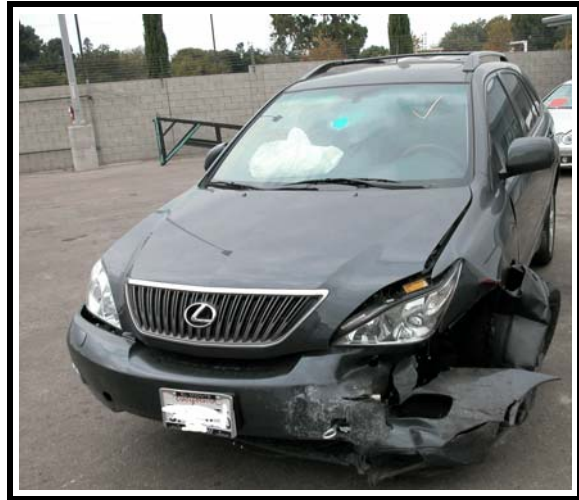
Figure 1. Front left, 2005 Lexus RX330

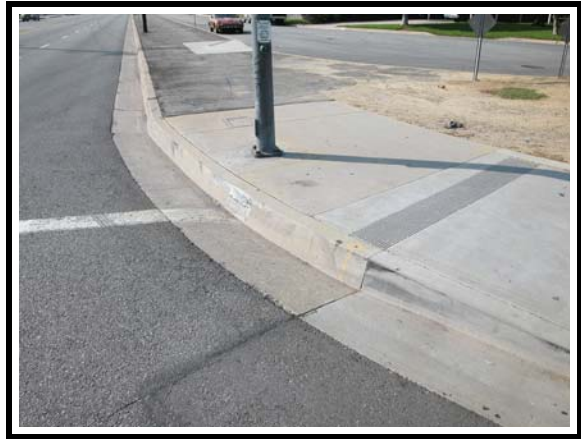
The left front of the Lexus struck the center front of the Accord. The impact severity was moderate and resulted in the deployment of the frontal air bag system in the Lexus. The missing vehicle routine of the WinSmash program computed a total delta V of 12.0 km/h (7.5 mph), based on the Lexus' front crush profile. The longitudinal and lateral components were -11.8 km/h (-7.3 mph) and 2.1 km/h (1.3 mph), respectively. The Lexus was redirected to the right and struck a raised concrete curb on the northwest corner of the intersection with its front right tire. The Accord rotated in a counterclockwise direction and came to rest in the intersection.

Figure 3. Impact 2, curb impact

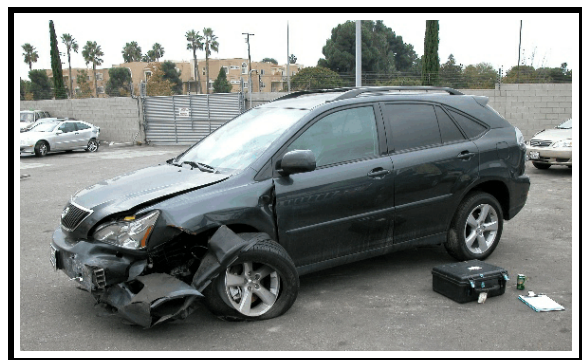
Damage Description: The 2005 Lexus RX330 sustained moderate front end damage as a result of the impact with the Honda Accord. The direct damage began 28.0 cm (11.0 in) left of the vehicle centerline and extended 43.0 cm (16.9 in) to the left bumper corner. The hood, bumper and left fender were damaged. The left front tire was restricted and flattened. The tire had come off the rim. The left wheelbase was shortened by 21.5 cm (8.5 in). All the doors remained closed and operational. The driver's door would open but with some difficulty. Six crush measurements were documented at the bumper level (at the width of the backing bar) as follows: C1 = 6.0 cm (2.4 in), C2 = 5.0 cm (2.0 in), C3 = 3.0 cm (1.2 in), C4 = 1.0 cm (0.4 in), C5 = 0 cm (0 in), C6 = 0 m (0 in).

CDC: Impact 1: 12FYLW1
Impact 2: 12FLWN3

Delta V (Impact 1):	Total	12.0 km/h (7.5 mph)
	Longitudinal	-11.8 km/h (-7.3 mph)
	Latitudinal	2.1 km/h (1.3 mph)
	Energy	8,500 joules (6,269 ft lbs)

Figure 4. Left side, 2005 Lexus

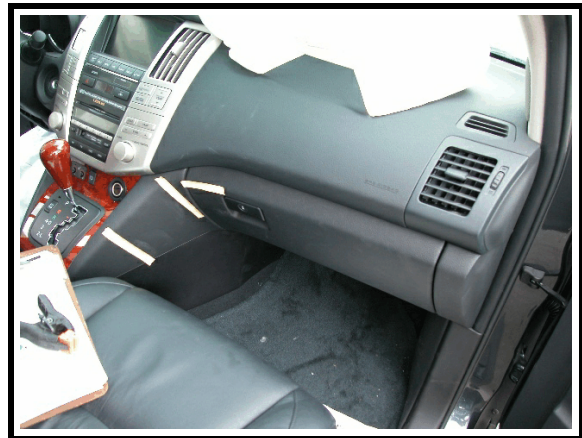
The 2005 Lexus RX330 sustained minor interior damage as a result of occupant contacts. Left knee scuffing was observed on the glove box and center console. The scuffing measured 15.0 cm (5.9 in) high by 13.0 cm (5.1 in) wide on the center console and 8.0 cm (3.1 in) wide by 7.0 cm (2.8 in) high on the glove box. Scuffs were observed on the bottom of the steering column. Food was spilled along the right side of the driver's seat. A white scuff was found on the right side of the front passenger's seat back.

Figure 5. Scuff from left knee of front right occupant

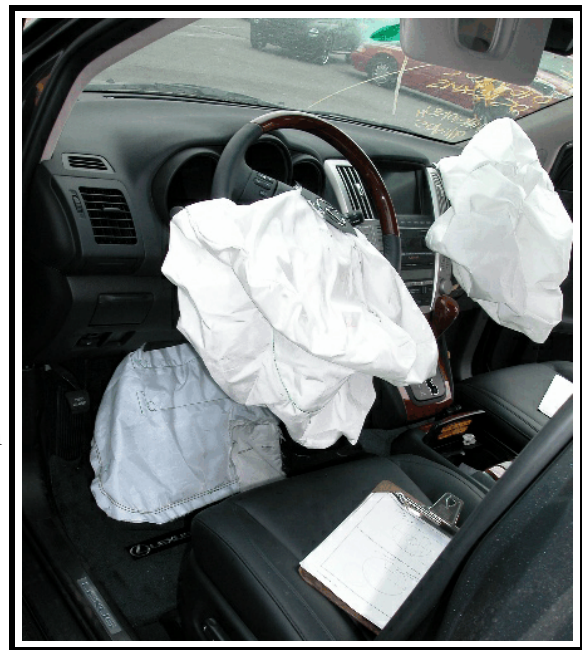
Figure 6. Frontal air bags

The driver's air bag deployed from the center of the steering wheel hub through Y-configuration module cover flaps. The top flap measured 13.0 cm (5.1 in) wide by 8.0 cm (3.1 in) high. The bottom flaps were symmetrical and measured 5.0 cm (2.0 in)/6.5 cm (2.6 in) high by 7.0 cm (2.8 in) wide. The deployed driver's air bag measured 64.0 cm (25.2 in) in diameter in its deflated state. The air bag was configured with a single internal tether that was attached to a 13.0 cm (5.1 in) diameter circular panel in the center of the air bag face. Two rectangular vent ports were located near the 12 o'clock aspect on the rear of the air bag.

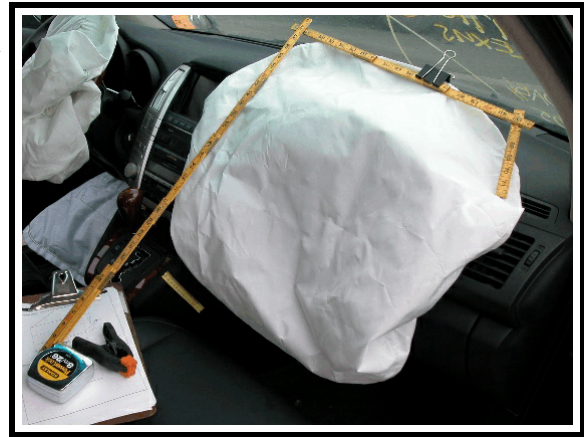
Figure 7. Front right passenger's air bag

The front right passenger's air bag deployed from a top mount module with symmetrical H configuration module cover flaps. The module flaps measured 10.0 cm (3.9 in) wide by 8.0 cm (3.1 in) high. The deployed front right passenger's air bag measured 58.0 cm (22.8 in) seam to seam and 65.0 cm (25.6 in) high. The maximum deflated excursion measured 69.0 cm (27.1 in). Two circular vent ports were located at the 3 and 9 o'clock aspects of each side panel of the air bag.

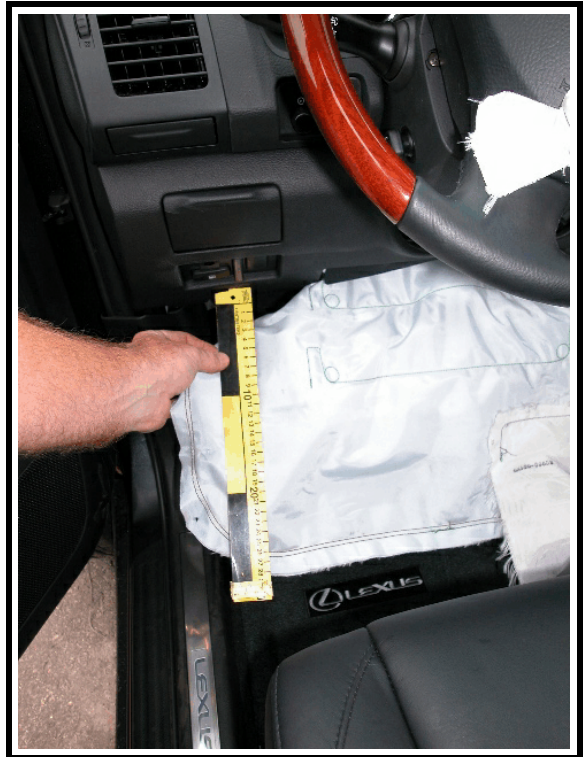
The driver's knee air bag deployed from a bottom mount module with symmetrical H configuration module cover flaps. The module flaps measured 24.0 cm (9.4 in) wide by 8.0 cm (3.1 in) high. The deployed driver's knee air bag was rectangular and measured 58.0 cm (22.8 in) wide and 33.0 cm (12.9 in) deep. Faint blue scuffing that measured 6.0 cm (2.4) by 7.0 cm (2.8 in) was located at the bottom left corner of the top of the air bag.

Figure 8. Driver's knee air bag
