CALSPAN ON-SITE CHILD SAFETY SEAT CRASH INVESTIGATION

CASE NO: CA05-055

VEHICLE: 1994 PLYMOUTH VOYAGER

CRASH DATE: OCTOBER 2005

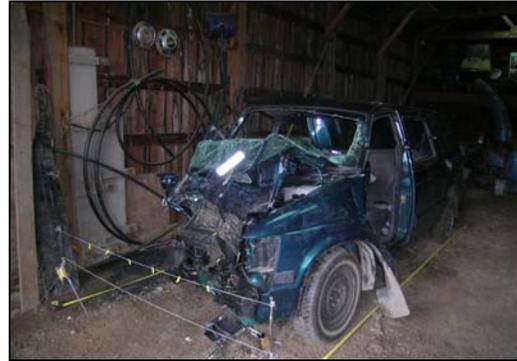
Figure 1 - Damaged 1994 Plymouth Voyager.

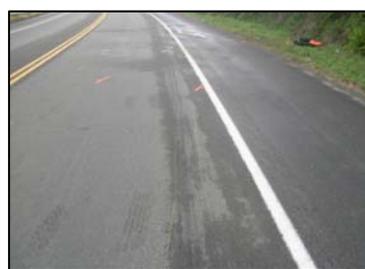
The 50-year old female driver of the Plymouth Voyager was traveling in an easterly direction on a two-lane roadway negotiating a right curve (**Figure 2**). According to a witness the vehicle was driving erratically weaving in out of the eastbound lane. As the Plymouth was negotiating the curve it entered the westbound lane and impacted a 1993 Chevrolet K-1500 pickup truck that was westbound on the same roadway (**Figure 3**). The 43-year old male driver of the Chevrolet applied and locked up his brakes prior to the impact evidenced by a 6.9 m (22.6') long skid mark from the front right tire. Roadway gouging was also present at the point of impact (**Figure 4**).

Figure 4 - Point of impact.

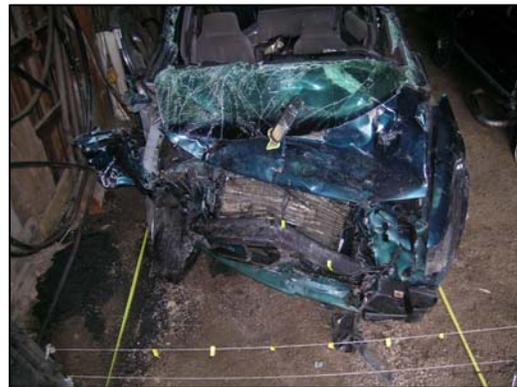
The 1994 Plymouth Voyager sustained severe frontal damage as a result of the impact with the Chevrolet (**Figure 5**). The direct contact damage began 29 cm (11.6") left of the vehicle's centerline and extended 80 cm (31.5") to the front right bumper corner. The combined direct and induced damage encompassed the entire width of the bumper beam and measured 113 cm (44.5"). The maximum crush was located at the front right bumper corner and measured 84 cm (33.1") in depth. The crush profile consisted of six equidistant crush measurements taken along the bumper beam and was as follows: C1 = 12 cm (4.7"), C2 = 50 cm (19.7"), C3 = 66 cm (26"), C4 = 75 cm (29.5"), C5 = 73 cm (28.7"), C6 = 84 cm (33.1"). The Collision Deformation Classification (CDC) for the impact with the Chevrolet was 12-FDEW-4.

Figure 5 - Crush profile of 1994 Plymouth Voyager.

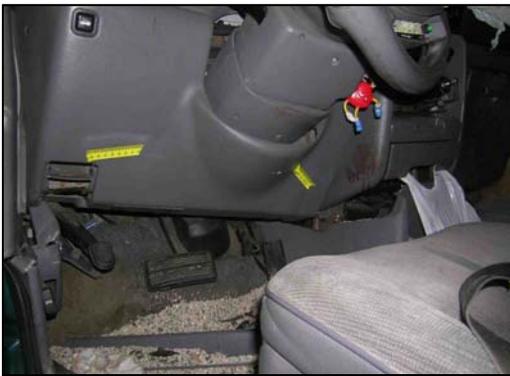
The 1994 Plymouth Voyager sustained moderate interior damage as a result of passenger compartment intrusion and occupant contact. The left rigid plastic knee bolster exhibited prominent scuff marks under the steering column on the left side due to probable contact

of the driver's knees (**Figure 6**). The first scuff mark attributed to the driver's left knee was located 10 cm (3.9") inboard of the left aspect and 13 cm (5.1") above the bottom edge of the instrument panel and was 8 cm (3.1) in length. The second scuff mark attributed to the driver's right knee was located 44 cm inboard of the left edge and 13 cm (5.1") above the bottom edge of the instrument panel and measured 11 cm (4.3") in length. Body fluid transfers were also present on the lower knee bolster and on the underside of the steering column. The brake pedal was bent probably due to a combination of toe pan intrusion accompanied with foot placement and loading force due to the kinematics of the driver (**Figure 7**). The steering wheel rim was also deformed as the driver loaded through the air bag and her abdomen contacted the lower aspect of the rim (**Figure 8**). The bottom half of the steering wheel rim bent forward 3 cm. (1.2"). The steering column completely separated from the shear capsules (**Figure 9**).

Figure 6 - Damaged knee left bolster.

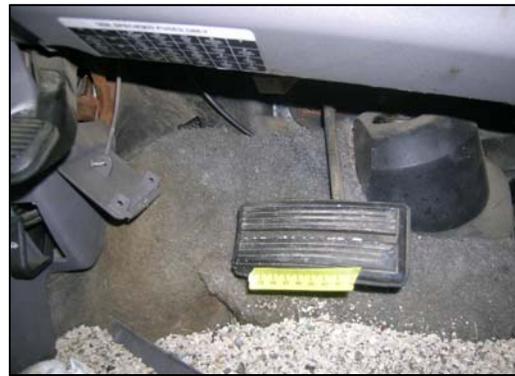
Figure 7 - Bent brake pedal.

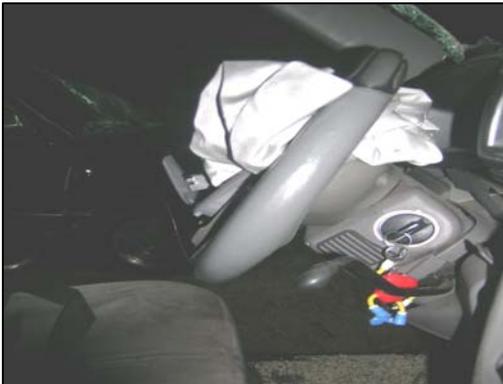
Figure 8 - Bent steering wheel rim.

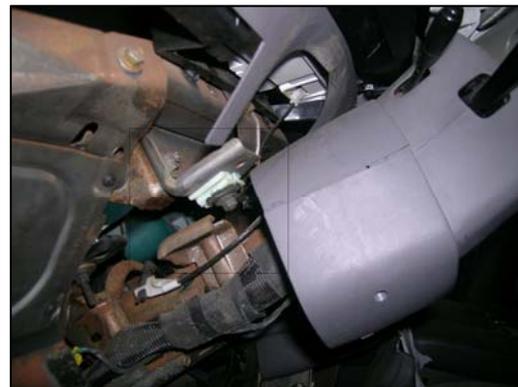
Figure 9 - Left shear capsule separation.

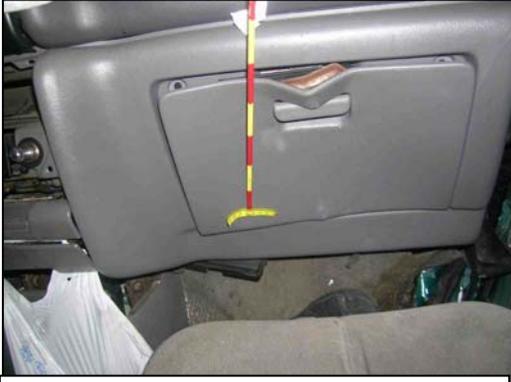
The right side knee bolster exhibited well-defined deformation from contact with the knees of the 19-year old male seated in the front right position. The deformation bowed the glove compartment door and was located inboard of the outer right edge and above the bottom edge of the instrument panel in two locations. The left knee contact (**Figure 10**) was located 44 cm (17.3") inboard and 11 cm (4.3") above the panel and the right

Figure 10 - Left knee contact evidence on front right glove compartment door.

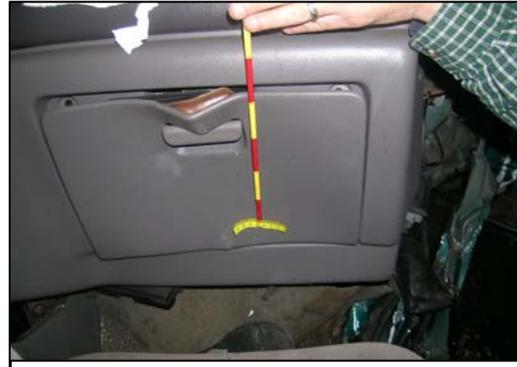
knee contact (**Figure 11**) was located 25 cm (9.8”) inboard and 14 cm (5.5”) above the bottom aspect. Both contacts were linear and measured approximately 5 cm (2”).

Figure 11 - Right knee contact evidence on glove compartment door.

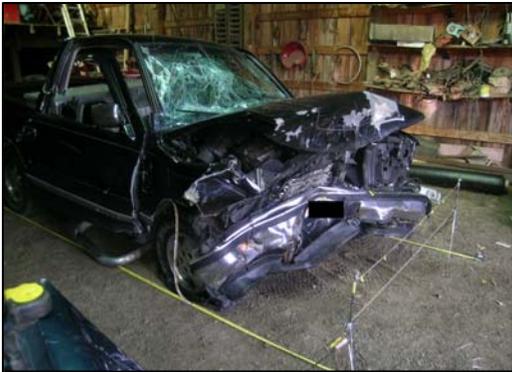
The 1993 Chevrolet K-1500 pickup truck sustained severe frontal damage as a result of the impact with the Plymouth (**Figures 12 and 13**). The direct contact damage began 38 cm (14.8”) left of the vehicle’s centerline and extended 116 cm (45.8”) to the front right bumper corner. The combined direct and induced encompassed the entire front bumper and measured 156 cm (61.5”). The maximum crush was located at the front right bumper

Figure 12 - Damaged 1993 Chevrolet K-1500.

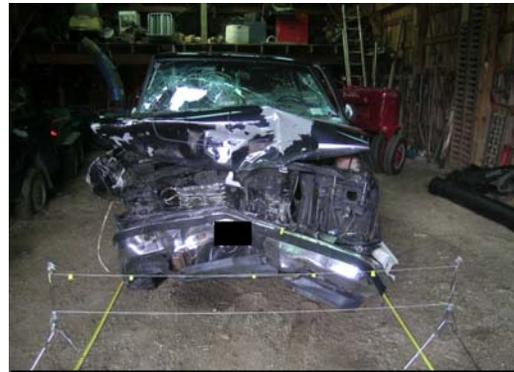
corner and measured 82 cm (32.3") in depth. The crush profile was measured along the damaged bumper and was as follows: C1 = 5 cm (2"), C2 = 28 cm (11"), C3 = 51 cm (20.1"), C4 = 69 cm (27.2"), C5 = 81 cm (31.9"), C6 = 82 cm (32.3"). The CDC for the impact with the Plymouth was 12-FDEW-4.

Figure 13 - Crush profile of 1993 Chevrolet K-1500.

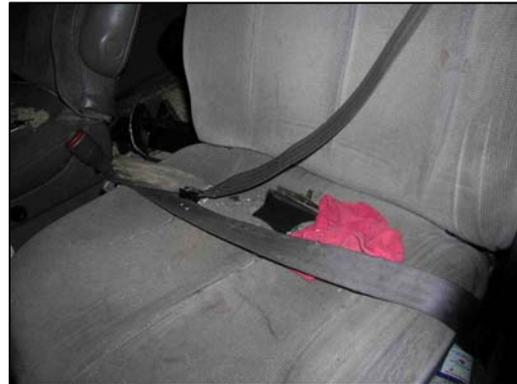
Figure 14 - Driver's 3-point lap and shoulder restraint.

emergency personnel to remove the driver from the vehicle (Figure 14). The webbing of the belt was roped inside the hardware of the cinching latch plate. Due to the roping of the webbing, the latch plate was in a fixed position 72 cm (28.5") above the anchor point. Occupant loading in the form of fiber transfers was present on the lap portion of the belt that began 23 cm (9") above the anchor point and terminated 71 cm above the same. The total length of the fiber transfer was 47 cm (18.5"). The incision on the shoulder belt was 19 cm (7.5") above the latch plate. There was no loading evidence on the front right seatbelt which is indicative of non-usage. Typically, in high severity crashes such as this,

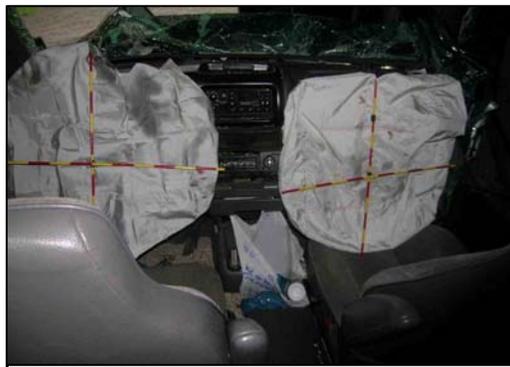
The 1994 Plymouth Voyager was equipped with frontal air bags for the driver and front right passenger positions (**Figure 15**). The driver's air bag was housed in the center of the steering wheel hub. The driver's air bag deployed from the steering wheel hub through symmetrical H-configuration module cover flaps. The cover flaps measured 18 cm (7") in width and 6 cm (2.5") in height. The driver's air bag measured 56 cm (22") in its deflated state and had an excursion of 33 cm (13"). The air bag was vented by two circular ports located in the 11 and 1 o'clock sectors on the back of air bag. The air bag was not tethered. There was no contact evidence on the air bag membrane. The following nomenclature was stamped on the bag of the air bag:

Figure 15 - Deployed frontal air bags.

The front right passenger's air bag deployed from a top-mount module configured with a single rectangular vinyl cover flap hinged at the top aspect. The cover flap measured 32 cm (12.5") in width and 15 in (5.75) height. The air bag measured 47 cm (18.5") in width and 56 cm (22") in height in its deflated state. The total excursion of the air bag was 57 cm (22.5"). The air bag was internally vented and was tethered by a single strap measuring 29 cm (11.5") in length. There was a body fluid transfer on the upper middle right aspects passenger's air bag.

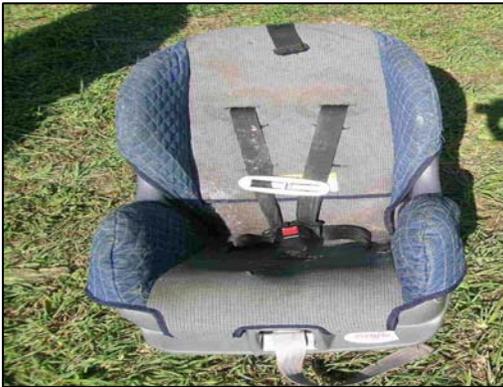
A convertible Evenflo Tribute CSS (**Figure 16**) was installed forward-facing in the third row right position of the Plymouth Voyager. The CSS was removed from the vehicle and located at the home of a family member where it was inspected. The model number was

Figure 16 - Evenflo Tribute convertible CSS.

At the time of the CSS inspection, the harness straps were routed through the top slots consistent with forward facing use. The harness retainer clip was positioned 24 cm (9.5") below the harness slots. There left harness webbing exhibited loading evidence located 32 cm (12.5") below the harness slots where the webbing was roped within the left latch plate. There were no discernable stress marks on the seat or shell of the CSS.

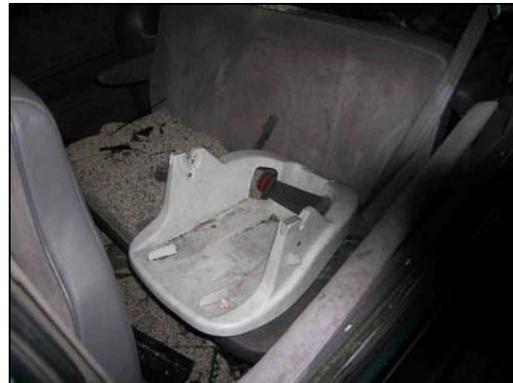
The base for a Cosco infant CSS was found installed in the second row left position during the SCI inspection (**Figure 18**). The model number for the CSS base was 4359

3340. No information was available on the model name or the date of manufacture. The base was 53 cm (20.75”) in length and 36 cm (14”) in width. It was secured in the vehicle by a manual 3-point lap and shoulder belt with a cinching latch plate. The base had a side-to-side excursion of approximately 5 cm (2”) there was minor rippling to the belt. The base was not used during the crash. The occupancy status of the second row left seating position was confirmed through a surrogate interview.

Figure 18 - Base for Cosco infant CSS.
