**ON-SITE AIR BAG NON-DEPLOYMENT/DRIVER FATALITY INVESTIGATION**  
**CALSPAN CASE NO: CA05-060**

**VEHICLE: 2004 FORD F150 PICK-UP TRUCK**  
**LOCATION: NORTH CAROLINA**  
**CRASH DATE: AUGUST, 2005**

<p>15. Supplementary Note An investigation of the non-deployment of the driver air bag in a 2004 Ford F150 in a frontal crash.</p>			
<p>16. Abstract This investigation focused on the crash dynamics, fatal injury sources, and the issues surrounding the non-deployment of the driver air bag in a 2004 Ford F150 Supercab Pick-up Truck during a fixed-object crash. The 66 year old driver of the Ford was restrained at the time of the crash by the manual safety belt and sustained fatal injuries due to contact with the steering wheel rim/column. He was the vehicle's sole occupant. The subject Ford departed the left side of the road for unknown reasons, and sustained an undercarriage impact with an embankment covering a culvert prior to a frontal impact with a hardwood tree. The Ford F150 was equipped with a Certified Advanced 208-Compliant (CAC) air bag system. The manufacturer of this vehicle certified that the F150 met the requirements of the advanced 208 Federal Motor Vehicle Safety Stand

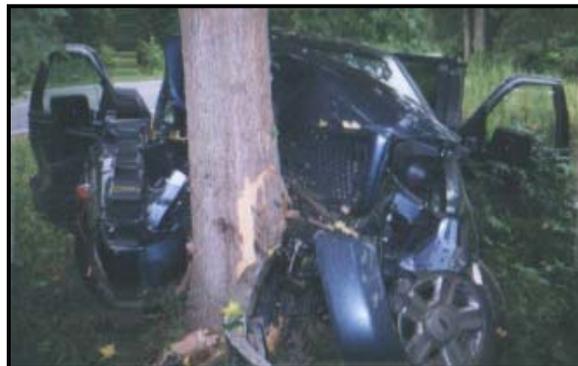
**Figure 1: On-scene police photograph of the Ford at final rest.**

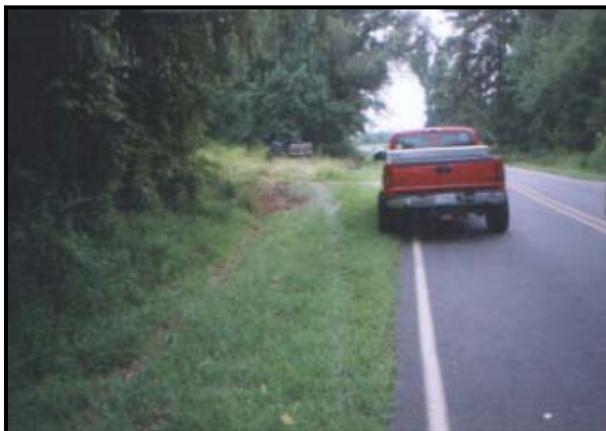
**Figure 2: Police photograph of the Ford's trajectory.**

The Ford F150 was driven by a 66 year old restrained male and was traveling southbound. The driver was the vehicle's sole occupant. For unknown reasons, the driver relinquished directional control of the vehicle allowing the Ford to cross the centerline, pass through the opposing travel lane, and depart the east (left) side of the road. The vehicle departed the road at a shallow angle (estimated at 5 degrees) in a tracking trajectory. Refer to **Figure 2** above.

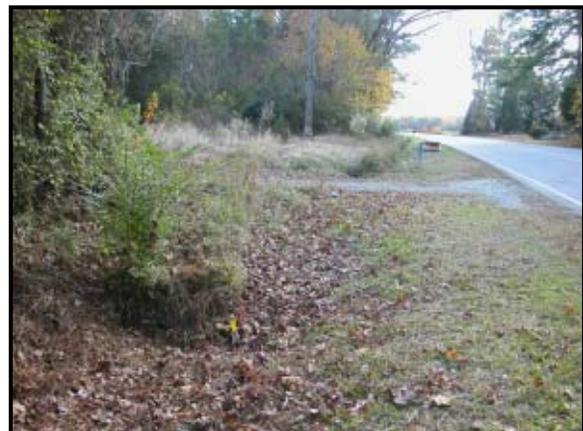
**Figure 3: Trajectory view at the culvert.**

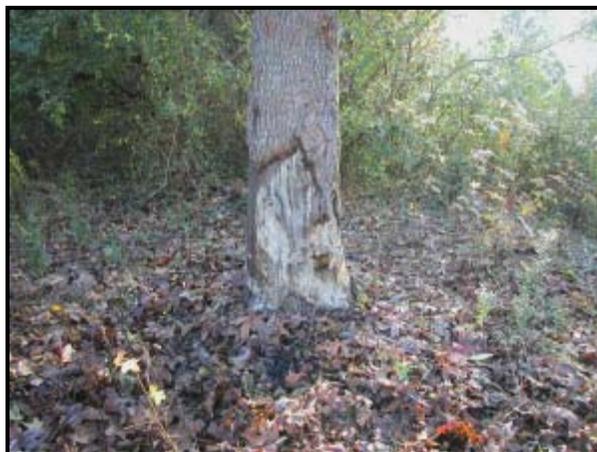
**Figure 4: View of the struck tree.**

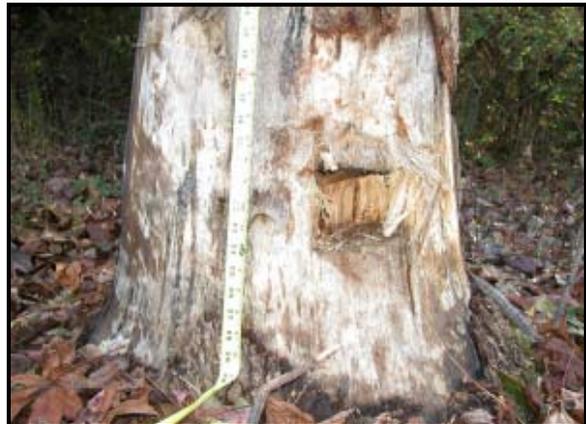
**Figure 5: Close-up view of the tree and the removed plug.**

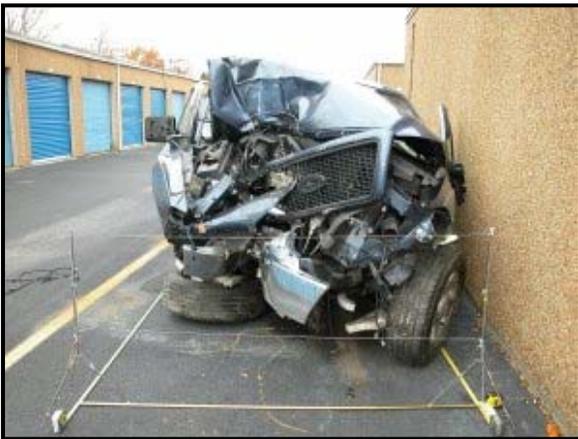
The exterior damage to the Ford consisted of dirt and debris embedded in the front undercarriage (Event 1), and severe impact damage to the front right aspect of the vehicle as a result of the tree impact (Event 2). **Figure 7** is a front view of the Ford. The alignment of the vehicle at impact was defined by the lateral location of the right frame rail relative to the plug fractured from the tree trunk. At impact, the centerline of the truck was located 53 cm (20.7 in) left of the center of the tree. The centerline of the truck was not involved in the direct contact. The direct contact damage at the bumper elevation began 9 cm (3.5 in) right of center and extended to a point located 56 cm (22.0 in) right of center. The direct damage along the hood face began 10 cm (4.0 in) right of center. The right frame rail collapsed and buckled longitudinally. The maximum crush of the rail measured 127 cm (50.1 in). Due to the penetration of the tree, the bumper

**Figure 7: Front view of the F150.**

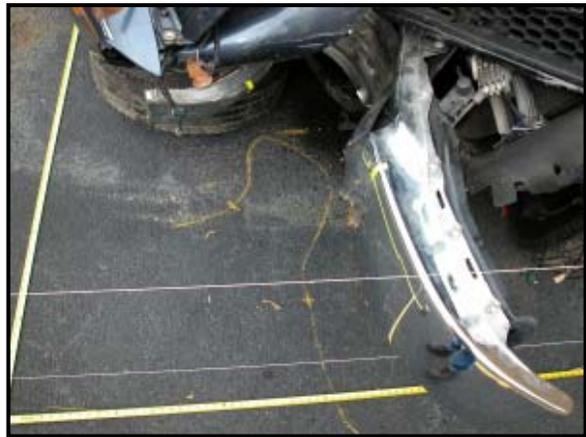
system and front structures of the Ford wrapped around the trunk. **Figure 8** is an overhead view of the bumper profile and its projection to the ground. The left frame rail deformed inboard and rearward due to bending. The end of the deformed left frame rail measured 55 cm (21.9 in) rearward and 55 cm (21.7 in) inboard of its original location. The residual crush profile was as follows: C1 = 15 cm (5.9 in), C2 = 127 cm (50.0 in), C3 = 129 cm (50.6 in), C4 = 94 cm (36.9 in). The right lower radiator mount was displaced rearward 77 cm (30.3 in). **Figure 9** is a right side view of the Ford. The right wheelbase was foreshortened 33 cm (12.9 in) and its suspension was rotated 90 degrees inboard. The left wheelbase was lengthened 22 cm (8.6 in) due to frame bending. The rake angles of the right and left A-pillars measured 53 degrees and 38 degrees, respectively. For reference, the rake angle of the A-pillar measured on an exemplar vehicle was 35 degrees. The steeper angle of the deformed right A-pillar caused a 26 cm (10.3 in) vertical buckle in the front right roof area. There was evidence of direct cab-to-bed contact at both left and right B-pillars due to compression. All the doors were open at the time of the inspection and could not be closed due to the body deformation. The Collision Deformation Classifications (CDC's) of the Ford were 00-UYDW1 and 12-FZAW6 for Events 1 and 2, respectively. The dynamics of the narrow object impact were beyond the limits of the WINSMASH model. The delta V of the crash was in excess of 55 km/h (34 mph).

**Figure 8: Overhead view of the bumper deformation.**

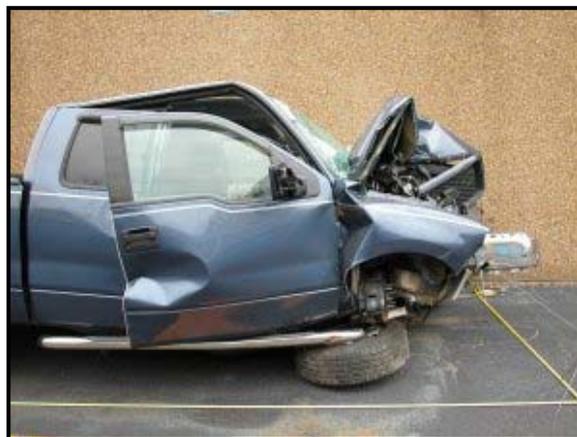
**Figure 9: Right side view.**

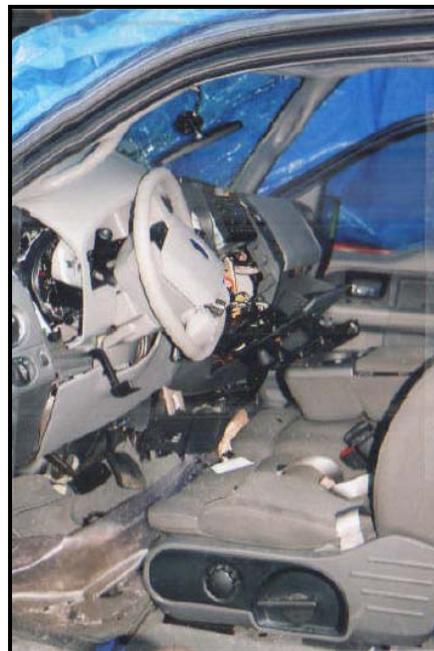
Two contact areas attributed to the driver's lower extremities were identified. The handle of the parking brake release was fractured due to contact with the left lower extremity. This contact was located on the lower instrument panel, 29 cm (11.5 in) left of the steering column. The right lower extremity contacted the bolster 18 cm (7.0 in) right of the steering column evidenced by a 10 cm x 8 cm (4 in x 3 in) scuff mark. A 3 cm (1 in) diameter fluid spatter was identified on the outboard aspect of the left sunvisor.

**Figure 10: Left front interior.**

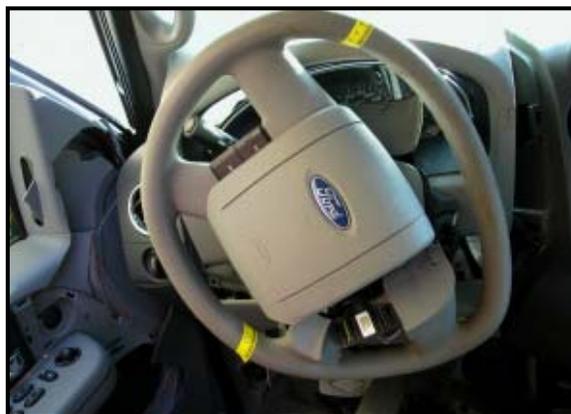
The four-spoke steering wheel rim was rotated 80 degrees clockwise at inspection. The cast alloy rim was deformed forward 15 cm (6.0 in) in the 3 o'clock sector and the 3 and 5 o'clock spokes were fractured. The deformed rim became elliptical in shape measuring 39 cm (15.5 in) in the 3/9 sector and 30 cm (12.0 in) in the 6/12 sector. The fractured spokes exposed the non-deployed driver air bag module. The intrusion of the steering wheel rim/column measured at the center hub was 14 cm (5.5 in).

**Figure 11: Deformed steering wheel rim and undeployed driver air bag module.**

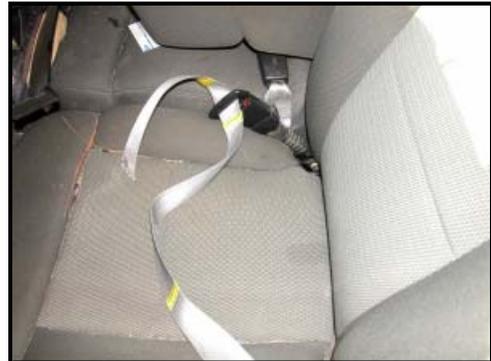
The driver’s manual restraint consisted of an integrated 3-point lap and shoulder belt with continuous loop webbing, sliding latch plate, Emergency Locking Retractor (ELR), and buckle pretensioner. Initial inspection of the manual restraint revealed the webbing had been cut by the first responders. The latch plate was still buckled into the receiver. The length of the cut webbing measured 91 cm (36 in) referenced to the outboard anchor. The balance of the webbing had spooled back into the seatback mounted retractor and was not visible for inspection. The lap portion of the cut webbing revealed 34 cm (13.5 in) of loading evidence. The loaded section began 25 cm (10.0 in) above the anchor. The webbing was creased within a 6 cm (2.5 in) section at the latch plate and an examination of the latch plate hardware revealed the friction surface of belt path was abraded. The latch plate revealed evidence of historical use. The buckle pretensioner did not fire. The measured length of the pretensioner barrel was 57 mm (2.25 in) consistent with the unused front right pretensioner measurement. This pretensioner measurement was also verified with an exemplar vehicle. Inspection of the driver’s manual restraint indicated he was restrained at the time of the crash and loaded the safety system during the ride-down of the event.

**Figure 12: Driver's manual restraint.**

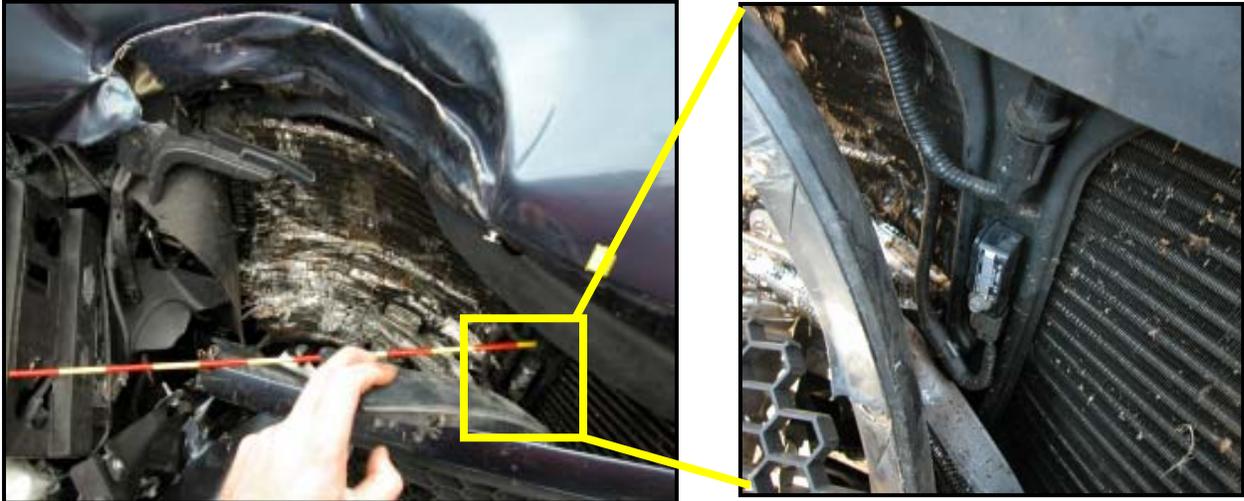
The frontal air bag system in the subject 2004 Ford F150 consisted of Certified Advanced 208 Compliant driver and front right passenger air bags. The manufacturer of the vehicle certified the F150 met the requirements of the advanced air bag FMVSS 208 standard. The system consisted of dual stage frontal air bags, a driver seat track position sensor, front safety belt buckle switch sensors, front safety belt pretensioners, and a front right occupant presence detection system. The system was monitored and controlled by a Restraint Control Module (RCM) mounted under the center instrument panel. The RCM was designed to deploy the appropriate safety systems based on the crash severity and inputs from those components. The crash and safing sensors were mounted within the RCM. The system also utilized a front satellite crash sensor mounted on the vehicle’s centerline at the radiator plane. The purpose of the satellite sensor was to enhance the transmission of a “soft” crash pulse to the RCM that may occur from a narrow object frontal impact between the frame rails. **Figure 13** is a view of the satellite sensor. The sensor was not involved in the direct contact and was undamaged.

**Figure 13: View of the undamaged front satellite sensor.**

The root cause of the non-deployed safety systems in this crash was not directly identified. There were no obvious mechanical or electrical faults. The subject vehicle was not involved in any known previous crashes; therefore a faulty repair was not an issue. Given that the location of the tree impact was directly on the frame rail, the force of the impact should have been immediately transmitted through the vehicle's frame to the crash sensors in the RCM. However, neither the driver air bag nor the driver pretensioner deployed in this crash. Upstream from the tree impact event, the Ford underwent a significant undercarriage impact with the ground beyond the culvert end. In terms of crash sensing, this event would have "woken-up" the system but the severity of the crash pulse did not require deployment of the safety systems. The vehicle then traveled over comparatively rough terrain to impact. It has been theorized that during this off-road trajectory, the sensing algorithm probably continued to analyze the long duration event and during this period the system either did not reset or timed-out, thereby suppressing the deployment of the safety systems. The non-deployed state of both the pretensioner and the driver air bag is indicative of a possible anomaly in the crash sensing, rather than a failure of a single component.
