CALSPAN ON-SITE CHILD SAFETY SEAT CRASH INVESTIGATION

CASE NO.: CA05-061

VEHICLE: 2002 FORD EXCURSION

DATE OF CRASH: DECEMBER 2005

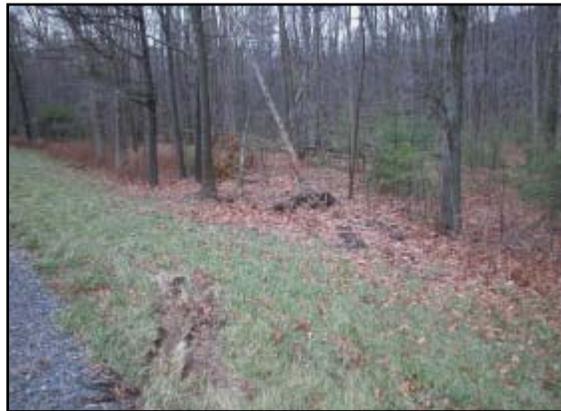
Figure 3. Yaw marks and tree impacts.

The left front fender area aft of the left front axle impacted a 24 cm (9.4") diameter tree which induced a rapid clockwise rotation. The left rear door impacted an 18 cm (7.1") diameter tree. These trees deflected at impact which allowed the Ford to ramp up the trees and induce a rollover event. As the Ford began to roll onto its left side, the left quarter panel struck a 38 cm (15") diameter tree. The vehicle continued to roll as it engaged the tree resulting in vertical crush across the full width of the roof. The Excursion came to rest on its left side facing a northeasterly direction against the 38 cm

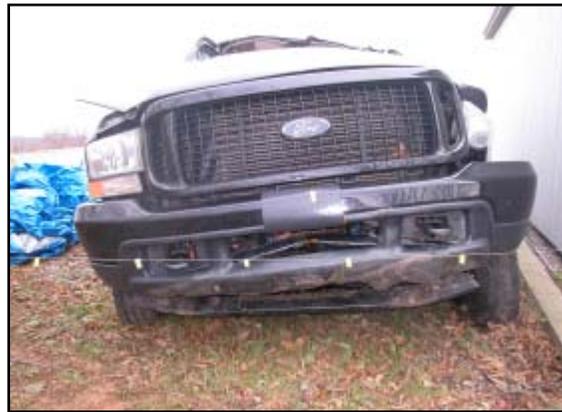
The frontal damage resulted from the impact with the ground. The maximum crush was 10 cm (4.0"), located 5 cm (2.0") right of the vehicle centerline on the bumper beam. The bumper beam was also displaced vertically by the non-horizontal impact force. The direct contact damage was located on the underside of the bumper fascia and began 70 cm (27.5") left vehicle centerline and extended 147 cm (57.8") to the right. The direct contact damage terminated inboard of the bumper corners. The residual crush was measured along the full width of the bumper beam (Field L) of 179 cm (70.5").

Figure 4. Frontal damage from the delineator post.

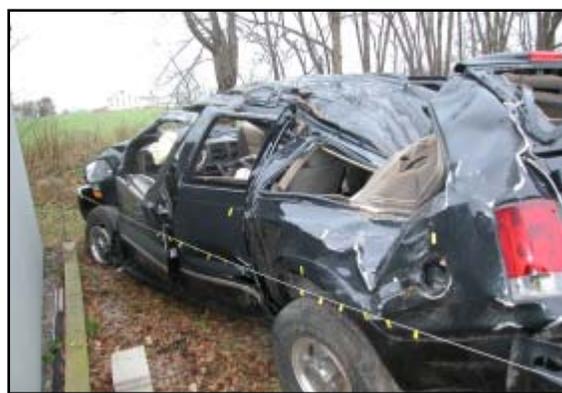
The 2002 Ford Excursion sustained minor damage from impact with the embankment (**Figure 4**) and severe damage to the left and top planes (**Figures 5 and 6**) as a result of the impacts with the trees. The delineator post impact damage was overlapped by the subsequent tree impact. The Collision Deformation Classification for this impact was estimated at 09-LFEN-1.

Figure 5. Overall view of the left side damage.

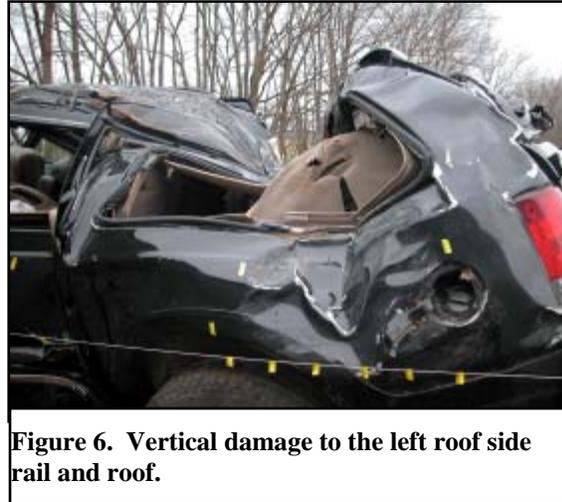
Figure 6. Vertical damage to the left roof side rail and roof.

During the rollover sequence, the Ford struck a 38 cm (15.0") diameter tree with the left rear quarter panel. The tree also engaged the left roof side rail and extended laterally the full width of the vehicle. The damage to the left side plane was documented at the mid-door level on the left rear quarter panel. The direct contact damage measured 62 cm (24.4"). The direct contact began 6 cm (2.4") and ended 68 cm (26.7") rear of the left rear axle, respectively. The maximum crush on the left side was 26 cm (10.2"). The crush profile at this level was as follows: C1 = 17 cm (6.7"), C2 = 19 cm (7.5"), C3 = 22 cm (8.7"), C4 = 26 cm (10.2), C5 = 24 cm (9.4"), C6 = 18 cm (7.1"). A crush profile was documented along the left roof side rail which was the area of maximum vertical crush. The crush profile at this location was as follows: C1 = 58 cm (22.8"), C2 = 37 cm (14.6"), C3 = 20 cm (7.9"), C4 = 23 cm (9.1"), C5 = 32 cm (12.6"), C6 = 34 cm (13.4"). The CDC for this impact was 00-TBDW-4.

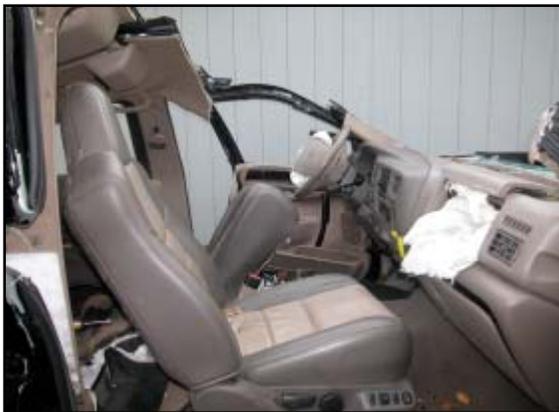
The interior of the Ford sustained severe damage that was attributed to passenger compartment intrusion and occupant contacts. The driver's contact points consisted of a black scuffmark to the left knee bolster, deformed door panel mounted arm rest, and deformed brake and parking brake pedals. The front right passengers contact points consisted of two laterally oriented black scuffmarks to the face of the glove box door. The front row section of the roof was cut from the vehicle by the fire department. The cut roof was not present at the time of the SCI inspection; therefore, it was unknown if possible occupant contact points were present to this area. Also, the front seats were cut from the vehicle during the extraction process of the driver. **Figure 7** is an overall view of the first row.

Figure 7. Overall view of the first row.

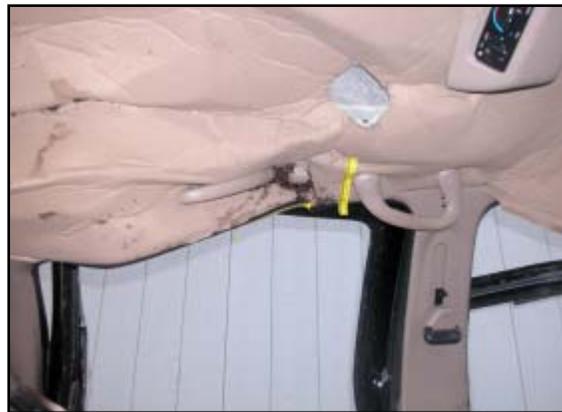
The second row left seat was occupied by the 1-year-old female passenger. The left roof side rail over this passenger's location intruded. A 22 cm (8.7") by 9 cm (3.5") area of denting/pocketing and body fluid were noted on the roof side rail (**Figure 8**). This was considered a possible occupant contact point by the 1-year-old female passenger's head.

Figure 8. Left roof side rail denting/pocketing and body fluid.

Although the installation was described as tight, the child safety was displaced vertically upward during the rollover event which allowed the 1-year-old female to contact the intruding left roof side rail with her head. This contact was supported by the

denting/pocketing and pooled body fluid at this location. This contact resulted in the left skull fracture and the left facial abrasions.

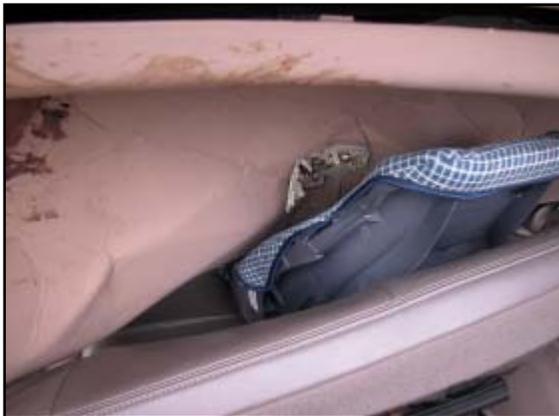
The 3-year-old female was seated in the third row right seat in a Cosco Voyager belt positioning booster seat and was restrained by the vehicles lap and shoulder belt. Due to the severe intrusion, the child safety seat was captured between the roof and seat cushion; therefore, the child safety was not fully inspected (**Figure 9**). The driver stated to the SCI investigator that the child safety seat was a Cosco Voyager. A fracture was noted to the right outboard aspect of the shell 22 cm (8.6") below the top from compression against the seat and roof (**Figure 10**). The total length of the fracture measured 19 cm (7.5"). Numerous stress marks were noted to the child safety seat shell which resulted from compression. Additionally, a cut was noted to the right aspect of the fabric cushion.

Figure 9. Belt positioning booster seat trapped by roof intrusion.

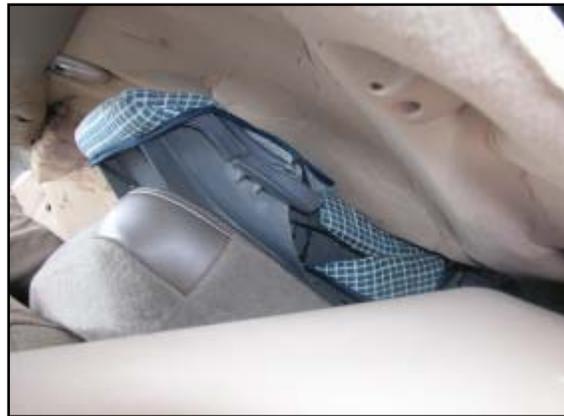
Figure 10. Damage to the right side of the belt positioning booster seat.
