**CALSPAN ON-SITE CHILD SAFETY SEAT CRASH INVESTIGATION  
GRACO SNUG RIDE REAR FACING CHILD SAFETY SEAT**

**CASE NO: CA06-008**

**VEHICLE: 2000 FORD EXPLORER**

**CRASH DATE: MARCH 2006**

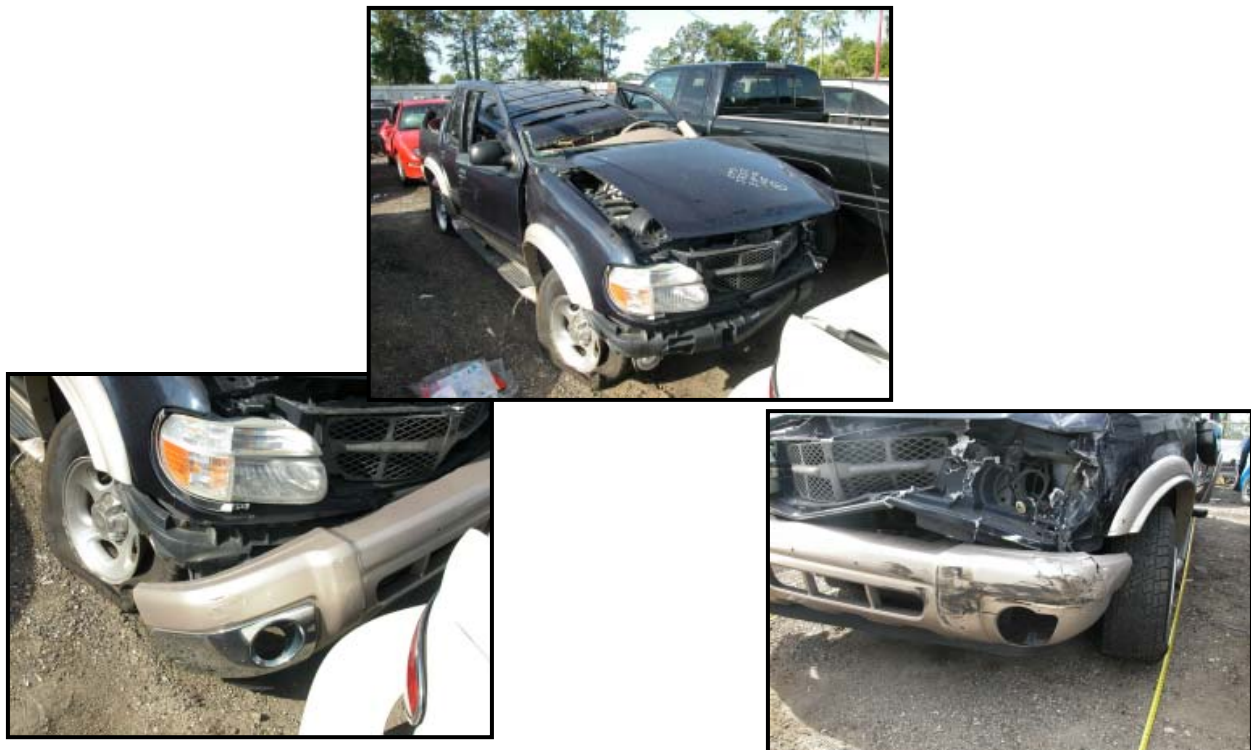
Frontal views of the Ford Explorer are depicted in **Figure 4**. Visual inspection of the Ford's exterior revealed three regions of direct contact damage consistent with the multiple event crash. The right aspect of the vehicle's front plane sustained approximately 16 cm (6 in) of direct contact damage that began 61 cm (24 in) right of the centerline and extended to the right corner. Refer to **Figure 4**. This damage was related to the minor sideswipe impact to the 1998 Ford (Event 1). The crush at the right corner was an estimated 5 cm (2 in). The direct contact was isolated to the outboard corner of the bumper system. The right fog lamp and right headlamp were not damaged in the impact. The Collision Deformation Classification of the impact was 12-FRLE1.

The left aspect of the frontal plane struck the median construction barrier as the vehicle neared final rest (Event 3). The direct contact had an estimated width of 58 cm (23 in) that began 20 cm (8 in) left of center and extended to the left bumper corner. The estimated maximum crush at the left bumper corner was 15 cm (6 in). The crush was uniform over its vertical height indicative of a barrier impact and involved the left headlamp assembly. The CDC of the impact was 11-FYEW1.

**Figure 4: Frontal views of the Ford Explorer.**

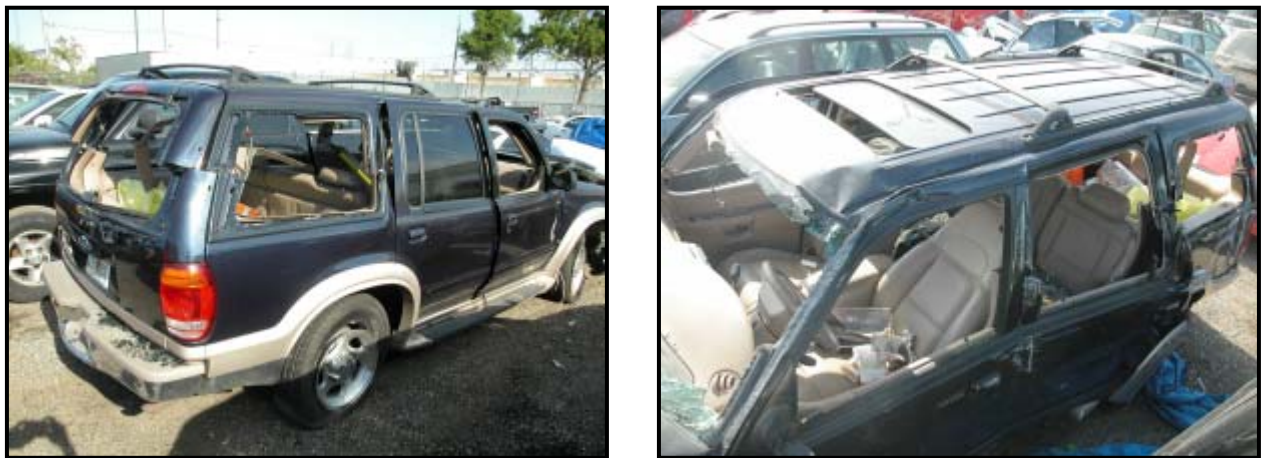
The vehicle's rollover damage consisted of a minor localized impact to the left A-pillar area of the roof and abrasions to the left side body panels. There was no noted damage to the right side of the vehicle and no surface abrasions to the roof. Refer to **Figure 5**. The first ground contact during the rollover (Event 2) occurred at the left A-pillar as the Ford was rolling between quarter turns 2 and 3. The vertical deformation at the left A-pillar was an estimated 5 cm (2 in). There was no lateral deformation of the greenhouse. The surface abrasions to the left side panels were oriented primarily in a single direction indicative of a single ground contact (quarter turn 4), **Figure 6**. The abrasions were oriented in a 2/8 o'clock direction. There was no measurable change in the wheelbase dimensions. All the side glazing disintegrated during the rollover with the exception of the glazing of the right rear door. All the side pillars were cut and the roof was removed during the operations to rescue of the driver. The windshield was also cut and removed. The CDC of the rollover damage was 00-LDAO1.

**Figure 5: Right and left side views of the Ford Explorer.**

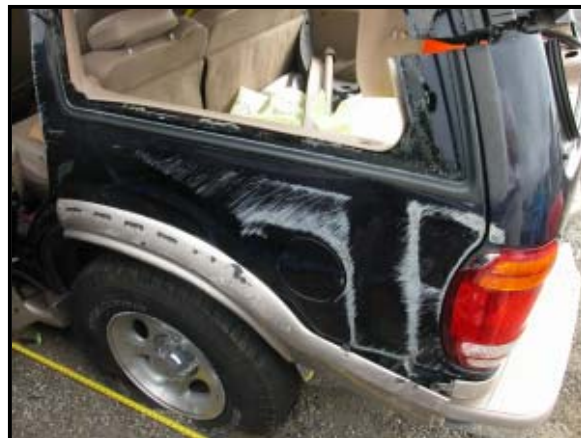
**Figure 6: 8/2 o'clock surface abrasions to the left rear quarterpanel of the Ford.**

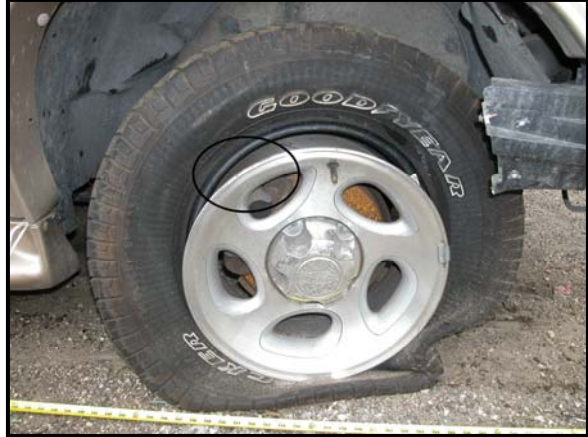
The subject Ford Explorer was equipped with Goodyear Tracker P255/70R16SL tires on OEM alloy wheels. This was the recommended tire size for the vehicle. The recommended tire pressure was 207 kPa (30 PSI). All four tires had adequate tread estimated at a minimum of 6 mm (8/32 in). Inspection of the tires revealed all four had aired out and debaded during the course of the rollover. An inspection of the front right wheel rim identified a 10 cm (4 in) long abrasion along the edge of the rim's circumference, **Figure 7**. This rim abrasion could only have occurred as a result contact with the road and was identified as the tripping mechanism of the crash. Examination of the right rear wheel rim was unremarkable. The left front and left rear wheel rims both exhibited minor surface abrasions about the circumference of the rim. In addition, the valve stems of both left rims were torn and separated from the rim. These damages to the left rims occurred when the vehicle was rolling through three quarter turns and was sliding on its left side.

**Figure 7: View of the front right tire and rim abrasion.**

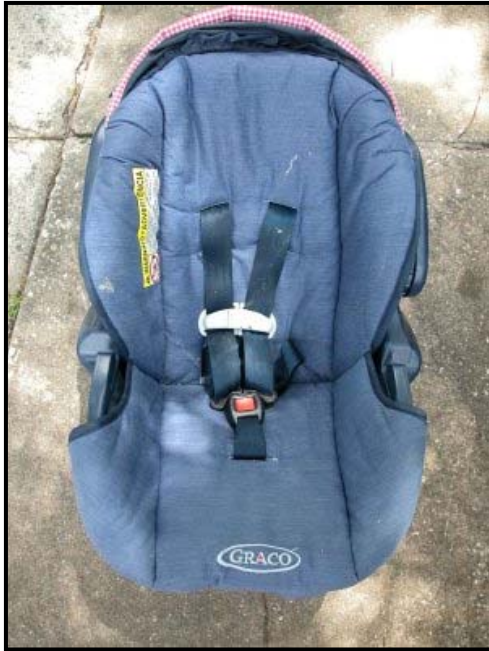
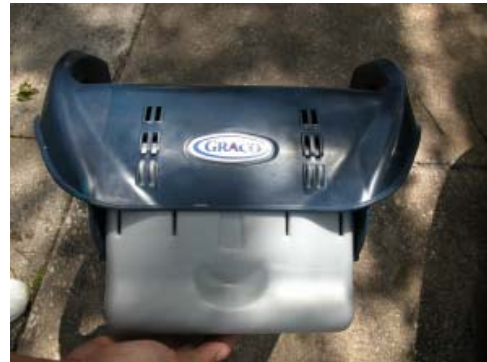
Figure 10: View of the child safety seat and base.

The Graco Snug Ride rear-facing Child Safety Seat (CSS) consisted of a carrier shell with a five-point harness and a detachable base, **Figure 10**. The CSS was manufactured on January 14, 2005 and was designated with the following Model and Serial numbers: 7235GGA, JJ0114050076. The seat was labeled for use by infants who weigh less than 9 kg (20 lb) and are less than 66 cm (26 in) in height. The CSS was an appropriate size for the weight and height of the 5-month old infant. The five point harness was adjusted to the top slots. The length of the left and right harness strap measured 52 cm (20.5 in) and 55 cm (21.7 in), respectively. The straps were not twisted or roped. The chest retainer clip was present and was located 18 cm (7 in) below the top slots. The CSS base was designed with an adjustable foot to control the recline angle of the CSS. The base was adjusted to position the carrier in the most reclined installed position. The CSS was designed and equipped with a LATCH belt that was not in use at the time of the crash.

During the SCI inspection, the 5 month old was observed sitting in the CSS carrier. She was restrained by the harness straps at that time. The driver (mother) reported that the straps had not been adjusted since the time of the crash. The chest retainer chip was positioned over the center of her chest and was typically adjusted to that location. The mother did report that the infant could move the retainer clip and at times would teethe on the clip or push it down. She did not know the at-crash position of the clip. With the infant in the carrier, the harness straps were a loose fit with approximately 5 cm (2 in) of slack in the harness strap at the shoulder level. The harness straps exited the carrier shell at the level of the infant's shoulders. There was no noted damage to the CSS.

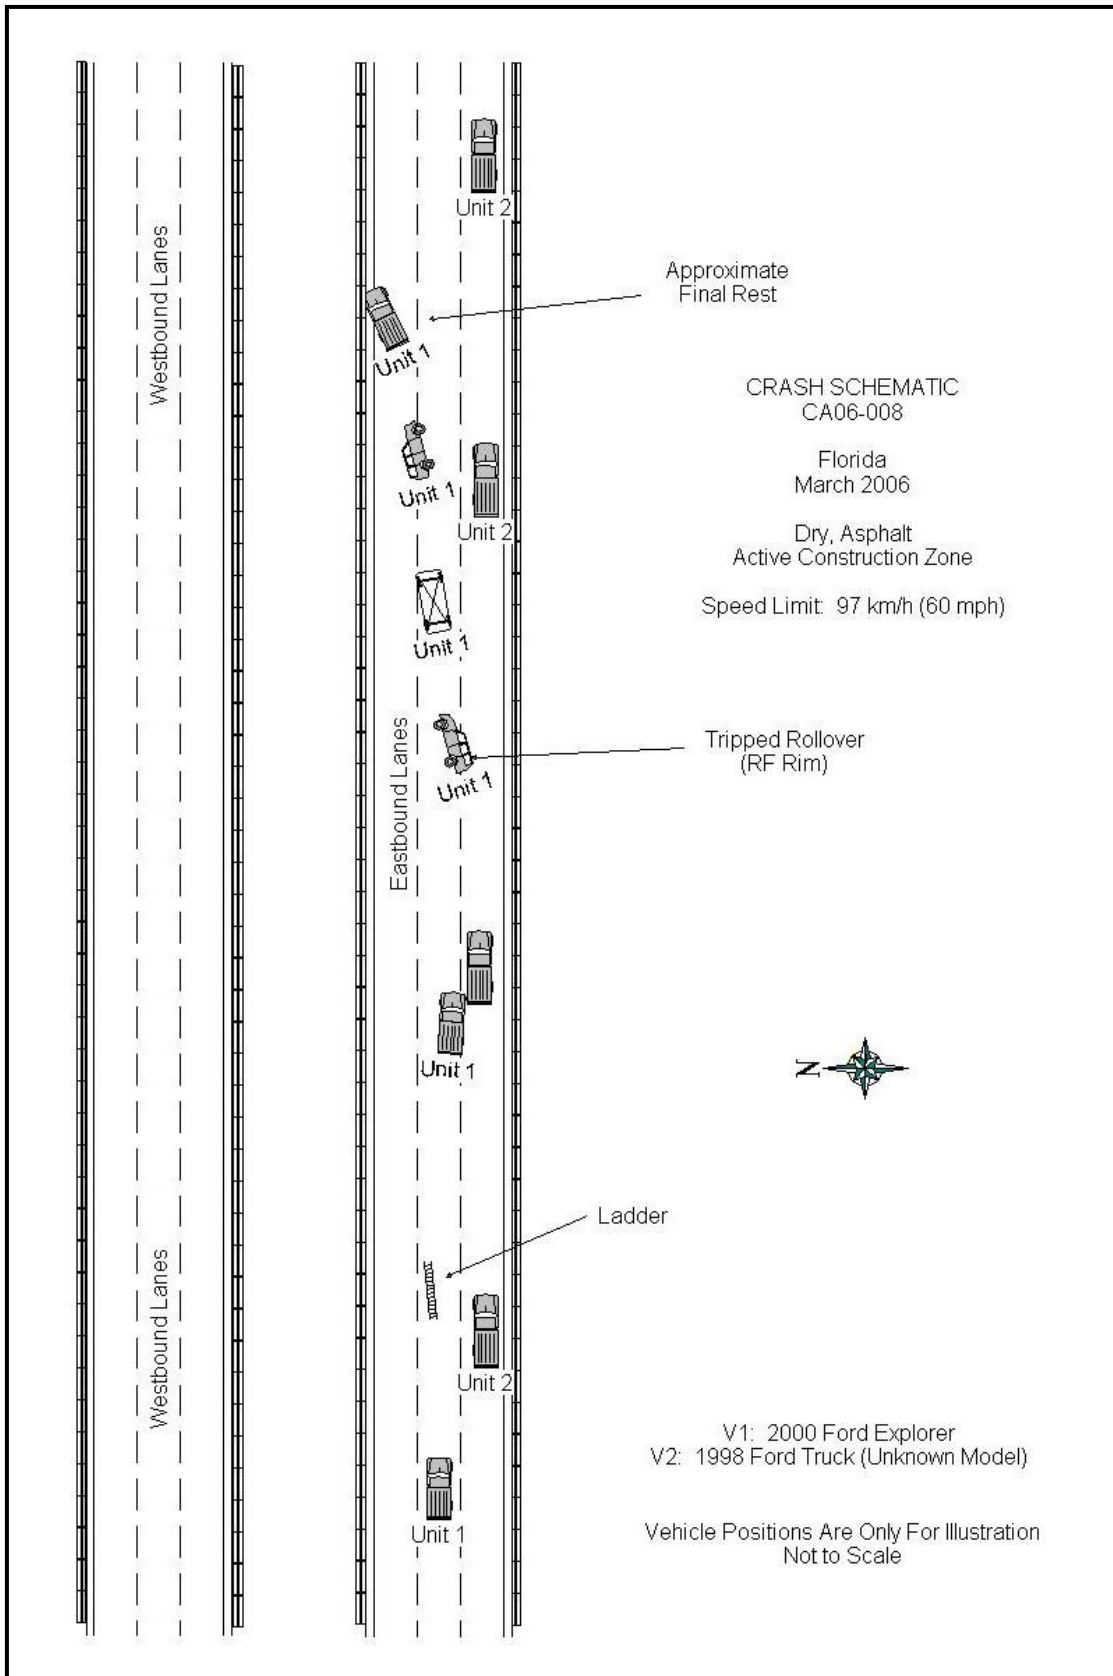
Figure 11: Crash Schematic.

The sudden right/left steering maneuver caused an over-steer condition and the rear tires of the Explorer lost traction. The driver of the Ford Explorer lost directional control and the vehicle began to rotate counterclockwise. The dynamics of these maneuvers caused a weight shift toward the front right aspect of the vehicle, which in-turn caused the front right tire to air out. The deflation of the front right tire allowed the rim to contact the road which initiated a tripping mechanism and resultant right side leading roll. The Ford Explorer rolled four-quarter turns along a northeastward trajectory. As the vehicle returned to its wheels, the left aspect of the Explorer's front bumper struck the center median Jersey barriers. The vehicle came to rest in the inboard lane of the interstate in-close proximity to the barrier facing northeast. **Figure 11**, at the end of this narrative report, is a generalized schematic of the crash sequence.
