Certified Advanced 208 Compliant Investigation / Vehicle to Vehicle
Dynamic Science, Inc. / Case Number: DS06009
2006 Chevrolet Impala
Colorado
January, 2006

1. Report No. DS06009	2. Government Accession No.		3. Recipient Catalog No.	
4. Title and Subtitle Certified Advanced 208 Compliant Air Bag Investigation			5. Report Date May 7, 2006

The focus of this on-site investigation was on the Certified Advanced 208 Compliant air bags installed in a 2006 Chevrolet Impala. The multi-stage air bags were certified by the manufacturer to meet the advanced air bag requirement of Federal Motor Vehicle Safety Standard (FMVSS) No. 208. The Chevrolet Impala was occupied by a 21-year-old female restrained driver. The Impala was traveling westbound on a curved, two lane roadway. A 2002 Toyota Tacoma pickup truck was traveling eastbound. The driver of the Impala lost control of her vehicle in the turn and entered the eastbound travel lane. The driver of the Impala braked and was likely skidding before being struck

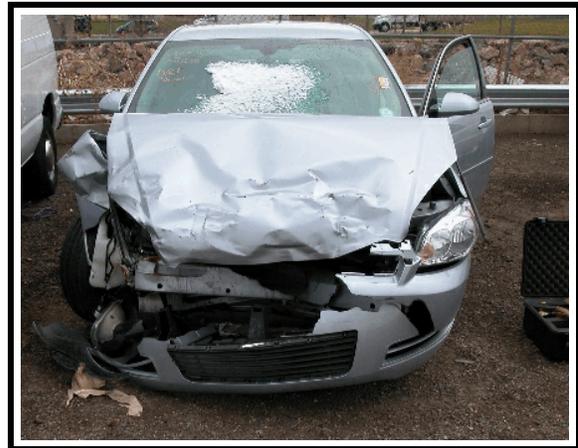
in the front end (see Figure 1) by the front of the Tacoma. The impact resulted in sufficient longitudinal deceleration of the Impala to command the deployment of the frontal air bag system. The Impala was pushed rearward and to the north where the rear bumper struck a guardrail. The driver of the case vehicle sustained bilateral knee contusions, a horizontal contusion across her abdomen, and a sternum fracture. She also complained of a stiff neck. She declined any treatment at the time. She was, however, transported from the scene to a local hospital by a friend. She was treated and then released.

Figure 1. Front, 2006 Chevrolet Impala

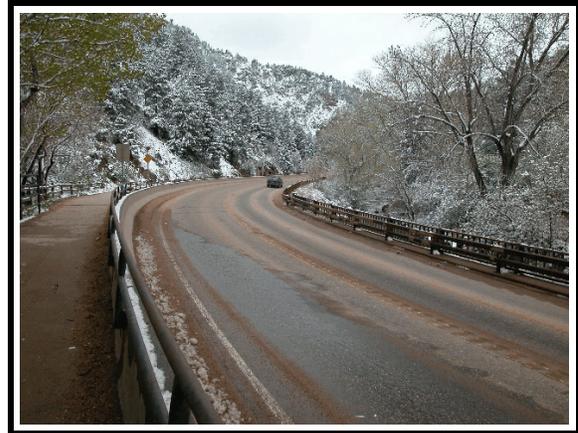
This two-vehicle crash occurred on a two-lane, undivided state highway (see Figures 2 and 3). The crash occurred in January 2006 at 0755 hours. The east/west roadway was configured with single lanes in each direction that were separated by a double yellow centerline. The centerline

Figure 2. Area of impact, looking west

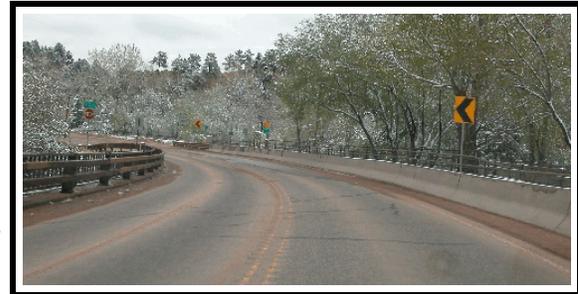
Figure 3. Area of impact, looking east

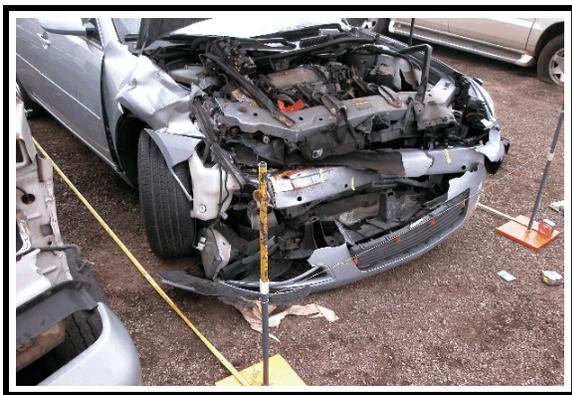
Damage Description: The 2006 Chevrolet Impala sustained moderate front end damage as a result of the impact with the Tacoma pickup and minor damage to the rear bumper from the impact with the metal guardrail. The direct damage on the front began at the right bumper corner and extended 102.0 cm (40.1 in) laterally across the frontal plane. There was damage to the hood, the backing bar, right fender, and the upper radiator support. The plastic frontal fascia was broken away. The right wheelbase was shortened by 13.0 cm (5.1 in). The front right tire was restricted but not flattened. The damage to the rear bumper began at the left rear bumper corner and extended 79.0 cm (31.1 in) laterally across the rear plane.

CDC: Impact 1: 12FZEW2
Impact 2: 06BYLW1

Six crush measurements were documented at the front bumper/backing bar level as follows: C1 = 12.0 cm (4.7 in), C2 = 23.0 cm (9.0 in), C3 = 37.0 cm (14.6 in), C4 = 44.0 cm (17.3 in), C5 = 43.0 cm (16.9 in), C6 = 46.0 cm (18.1 in). The maximum crush fell between C3 and C4 and measured 48.0 cm (18.9 in).

Figure 5. Impala frontal damage from impact with truck

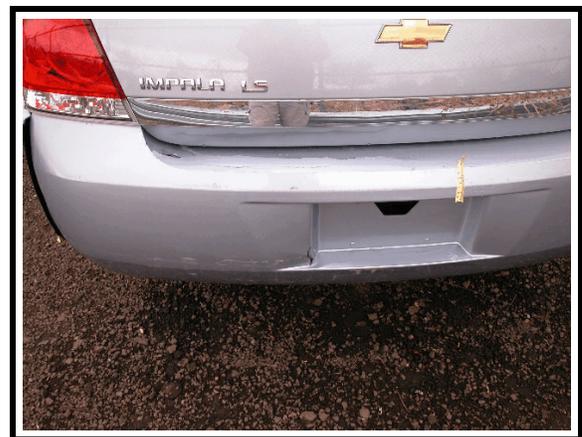
Figure 6. Impala rear damage from impact with guardrail

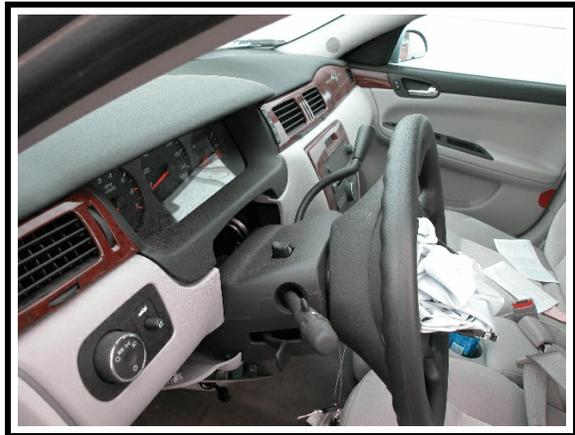
The Chevrolet Impala sustained moderate interior damage as a result of the air bag deployment and occupant contacts. There was loading to the steering wheel column and complete left and right shear capsule separation. The plastic panel beneath the steering column was dislodged by the movement of the column. The glove box was found fully opened at the time of the inspection. The center panel that contains the two power hookups was dislodged but power was still available through the hookups. The driver's door was jammed shut immediately after the crash and had to be opened by rescue personnel. The other doors remained closed and operational. There was no intrusion and no integrity loss.

Figure 7. Steering column separation (Chevrolet Impala)

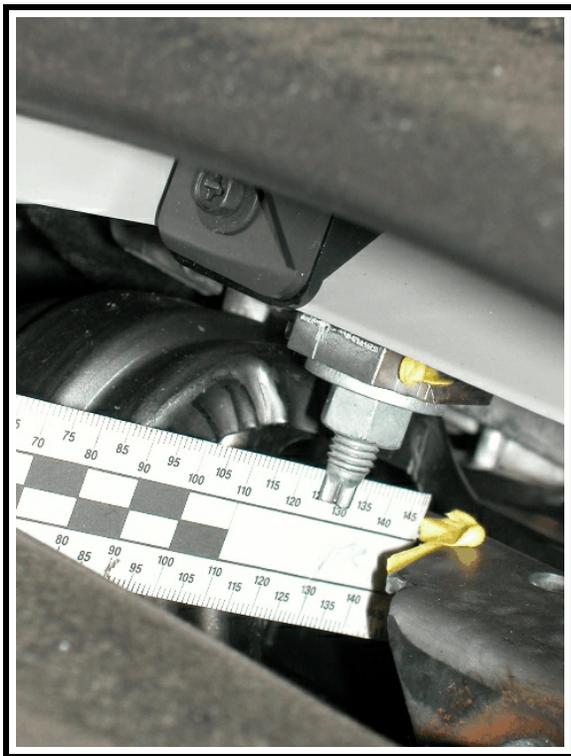
Figure 8. Left shear capsule (Chevrolet Impala)

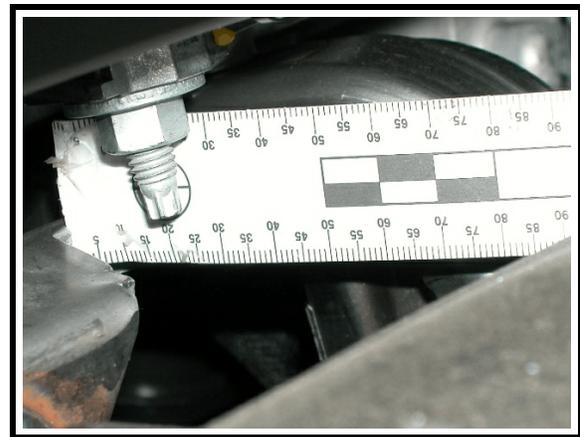
Figure 9. Right shear capsule (Chevrolet Impala)

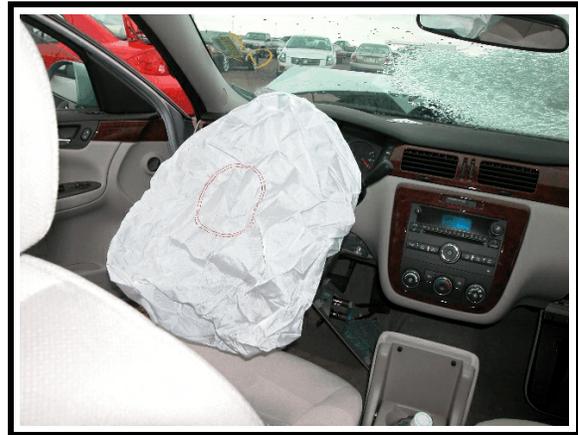
The driver's air bag deployed from the center of the steering wheel hub through symmetrical I-configuration module cover flaps. Each flap measured 13.0 cm (5.1 in) high by 6.0 cm (2.4 in) wide. The deployed driver's air bag measured 52.0 cm (20.5 in) in diameter in its deflated state. The air bag was tethered by a single internal strap attached to the center stitching. Two circular vent ports were located at the 11 and 1 o'clock positions on the rear of the air bag.

Figure 10. Driver's air bag

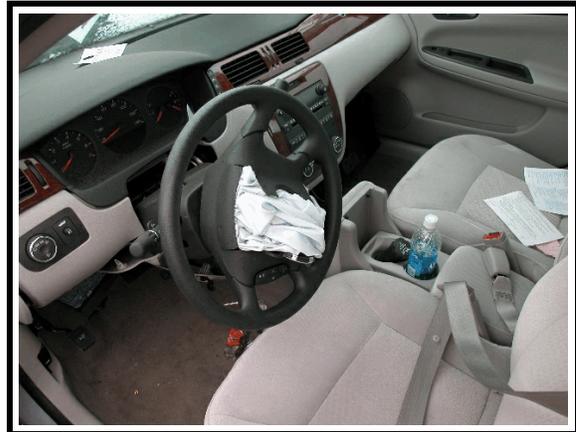
Figure 11. Driver's air bag, module covers

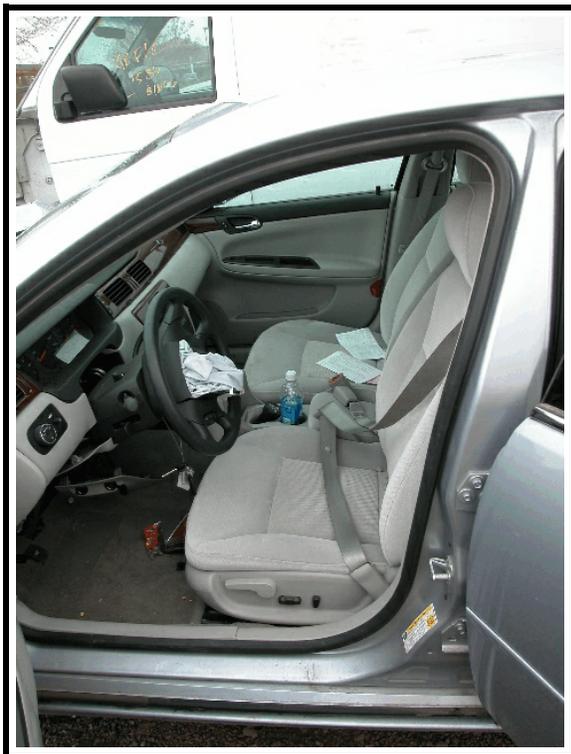
The 21-year-old driver of the case vehicle was seated in an upright fashion. She was wearing the manual 3-point lap and shoulder belt. The shoulder harness adjustment was in the full down position. The seat was in the middle track position. The driver was not wearing eyeglasses or contacts. Her hands were at the 10 and 2 o'clock positions on the steering wheel. Prior to impact, she was braking. Her right foot was on the brake, the left on the floor. At impact, the driver's air bag deployed and the safety belt pretensioner actuated. The driver initiated a forward and slightly left trajectory. Both knees contacted the knee bolster, causing minor contusions. She loaded the safety belt, causing the abdominal contusion. As the driver pitched forward she loaded the shoulder portion of the safety belt, as well as the air bag and steering wheel column. There was complete left and right shear capsule separation due to loading. The driver sustained a sternum fracture that was most likely sustained due to loading the shoulder harness. The driver remained seated post crash until the fire department arrived. The fire department forced open the driver's door.

Figure 12. Impala driver's seated area

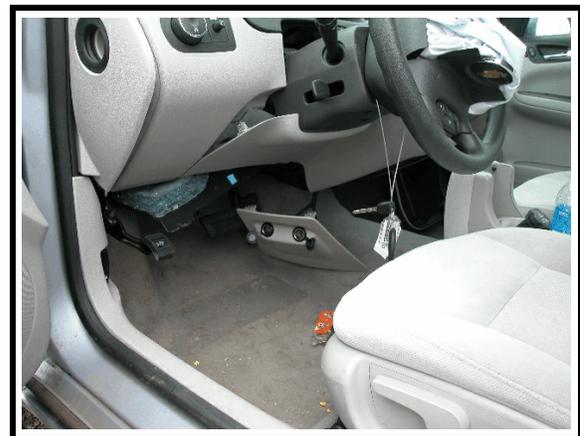
<u>Injury</u>	<u>OIC Code</u>	<u>Injury Mechanism</u>	<u>Confidence Level</u>
Contusion, right knee	890402.1,1	Knee bolster	Probable
Contusion, left knee	890402.1,2	Knee bolster	Probable
Contusion, abdomen	590402.1,4	Seat belt webbing	Probable
Fracture, sternum	450804.2,4	Seat belt webbing	Probable

Figure 13. Impala lower instrument panel, knee bolster
