**CALSPAN ON-SITE CERTIFIED ADVANCED 208-COMPLIANT VEHICLE
CRASH INVESTIGATION**

SCI CASE NO.: CA06-013

VEHICLE: 2004 FORD F-150 SUPERCAB PICKUP TRUCK

CRASH DATE: MAY 2006

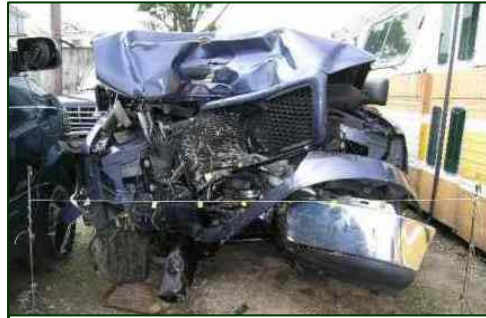
Figure 1. Severe frontal damage to the Ford F-150 pickup truck.

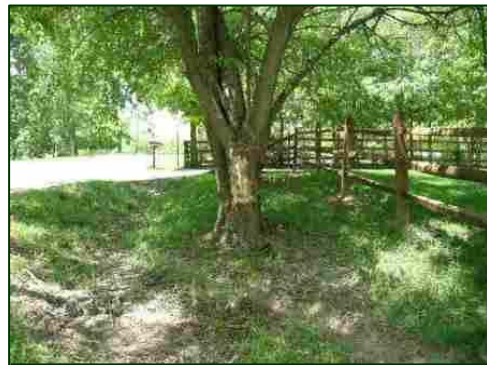
Figure 3. Struck tree cluster.

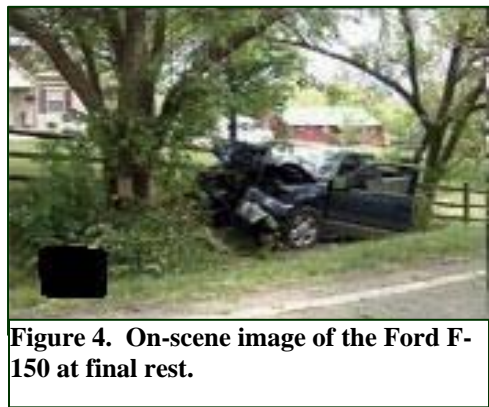
Figure 4. On-scene image of the Ford F-150 at final rest.

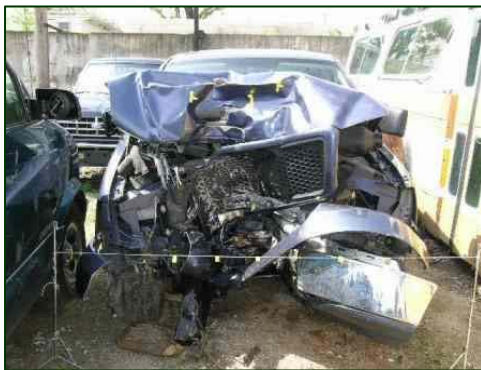
Primary - The frontal area of the Ford F-150 sustained severe damage as a result of the impact with the large diameter tree cluster (**Figure 5**). This, the fourth of five impact events, masked the damage from the utility pole and the small diameter tree. Maximum crush was measured at 82 cm (32.25"), located on the bumper 29 cm (11.25") right of the vehicle's centerline (**Figure 6**). The direct contact damage from the tree cluster impact began on the centerline and extended 36 cm (14") to the right. The chrome bumper fractured inboard of the right frame rail; however, the crush profile was not altered by this separation. The position of the right corner was estimated resulting in a Field L measurement of 95 cm (37.5"). A reference line was established to reflect the original length of the F-150. The crush profile was documented using six equidistant crush values across the deformed width of the vehicle. These values were as follows: C1 = 0 cm, C2 = 11 cm (4.4"), C3 = 40 cm (15.7"), C4 = 80 cm (31.3"), C5 = 77 cm (30.4"), C6 = 30 cm (12"). This C6 value was estimated due to the separated front bumper. The Collision Deformation Classification (CDC) for this event was 12-FYEN-4.

Figure 5. Tree impact damage to the Ford F-150.

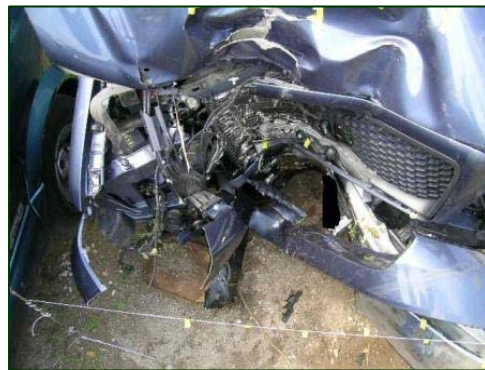
Figure 6. Overhead view documenting the depth of frontal crush at bumper level.

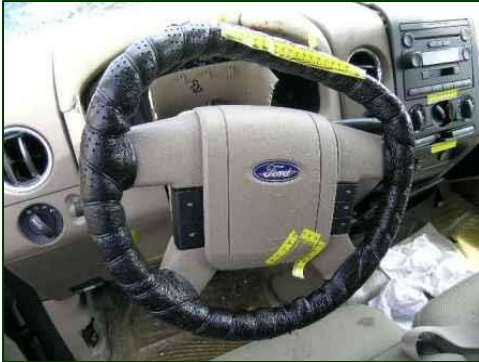
His torso loaded the upper steering wheel rim which displaced the upper rim 6 cm (2.25") forward and 5 cm (2.1") downward (**Figure 7**). This loading of the steering wheel compressed the energy absorbing steering column. This redesigned steering column did not have conventional shear capsules. Interior measurements indicated that the column was compressed approximately 3 cm (1").

Figure 7. Deformation to the steering wheel rim.

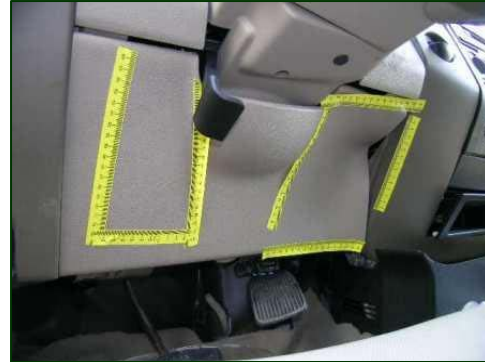
Figure 8. Knee contacts to the rigid bolster panel.

The driver's knees contacted the knee bolster and the locking lever for the tilt steering wheel (**Figure 8**). His left knee impacted and scuffed the bolster 52-59 cm (20.5-23.25") left of center and 32-48 cm (12.5-19") below the top instrument panel. Located to the right of this contact point and left of the steering column was the locking lever for the tilt wheel. This knee contact fractured the lever arm at the attachment point to the column.

The driver's right knee loaded and deformed the rigid bolster panel; however, the contact did not deform the steel backer panel. The contact scuffed and deformed the panel 23-36 cm (9.25-14") left of center and 28-48 cm (11-19") below the upper instrument panel. The panel was deformed 5 cm (2") forward.

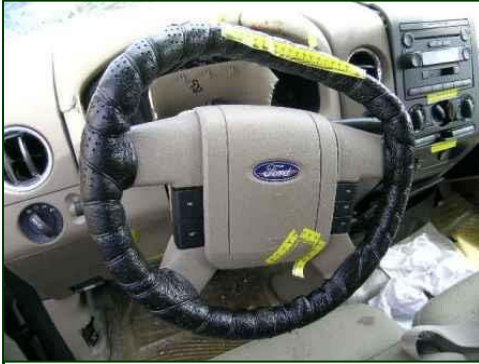
Figure 9. Non-deployed driver's air bag module.

The driver's air bag was concealed by a single top hinged cover flap that was located within the four-spoke steering wheel rim. The lower aspect of the cover flap was abraded from driver loading against the steering assembly. The vertically oriented abrasion was 3 cm in height and 1 cm (0.4") in width. This abrasion did not affect the deployment status of the driver's air bag.

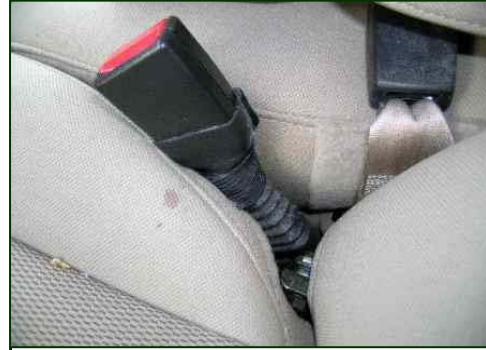
This 2004 Ford F-150 SuperCab pickup truck was equipped with a Certified Advanced 208-Compliant frontal air bag system for the driver and front right passenger positions. The manufacturer of this vehicle has certified that this F-150 meets the advanced air bag requirements for Federal Motor Vehicle Safety Standard No. 208. The system consisted of dual stage frontal air bags for both front outboard positions, seat track positioning sensors, a front right occupant presence system, and buckle pretensioners. During the crash, this CAC system did not command a deployment of the driver's air bag (**Figure 9**) or the firing of the driver's buckle pretensioner (**Figure 10**).

Figure 10. Non-fired driver's buckle pretensioner.

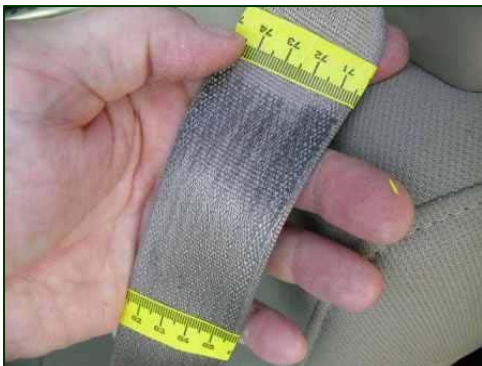
The belted driver loaded the integrated belt system which was evidenced by a frictional abrasion on the latch plate and a seat belt guide transfer on the shoulder belt webbing. These are addressed in further detail in the *Manual Safety Belt Systems* section of this report.

Figure 13. Belt guide abrasion on the shoulder belt webbing.

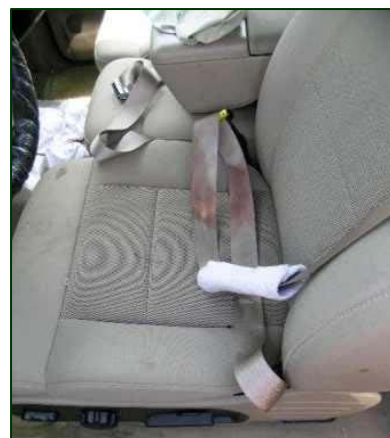
Figure 14. Body fluid transfers on the lap and shoulder belt webbing.

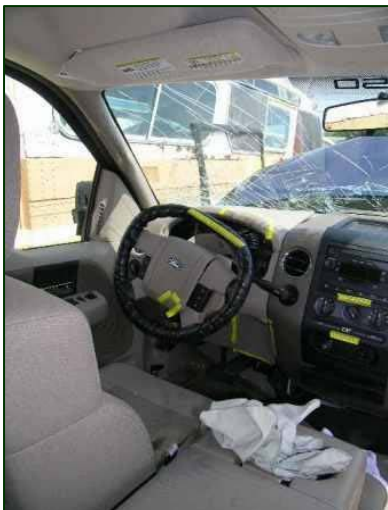
Figure 15. Driver's trajectory and contact points.

The driver's knees engaged the rigid knee bolster on each side of the steering column. His left knee scuffed the bolster panel while his right knee scuffed and deformed the panel to a depth of 5 cm (2"). The driver sustained multiple abrasions of the anterior aspects of the lower legs from the bolster engagement. His left leg contacted and fractured the tilt wheel adjustment lever. This protruding lever lacerated the anterior aspect of his left leg. **Figure 15** is an overall view of the driver's trajectory and the resulting contact points.

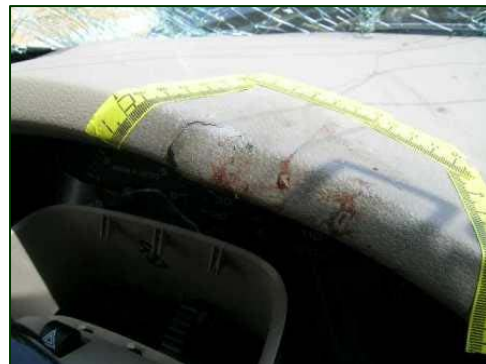
Figure 16. Head/facial contact to the top of the instrument panel.

The driver's head hyper flexed over the belt system and the steering wheel rim. His chin contacted the top surface of the wheel rim which resulted in an abrasion. The driver's head and face impacted the top surface of the upper instrument panel and fractured the plastic panel (**Figure 16**). Body fluid was present within and surrounding the fracture site. As a result of this contact, the driver sustained a frontal skull fracture, bilateral fractures of the orbital plates, subdural and subarachnoid hemorrhages, and facial lacerations. The driver sustained lacerations to the sides of his nose that were suspected to be related to eyeglasses as they were displaced by the head/facial contact to the top surface of the instrument panel.
