Rollover Investigation / Vehicle to Objects  
Dynamic Science, Inc. / Case Number: DS06019  
2006 Mercedes-Benz CLK500  
Washington  
July 2006

1. Report No. DS06019		2. Government Accession No.		3. Recipient Catalog No.	
4. Title and Subtitle  Rollover Investigation		5. Report Date March 23, 2007		6. Performing Organization Report No.

This on-site investigation focused on the rollover of a 2006 Mercedes-Benz CLK500. This single vehicle crash occurred in July 2006 at 1528 hours in an urban area of Washington. The crash occurred on a four lane, two way, undivided city street.

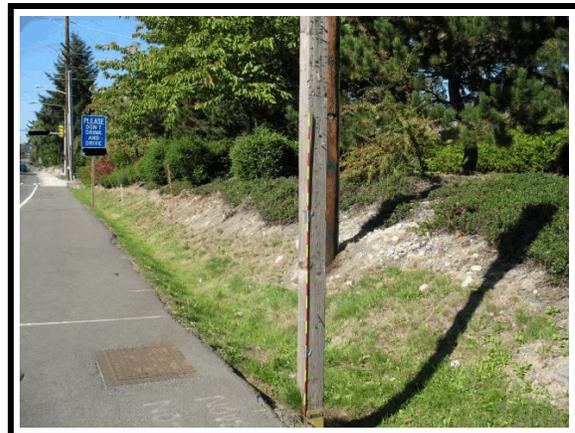
The case vehicle traveled off the north edge of the roadway and the front of the Mercedes-Benz impacted a signpost (12FYEN2) that was adjacent to the north shoulder, shearing the post from its base. The vehicle continued west into the shallow ditch, traveled a short distance and the front of the Mercedes-Benz (12FREE3) struck the wood utility pole, shearing the pole from its base, and resulting in the actuation of the driver’s seat belt retractor pretensioner and the deployment of the driver’s front air bag. The barrier equivalent routine of the WinSmash program computed a total delta V of 7.0 km/h (4.3 mph). The longitudinal and lateral components were -7.0 km/h (-4.3 mph) and 0.0 km/h (0.0 mph), respectively.

**Figure 5.** Signpost - first object struck by the case vehicle (west)

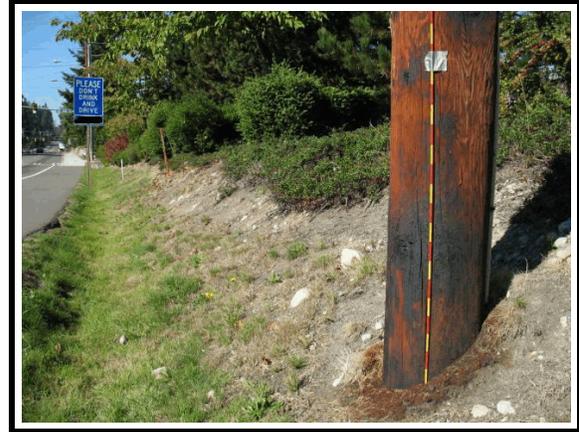
At the time of the scene inspection, it did not appear that the post had been replaced, but there was no apparent damage from the impact. Just west of the signpost, approximately halfway up the embankment there was a wooden utility pole that was also struck by the case vehicle. The post had a diameter of 0.4 m (1.3 ft). According to the police report, the pole broke away during the impact and a utility crew came to the scene in order to “take care of the power lines and pole”. At the time of the scene inspection, it appeared that the pole had been replaced.

**Figure 6.** Shallow ditch, embankment and second struck object (pole replaced)

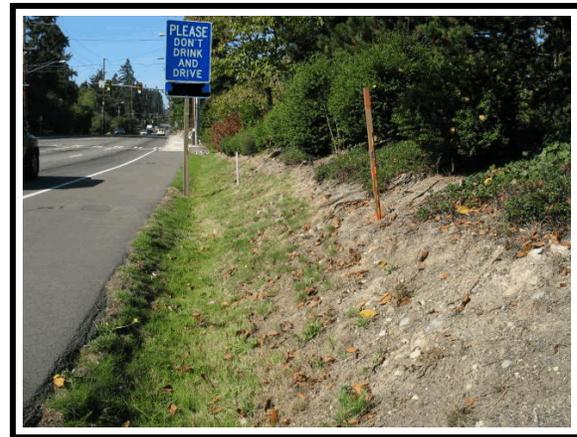
**Figure 7.** Approximate final rest location and wooden marker (contacted during rollover event)

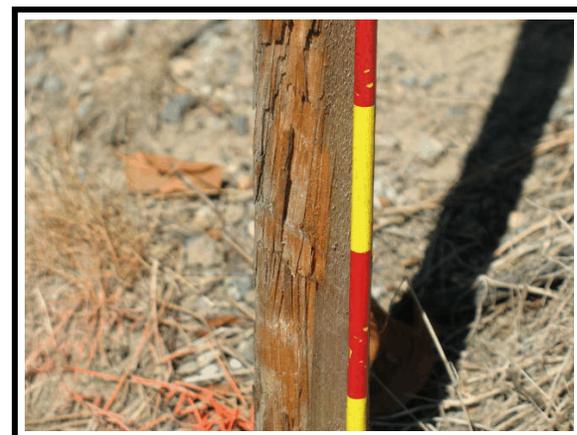
**Figure 8.** Damaged wood marker (left transfers on the case vehicle's left rear bumper and tailpipe)

The vehicle's back bumper came in contact with a wooden marker post that was located in the area near the top of the embankment, resulting in brown transfers to the bumper, but no crush. The CDC for this event was 99BLLN1.

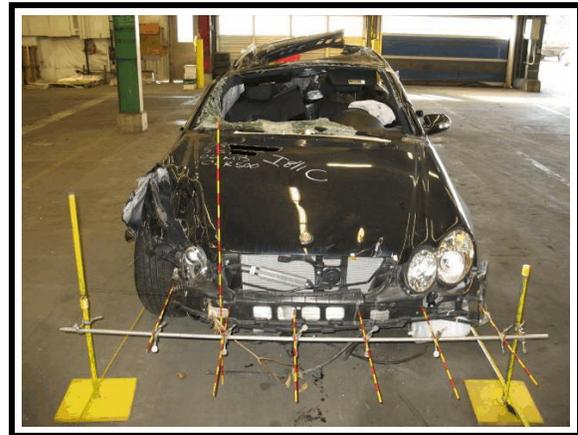
In order to calculate and report the correct amount of crush, an exemplar vehicle was located and measured. Six crush measurements were documented along the front bumper as follows: C1=0.0 cm (0.0 in), C2=3.0 cm (1.2 in), C3=3.0 cm (1.2 in), C4=4.0 cm (1.6 in), C5=3.0 cm (1.2 in), C6=14.0 cm (5.5 in). The location of maximum crush for this event was best represented at C3. The CDC for this event was 12FYEN2.

**Figure 10.** Front crush profile

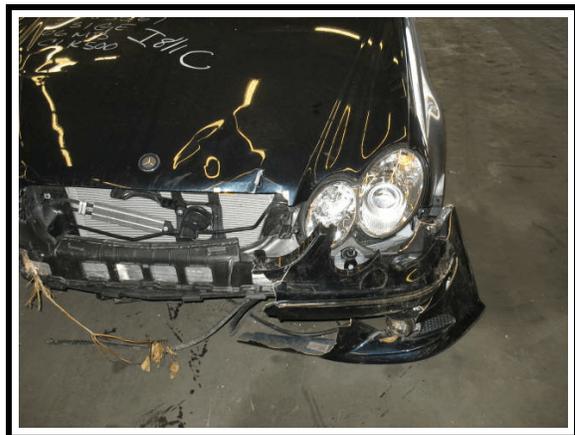
The vehicle sustained 16.0 cm (6.3 in) of direct damage along the leading edge of the hood, beginning 21.0 cm (8.3 in) left of the precrash center point of the vehicle, extending to the left. The bumper cover and energy absorbing foam were no longer attached to the bumper. The left front section of the bumper cover and a section of the foam were found inside the passenger compartment. It appears that the bumper cover may have split and separated from the vehicle during this impact. A small piece of the right front bumper cover was found in the damaged area between the right front frame rail and the damaged right fender. The majority of the right and center bumper cover sections were not with the vehicle.

**Figure 11.** Hood damage ("V" indentation) from impact with signpost

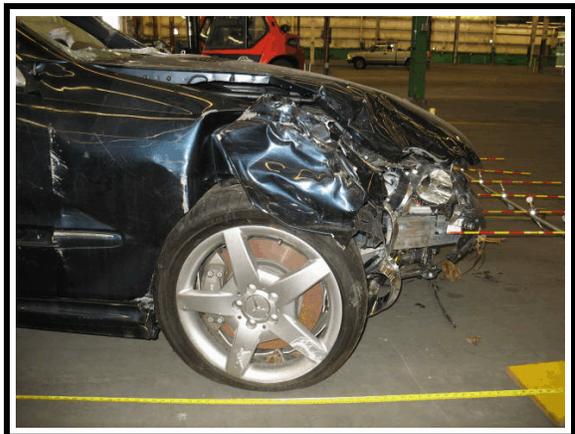
The case vehicle sustained moderate front end damage as a result of the impact with the utility pole. In addition to the narrow end engagement at the right front bumper corner, the Mercedes-Benz's right front tire came in contact with the pole, causing the right wheelbase to be shortened by 12.0 cm (4.7 in). The vehicle sustained approximately 39.0 cm (15.4 in) of direct damage along the hood and bumper backing

**Figure 12.** Right front damage

bar, beginning 39.0 cm (15.4 in) right of the vehicle's precrash center point, extending to the right. Due to the missing bumper cover, the direct damage location and width were mainly determined from the hood damage. The same six crush measurements were documented along the front bumper as were documented for the first crash event. The location of maximum crush for this event was C6. The direct damage from this impact extended 62.0 cm (24.4 in) down the right side of the case vehicle. The CDC for this event was 12FREE3.

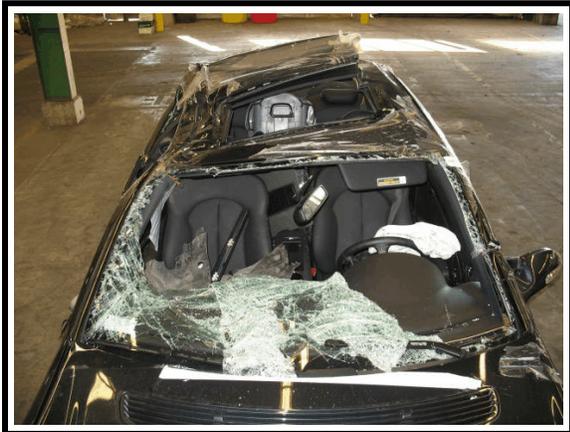
The Mercedes-Benz sustained light to moderate right, top and left side damage during the rollover event. The area of maximum crush was located 101.0 cm (39.8 in) forward of the right rear axle. There was 17.0 cm (6.7 in) of vertical crush, which is the maximum crush documented for the rollover event. The area of maximum lateral crush was in the same location on the vehicle and measured 5.0 cm (2.0 in). The CDC for this event was 00TZDO3.

**Figure 13.** Passenger compartment rollover damage

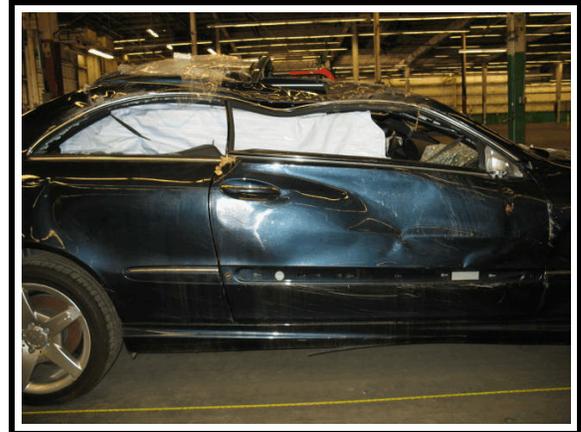
**Figure 14.** Rollover event - vertical and lateral max crush location

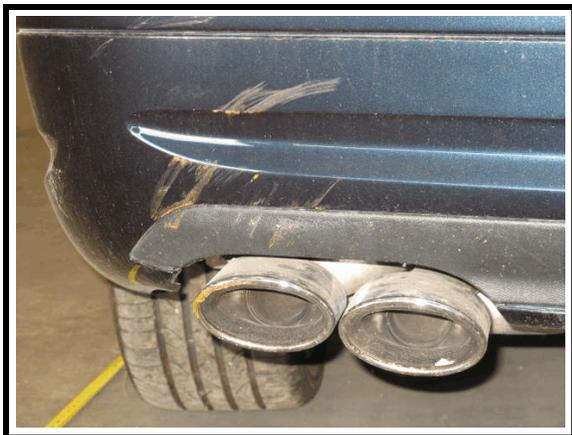
**Figure 15.** Brown transfers from wood marker contacted during the rollover event

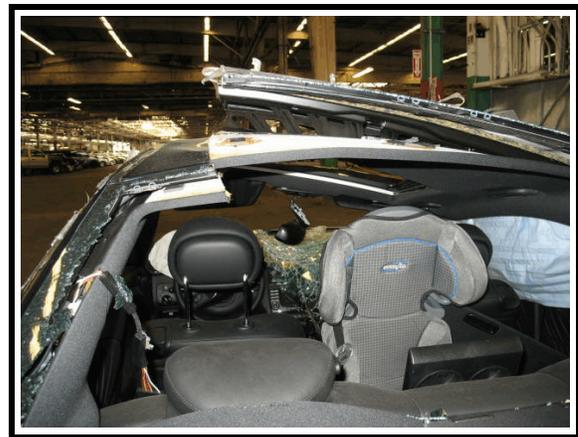
Rescue personnel cut the windshield along the windshield header and left A pillar, causing the glazing to collapse. During the driver extrication, the left A pillar and roof were also cut by rescue personnel.

**Figure 16.** Roof cut by fire/rescue personnel

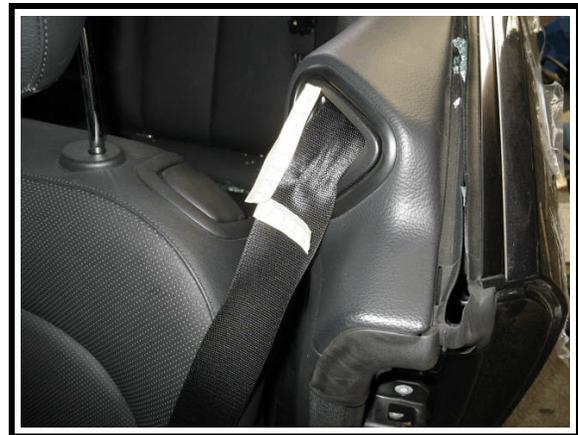
There were signs of occupant loading to the driver's seat belt. The shoulder belt showed signs of stress and the lap portion had friction burns to a small section of the belt material. All four of the Mercedes-Benz's seat belts were equipped with Emergency Tensioning Devices (ETDs) and seat belt force limiters. The front left and two second row seat belt ETDs activated during the crash. See the Manual Restraints section of this report for more information on these seat belt devices.

**Figure 17.** Signs of occupant loading to driver's shoulder belt

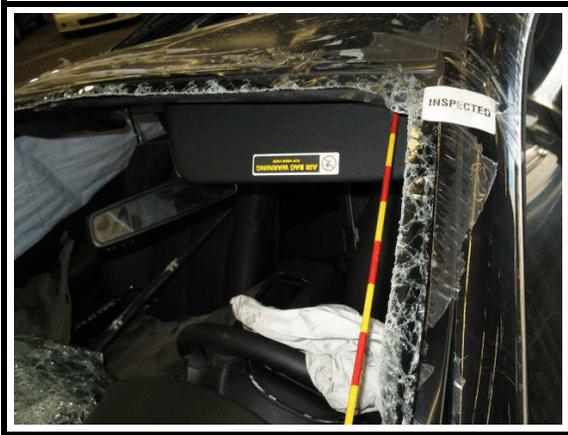
**Figure 18.** Windshield cut by fire/rescue personnel

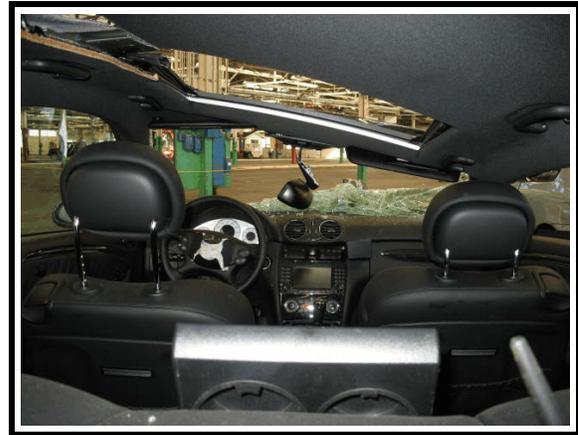
**Figure 19.** Intrusion into passenger compartment area

There were several vertical and lateral intrusions into the passenger compartment seating areas. The specific passenger compartment intrusions were documented as follows:

Row/Position	Intruded Component	Magnitude of Intrusion	Direction
1C	Windshield header	2.0 cm (0.8 in)	Vertical
1R	Roof	21.0 cm (8.3 in)	Vertical
1R	Roof side rail	17.0 cm (6.7 in)	Vertical
1R	Roof side rail	12.0 cm (4.7 in)	Lateral
1R	A Pillar	8.0 cm (3.1 in)	Vertical
1R	Windshield header	5.0 cm (2.0 in)	Vertical
1R	A Pillar	3.0 cm (1.2 in)	Lateral
2R	B Pillar	4.0 cm (1.6 in)	Lateral

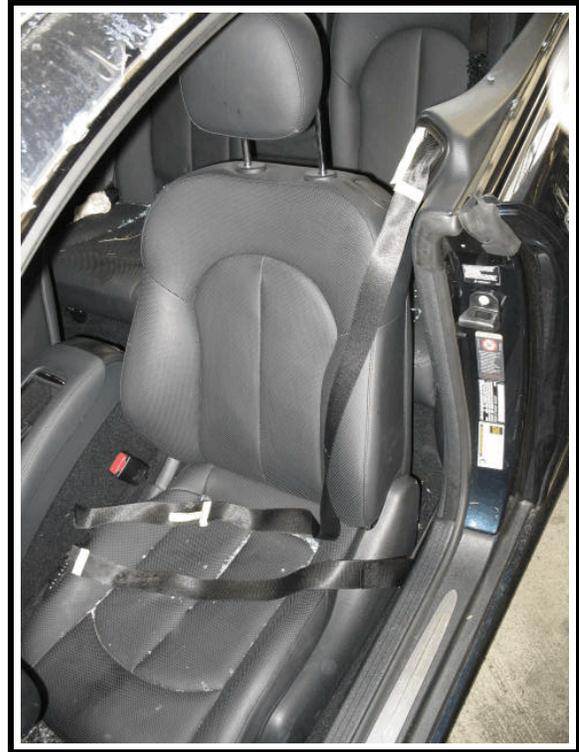
**Figure 20.** Driver's seat belt (cut by fire/rescue)

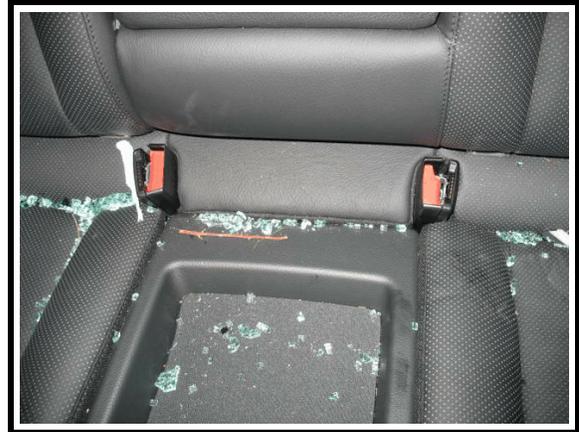
The front row ETDs are designed to activate only if the belt latchplates are properly fastened. The second row ETDs will activate regardless of whether or not the latchplates are buckled at impact. The left front ETD activated, removing the slack from the driver's belt. The second row seat belts were equipped with buckle pretensioners that actuated during the crash. An exemplar vehicle was measured in order to obtain exact pretensioner retraction measurements. Both second row buckle pretensioners retracted 9.0 cm (3.5 in) from their original positions.

**Figure 22.** Second row seat belt buckle pretensioners activated

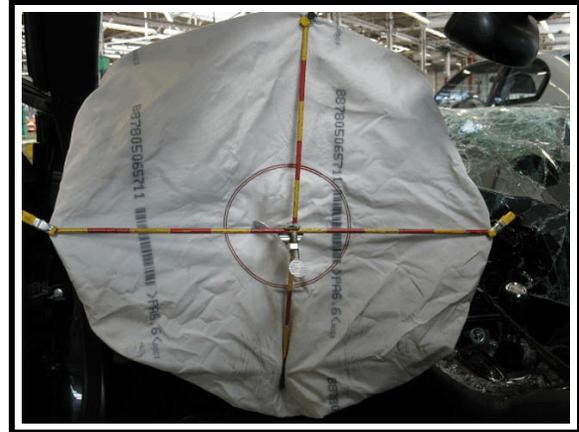
The driver's front air bag deployed as a result of the longitudinal deceleration that occurred during the collision between the case vehicle and the pole. The driver's air bag was mounted in the center of the steering wheel hub. The air bag module had a general H configuration. The left and right cover flap measurements were as follows: the outer flap edge heights were 10.0 cm (3.9 in), the upper flap edges were 5.0 cm (2.0 in) wide, the lower flap edges were 2.5 (1.0 in) wide, the top inner flap edge heights were 4.0 cm (1.6 in), and the bottom inner flap edge heights were 5.0 (2.0 in). The top cover flap was fairly circular in shape and measured 6.0 cm (2.4 in) wide by 7.0 cm (2.8 in) high. The bottom cover flap was fairly rectangular in shape and measured 6.0 cm (2.4 in) wide along the upper edge, 10.0 cm (3.9 in) wide along the lower edge and 5.0 cm (2.0 in) high along both sides. The air bag was circular in shape and measured 60.0 cm (23.6 in) high/wide in its deflated state. The maximum excursion measured 28.0 cm (11.0 in) from the module face. The distance between the module face and the front left seat back was 75.0 cm (29.5 in). The air bag had three internal tethers. There was one vent port located on the back of the bag at the 12 o'clock position, lower on the bag, closer to the module. Black cover flap streaks were found on the upper center portion and lower front and back sections of the bag. The deployed air bag was not damaged and showed no signs of occupant contact.

**Figure 24.** Deployed driver's front air bag

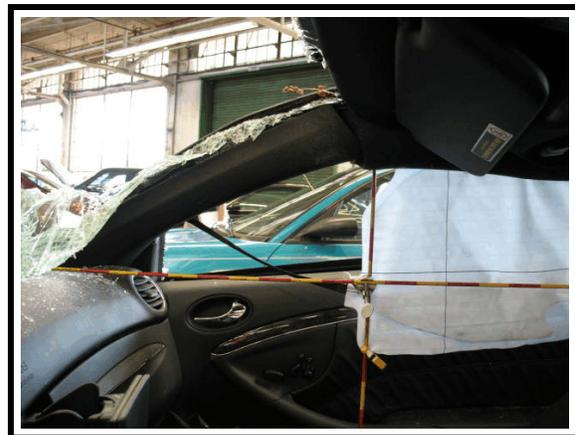
The right side curtain deployed when the right side impacted the ground during the rollover event. The deployed right side curtain extended from the A pillar to the B pillar. In this vehicle, the B pillars are located behind the second row seat backs. There were small coverage gaps present at the right A and B pillars. The gap near the A pillar had a trapezoidal shape which measured 12.0 cm (4.7 in) vertically near the A pillar, 45.0 cm (17.7 in) diagonally along the right A pillar, 32.0 cm (12.6 in) vertically along the front aspect of the curtain, and 38.0 cm (15.0 in) horizontally along the belt line. The coverage gap closer to the B pillar was caused by the fact that all of the curtain material did not deploy from the roof cladding. The back lower corner did not fully deploy and was partially cinched in the B pillar. The gap was triangular in shape and measured 16.0 cm (6.3 in) vertically, 40.0 cm (15.7 in) horizontally along the belt line, and 34.0 cm (13.4 in) diagonally. The side curtain was rectangular in shape and in its deflated state, measured 143.0 cm (56.3 in)

**Figure 25.** Deployed right side curtain - gap at A pillar

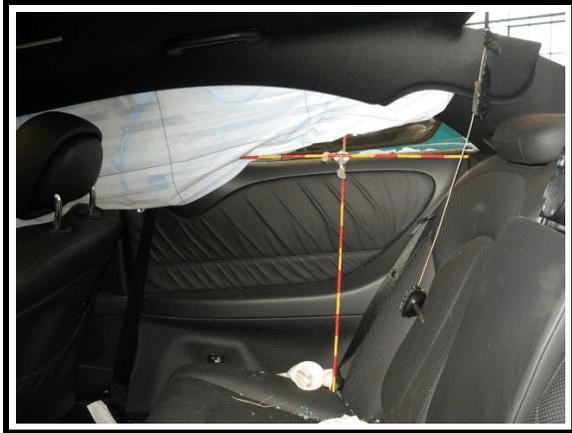
in length. The height of the right side curtain was 32.0 cm (12.6 in) at the front aspect and 25.0 cm (9.8 in) at the back. The curtain deployed from the right roof side rail, had two tethers, no vent ports, and showed no visible signs of occupant contact or damage.

**Figure 26.** Deployed right side curtain - gap at B pillar

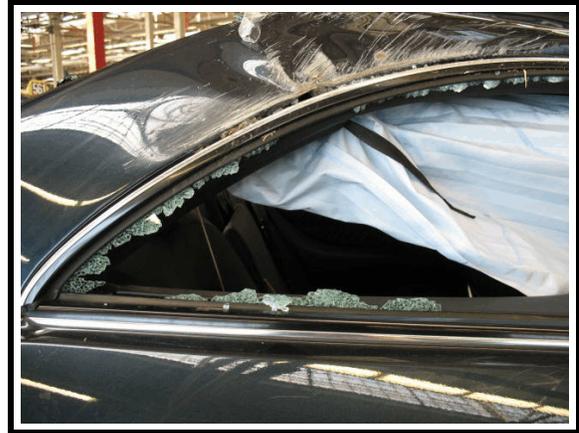
**Figure 27.** Side curtain cinched at the right B pillar

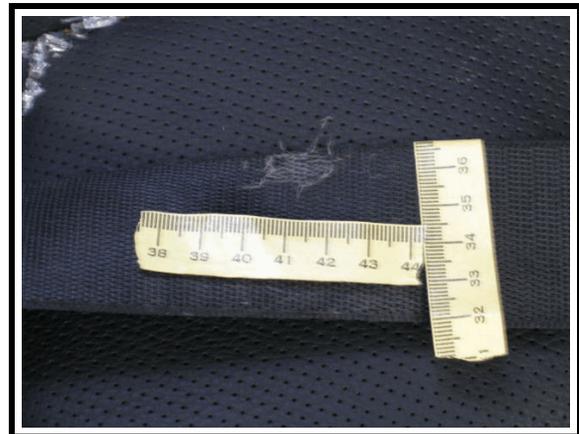
**Figure 32.** Close-up - driver's seat belt webbing
