**CALSPAN ON-SITE POTENTIAL SAFETY-RELATED
DEFECT CRASH INVESTIGATION**

SCI CASE: CA06-021

**VEHICLE: 1998 FORD EXPLORER
LOCATION: NEW MEXICO
CRASH DATE: JULY 2005**

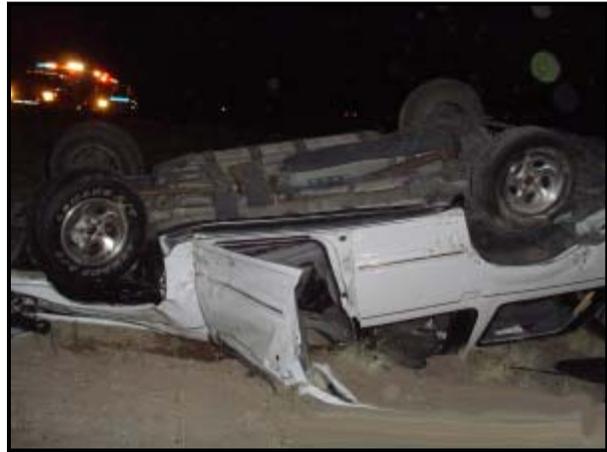
This on-site investigation focused on the alleged tire tread separation and subsequent rollover crash of a 1998 Ford Explorer, **Figure 1**, which resulted in fatal injuries to the 47 year old male restrained front right passenger. The crash occurred during the nighttime hours of July 2005. It was dark without artificial lighting. The reported weather was clear and was not a crash factor. The crash occurred on the southbound lanes of a two-lane divided interstate highway in rural New Mexico. The asphalt roadway was straight and level in the area of the crash. The Ford was southbound in the outboard lane traveling at approximately the 120 km/h (75 mph) speed limit. The southbound Ford Explorer was driven by a 42 year old female and was occupied by a 47 year old male front right passenger, a 37 year old male left rear passenger and a 25 year old male right rear passenger. All four occupants of the Ford were restrained at the time of the crash. The driver lost control of the Ford due to a reported “blow out” of the right rear tire. The tread separation caused the Ford to pull to the right and onto the road shoulder. The driver steered to the left in a reaction to the altered vehicle dynamics. Subsequently the Ford crossed the center divider, traveled through the inboard lane and departed the inboard road shoulder. The driver then steered back to the right in an attempt to regain the road. The vehicle tripped as it reentered the road into a left side leading roll. The vehicle rolled six quarter turns and came to rest on its roof. There were no ejections during the rollover event.

Figure 1: Final rest position of the 1998 Ford Explorer.

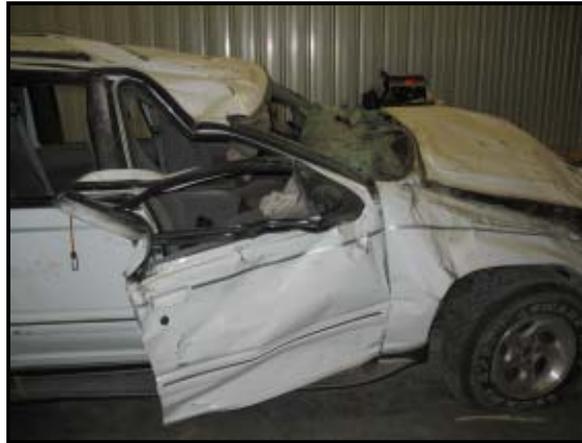
- Mileage: 205,768 km (127,862 miles)
- Right Rear Tire Tread Separation
- Tripped Left Side Leading Roll – Six Quarter Turns
- Maximum lateral and vertical crush located on the right roof rail within the A-pillar area
 - Max Lateral Displacement: 12 cm (4.8 in)
 - Max Vertical Crush: 24 cm (9.4 in)
- Damage to right rear wheelhouse and surrounding body panels from partial detread slap
- Undercarriage: Good condition, all bushings and links tight, no leaking seals, no broken springs, brake lines intact, all parts appear to be OEM.

Figure 6: Maximum crush in the right A-pillar area.

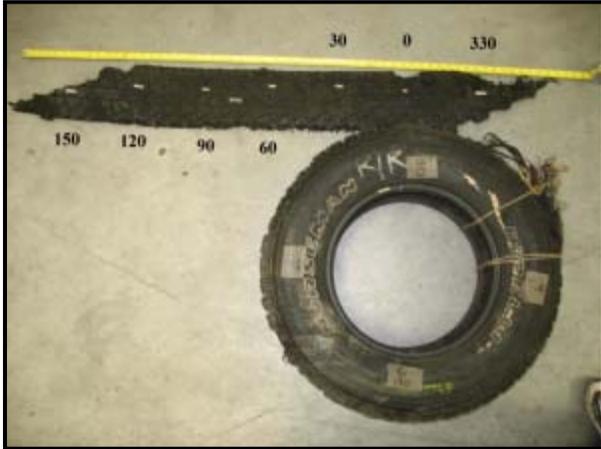
The overall general condition of the tire was considered to be good, **Figures 7 and 8**. There was adequate tread life remaining and the rubber did not appear dry rotted. Damage to the tire consisted of a combination of a separated tread section and destruction of the casing and sidewall. The casing and sidewall were cut completely through compromising the integrity of the tire. The cut measured 15 cm (5.8 in) in length and was oriented in the radial direction at 330 degrees, **Figures 9 and 10**

Figure 7: Overall view of tire and detread. Non DOT side shown.

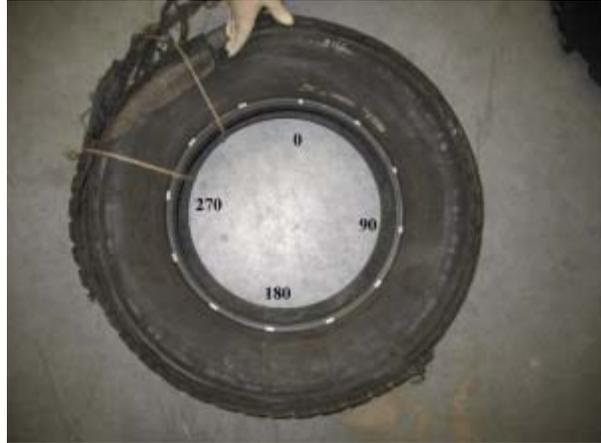
Figure 8: DOT side of tire.

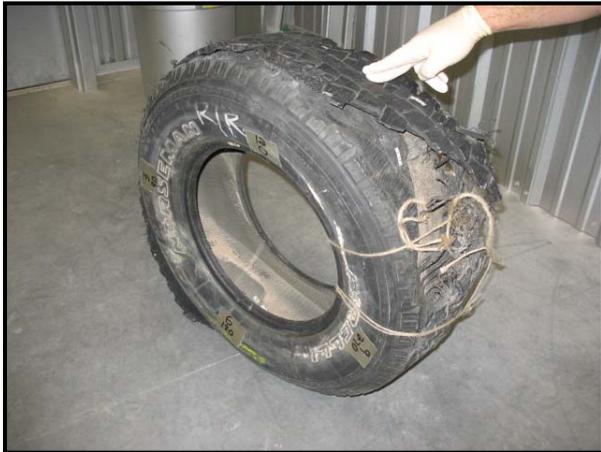
Figure 9: Detread section and tire.

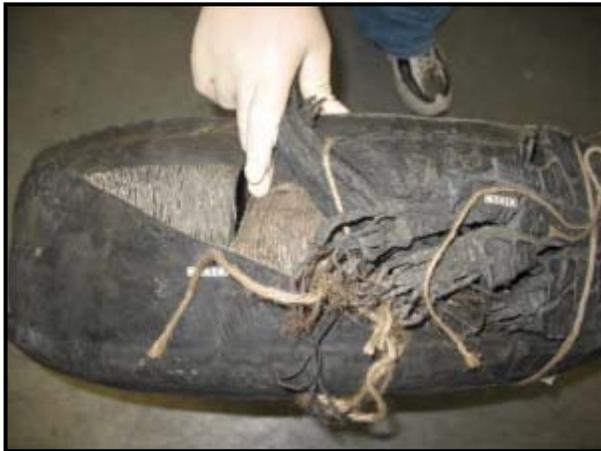
Figure 10: Casing damage at 330 degrees

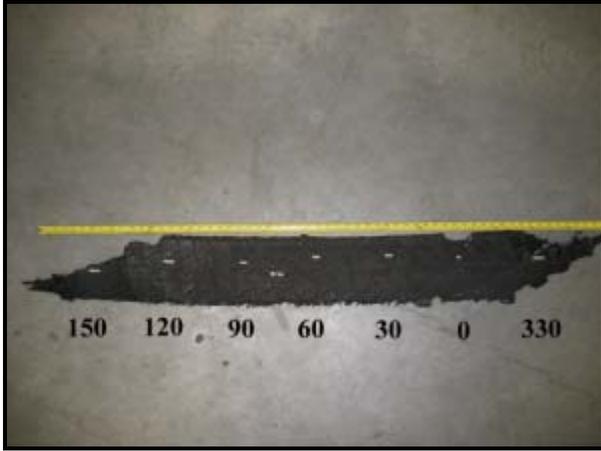
The separated tread section measured 150 cm (59 in) and separated from the tire between 180 to 300 degrees, **Figure 11**. This separation of this tread section occurred between the steel plys. The separated section appeared to have occurred near the construction seam located at 130 degrees, **Figure 12**. A nail was embedded in the separated tread section and was located at 120 degrees, **Figure 13**. The nail head was worn smooth and the nail point was worn flat. The nail

Figure 11: Detread section (Exterior side).

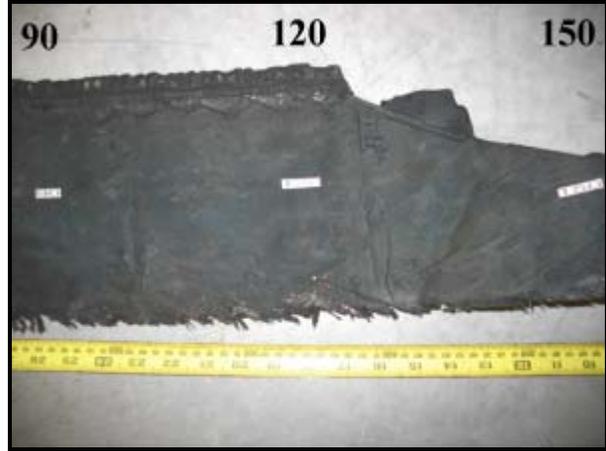
Figure 12: Detread section (interior side).

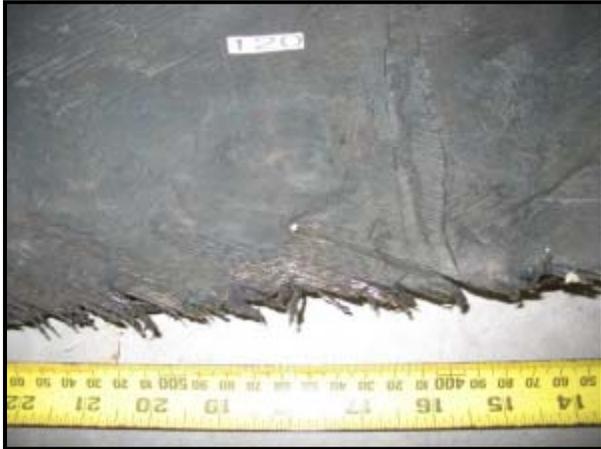
penetrated the tread and top steel ply but did not penetrate the casing. An arrow shape (possible fatigue) section emanated from the nail toward the construction seam. Refer to **Figures 13 and 14**. There was an additional partial tread separation located from 330 degrees to 240 degrees measuring 58 cm (23 in) in length. The nail puncture may have contributed to the damage of this tire. This was not a typical/classic tread separation.

Figure 13: Close-up of nail and construction seam.

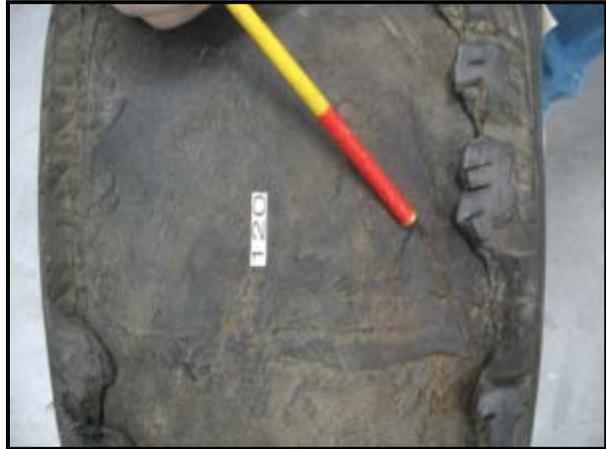
Figure 14: Close-up of tire at the construction seam. Note the nail location.
