CALSPAN ON-SITE CVPI REAR CRASH/FIRE INVESTIGATION

SCI CASE NO.: CA06-023

VEHICLE: 2005 FORD CROWN VICTORIA POLICE INTERCEPTOR

CRASH DATE: SEPTEMBER 2006

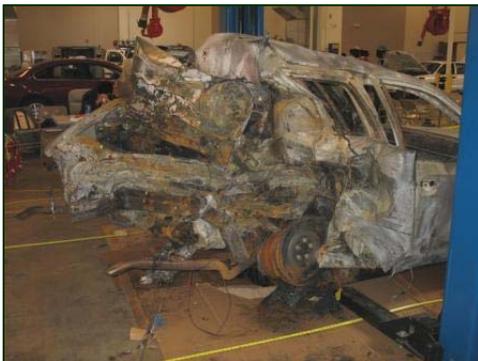
The 2005 Ford CVPI sustained severe damage to the back plane (**Figure 6**) from the impact with the Chevrolet Silverado. Maximum crush was 174 cm (68.4”) located at the right corner of the rear wall of the trunk. The impact crushed the rear bumper system and trunk into the rear seat area of the CVPI and engaged the C-pillars which deflected the backlight header forward. The crush jammed the left side doors and right rear door in the closed positions. The right front door remained closed during the crash and was opened

Figure 6. Right side view of the extent of crush and deformation.

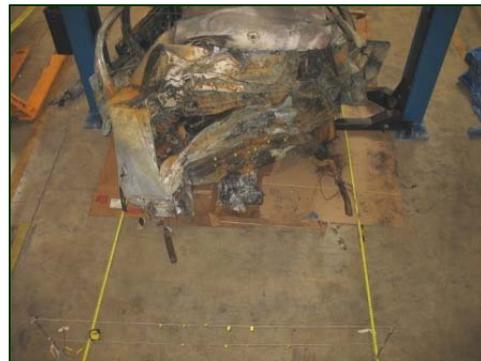
Figure 7. Overhead view of the crush depth.

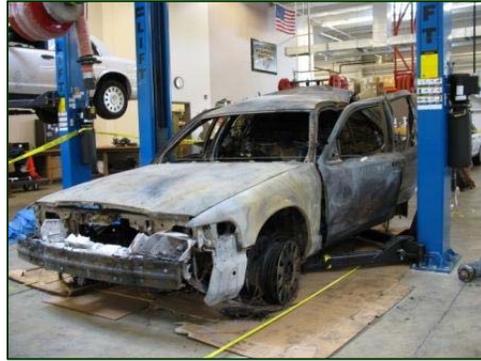
Fire department personnel used hydraulic equipment to cut the left B-pillar from the vehicle. The pillar was cut from the level of the beltline to the roof side rail. The left front door was pried open to extricate the body of the driver. **Figure 8** is a frontal view of the CVPI documenting the extent of damage due to fire and extrication efforts.

Figure 8. Front left view of the CVPI and associated fire and rescue damage.

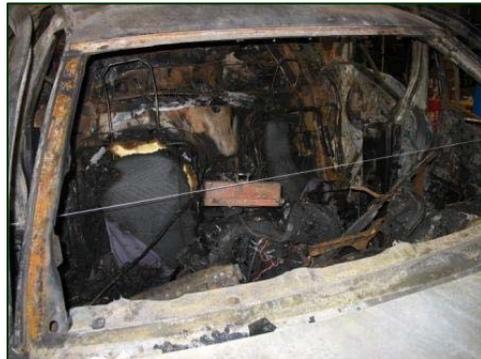
The interior of the CVPI was severely damaged by the crash and consumed by the ensuing fire (**Figure 9**). The three rear seat positions of the vehicle were completely crushed by the forward displacement of the rear wall of the passenger compartment. This intrusion engaged the prisoner cage and displaced the cage forward into the front seat backs. The maximum forward displacement of the front right seat back was 37 cm (14.5"), while the front left seat back was displaced 10 cm (3.75") forward. The residual intrusion of the cage at the inboard aspect of the front right seat back was 21 cm (8.25").

Figure 9. Front interior view of the CVPI.

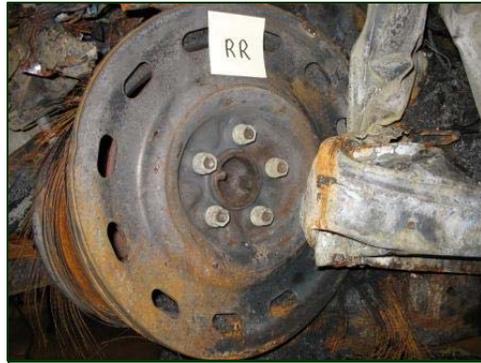
The OEM steel wheels of the CVPI were a new design for 2005. The deep dish style steel wheel was identified as a 12 window wheel, with 12 rectangular slots around the outboard circumference. All four wheels were equipped with OEM hubcaps that melted during the fire. The inboard and outboard bead areas of the right rear tire were deformed from the extreme crush located at the back right corner of the vehicle. The remaining wheels were not damaged with tire cord fragments remaining on the wheels. The Goodyear Eagle tires were completely burned by the fire. There no weld fractures or cracking of the wheels. **Figure 10** is of the right rear wheel of the CVPI.

Figure 10. Right rear wheel of the CVPI.

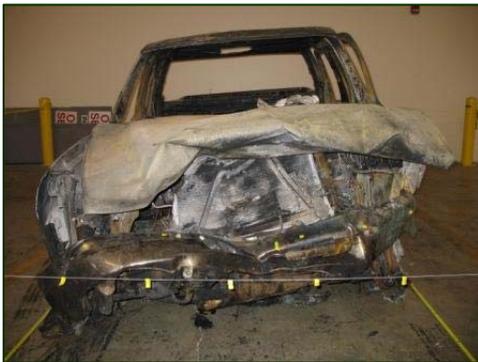
The Silverado sustained moderate severity frontal damage as a result of the crash with the CVPI. The direct contact damage on the hood face began approximately 44 cm (17.5”) right of center and extended 130 cm (51”) to the left corner (**Figure 11**). The impact crushed the full frontal width of the vehicle resulting in a combined induced and direct contact damage length of 148 cm (58.5”) along the deformed bumper. Maximum crush was 76 cm (29.75”) located at the left corner of the bumper. The crush profile documented at bumper level (**Figure 12**) was as follows: C1 = 76 cm (29.75”), C2 = 60 cm (23.75”), C3 = 60 cm (23.5”), C4 = 53 cm (21”), C5 = 29 cm (11.5”), C6 = 14 cm (5.5”). The CDC for this impact event was 12-FDEW-3.

Figure 11. Frontal damage to the Chevrolet Silverado.

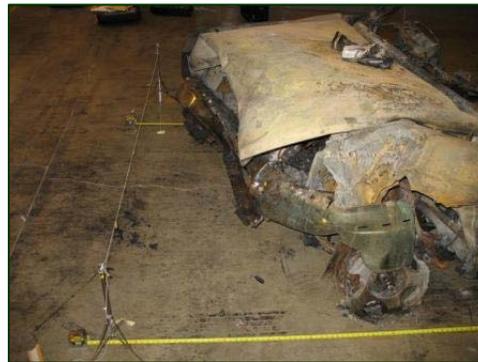
Figure 12. Left lateral view documenting the extent of crash.

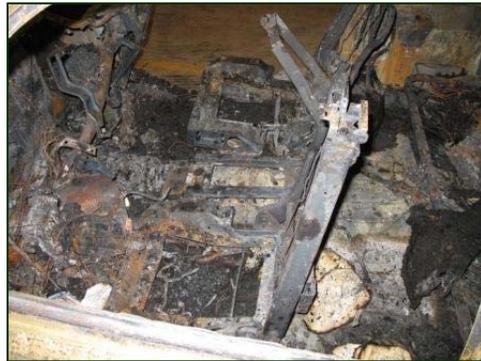
The interior of the Silverado was completely consumed by the fire (**Figure 13**). Available evidence related to the trajectory and contact points of the driver was limited to minimal forward deflection of front left seat back. This seat was equipped with an integrated safety belt system. It was unknown if the driver was restrained, however, seat back deflection was a subtle indication of possible safety belt use and loading.

Figure 13. Left side interior view of the Silverado.

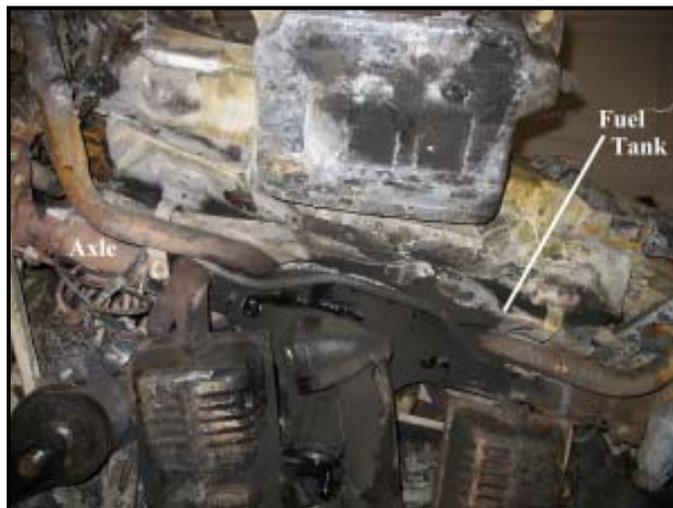
Figure 15: Deformed undercarriage of subject CVPI.

During the impact sequence, the aft section of the CVPI crushed and deformed forward. The fuel tank mounted on the forward wall of the trunk was in-turn displaced forward and into contact with the differential and rear axle. The aluminum drive shaft fractured forward of the differential yoke and separated. An examination of the tank revealed that its lower central and right aspects were crushed to near full-thickness due to the right bias of the impact location. As the deformation occurred, hydraulic pressure developed within the steel fuel tank. The over-pressurization exceeded the strength of the sidewall of the tank, therefore the left side of the tank ruptured. The aft wall of the tank compressed the full depth of the tank and the sending unit located on the forward side of the tank was dislodged.

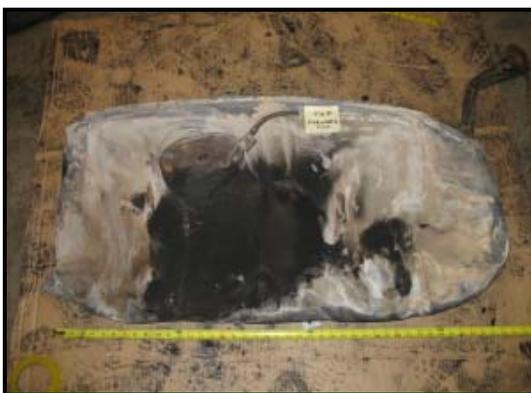
Figures 16 and 17 are views of the forward and rear sides of the tank, respectively. There were no punctures of these major exposed sides. A small 2 cm x 2 cm (0.8" x 0.8") hole was located on the top surface of the deformed tank. It was located 15 cm (5.8") inboard of the left tank strap. This hole was not the result of a direct puncture, but occurred as the result of a crease and subsequent tear of the steel as the tank was

Figure 16. Forward aspect of the fuel tank.

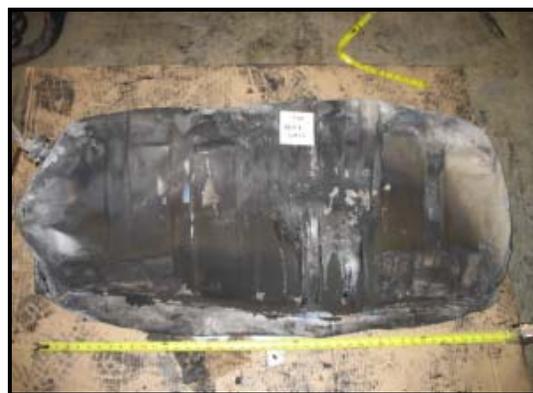
Figure 17. Rear aspect of the tank.

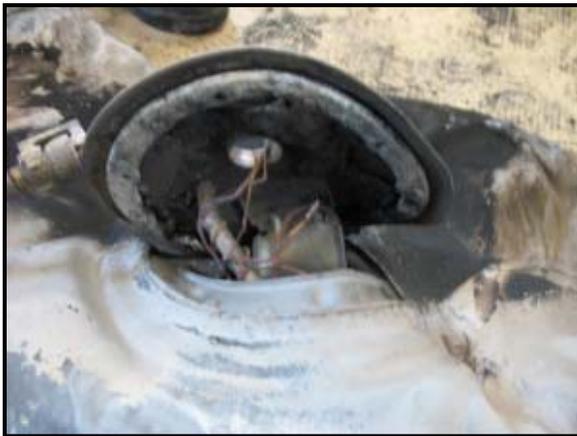
compressed against the undercarriage of the CVPI. The sending unit was dislodged by mechanical deformation, **Figure 18**. The sending unit was fastened to the tank by cap screws that engage a retaining ring that was crimped in place by the tank's sheet metal. The sending unit completely dislodged due to a combination of the deformation of the crimp holding the retaining ring in place and by contact between the internal fuel pump and the crushed rear tank wall.

Figure 18. Displaced sending unit from forward aspect of tank.

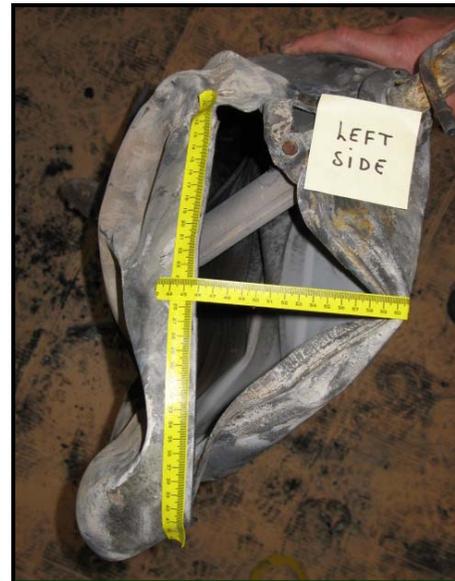
Figure 19 is a view of the ruptured left side of the tank. The ruptured area deformed into a triangular pattern. The rupture measured 32x14 cm (12.5x5.5"), length by height. It should be noted that the rupture occurred in the parent metal outboard of the welded seam. The welded seam remained intact along its entire length. The fuel filler neck was not damaged during the deformation and was intact.

Figure 19. Ruptured left side of the fuel tank with filler tube in place.
