**CALSPAN ON-SITE CHILD AIR BAG RELATED SERIOUS INJURY  
CRASH INVESTIGATION**

**CASE NO: CA06-025**

**VEHICLE: 1995 FORD CONTOUR**

**CRASH DATE: OCTOBER 2006**

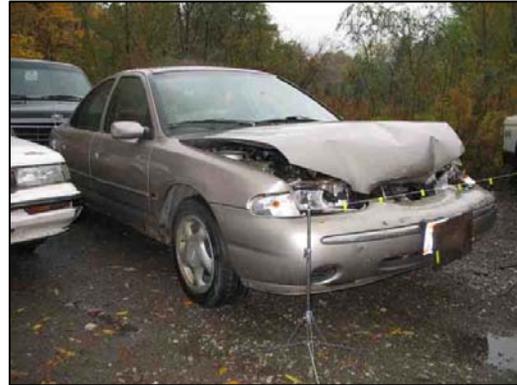
This on-site investigation focused on the severity of the crash and the source and severity of injury for a 6-year old male front right passenger of a 1995 Ford Contour (**Figure 1**). The Contour was equipped with first generation frontal air bags for the driver and front right passenger positions that deployed as a result of a minor severity rear-end crash with a 1998 Jeep Cherokee. The 20-year old male driver of the Contour was apparently distracted and failed to detect the Cherokee as it stopped for traffic. The driver of the Contour applied a rapid braking force immediately prior to impact. The

**Figure 1 - Damaged 1995 Ford Contour.**

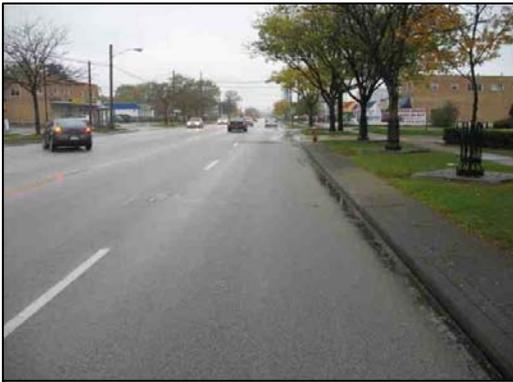
The 20-year old male driver of the Ford Contour was traveling in a southerly direction on the outboard lane at approximately the posted speed limit of 40 km/h (25 mph). As he approached the Jeep Cherokee, the driver of the Contour was momentarily distracted from the driving task. He redirected his attention forward and observed the stopped Cherokee directly forward of his path of travel. The Contour driver applied a rapid braking force in an attempt to avoid the crash. This braking force compressed the front suspension as the vehicle continued forward to impact. **Figures 2** and **3** illustrate the pre-crash direction and point of impact of both vehicles.

**Figure 2 - Southbound approach of both vehicles.**

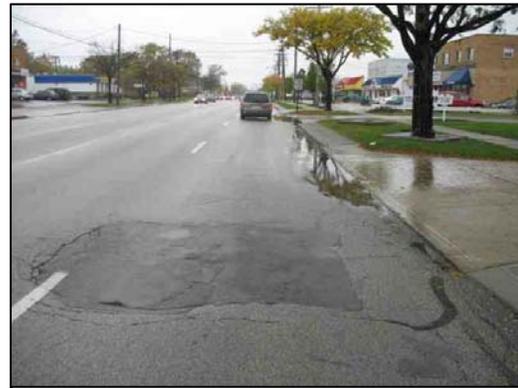
**Figure 3 - Area of impact.**

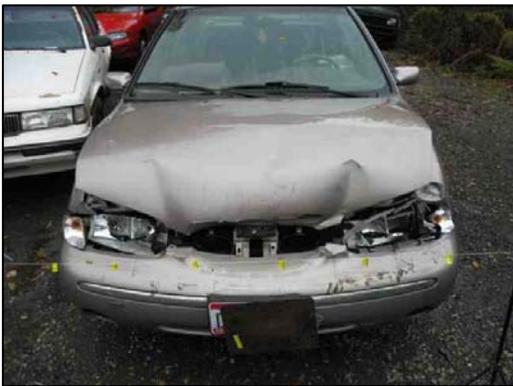
The frontal area of the Ford Contour sustained minor severity damage that involved the front bumper fascia, hood, grille, both headlight and turn signal assemblies, the leading edges of the front fenders, and the upper radiator support panel (**Figures 4 and 5**). The top surface of the Contour's front bumper initially engaged and underrode the rear bumper. The grille, hood face, and upper radiator support subsequently engaged the rear bumper as the Contour continued forward. The direct contact damage on the bumper fascia began 66 cm (26") right of center and extended 136 cm (53.5") to the left corner. There was no crush at the level of the bumper. The hood face crushed rearward against the upper radiator support and the hood latch released. The full-width of the support was deformed resulting in a "Field L" measurement width of 130 cm (51"). Maximum crush was 8 cm (3") located at the left corner of the radiator support. The crush profile at the level of the support was as follows: C1 = 8 cm (3"), C2 = 2 cm (0.8"), C3 = 3 cm (1.1"), C4 = 1 cm (0.4"), C5 = 3 cm (1.2"), C6 = 2 cm (0.8"). The Collision Deformation Classification (CDC) for this impact was 12-FDEW-1.

**Figure 4 - Frontal perspective of damage.**

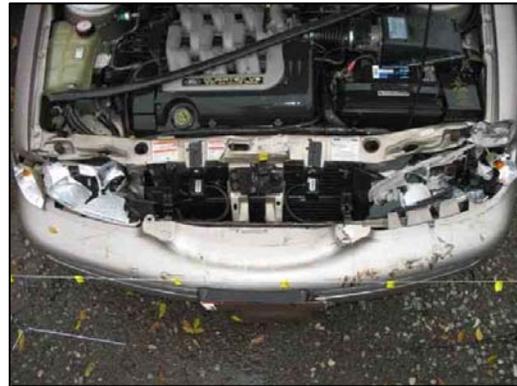
**Figure 5 - Overhead perspective of frontal damage.**

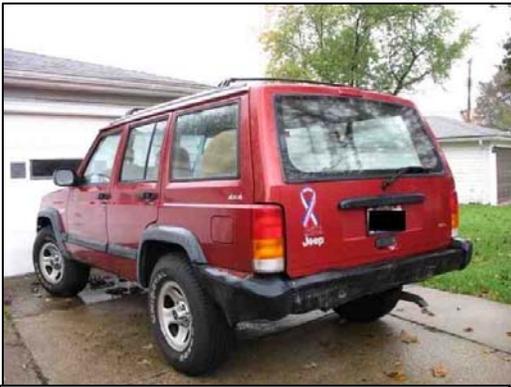
The back plane of the Jeep Cherokee sustained minor severity damage as a result of the impact with the Ford Contour (**Figures 6 and 7**). The damage was limited to the rear bumper which was crushed forward, indicative of the 6 o'clock direction of force. The direct contact damage began 43 cm (17") right of center and extended 119 cm (47") to the left corner. Maximum crush was 8 cm (3") located on the bumper face, 33 cm (13") inboard of the left corner. The crush profile was along the total damage width of 163 cm (64") and was as follows: C1 = 0 cm, C2 = 8 cm (3"), C3 = 4 cm (1.5"), C4 = 3 cm (1"), C5 = 1 cm (0.25"), C6 = 0 cm. The CDC for this impact was 06-BDLW-1.

**Figure 6 - Damaged 1998 Jeep Cherokee.**

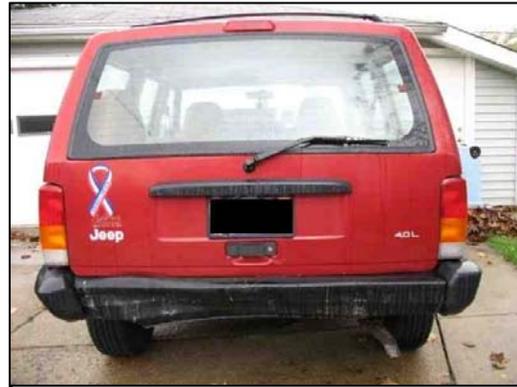
**Figure 7 - Damaged 1998 Jeep Cherokee.**

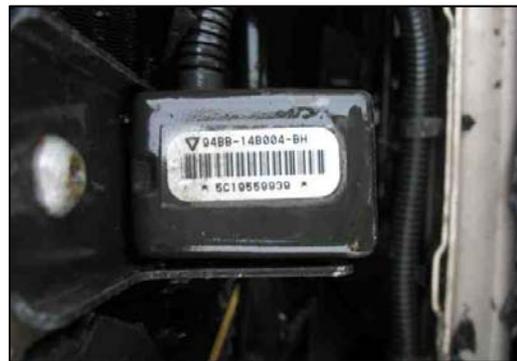
The Ford Contour was equipped with a first generation frontal air bag system for the driver and front right passenger positions. The system consisted of a conventionally mounted driver air bag module within the four-spoke steering wheel rim, a mid-mount front right air bag module, two ball-in-tube electro-mechanical sensors that were mounted to the forward face of the upper radiator support panel (**Figure 8**), a right kick-panel mounted safing sensor, and a right lower instrument panel air bag control module. The frontal air bags deployed as a result of the frontal engagement against the rear of the Jeep. The front mounted crash sensors were not damaged as a result of the underride crash.

**Figure 8 - Air bag sensor.**

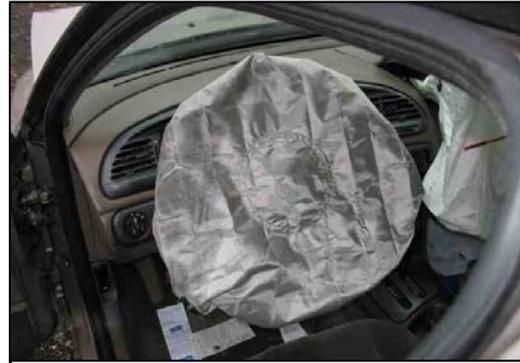
The driver's air bag deployed from an H-configuration module (**Figure 9**). The cover flaps were 19 cm (7.5") in width at the horizontal tear seam. The upper flap flared to a

width of 12 cm (10.1”) and was 9 cm (3.6”) in height. The lower flap was 7 cm (2.75”) in height. The air bag was vented by two 2 cm (0.75”) diameter ports located on the back side of the bag at the 12 o’clock sector. The ports were centered 6 cm (2.5”) forward of the peripheral seam. The air bag was also tethered by four internal straps at the 12/6 and 3/9 o’clock positions. The maximum excursion of the air bag at the tether location was 23 cm (9”).

**Figure 9 - Deployed driver's air bag.**

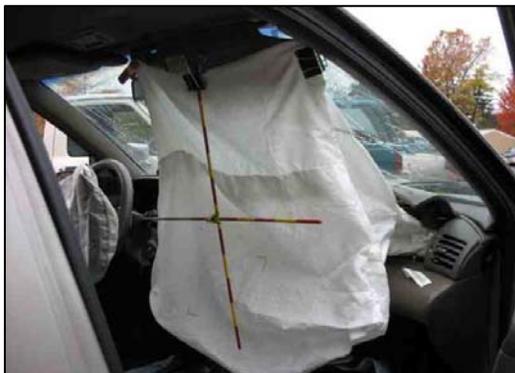
The front right air bag deployed from a mid mount module that was incorporated into the apex of the top and mid right instrument panel (**Figure 10**). The single cover flap was formed to the contour of the instrument panel and was reinforced with a sheet metal backer that acted as a hinge. The flap’s overall dimensions were 36 cm (14.25”) in width and 17 cm (6.75”) fore and aft. The acronym SRS (Supplemental Restraint System) was embossed into the lower right aspect of the flap. As the air bag deployed, the cover flap opened in an upward and forward direction and contacted and fractured the windshield.

The deployed front passenger air bag was tethered by a single wide band tether that was sewn to the face of the bag 23 cm (9”) below the top surface of the bag face. The face of the air bag measured 61 cm (24”) in width and 51 cm (20”) in height. The top and bottom seams of the bag protruded 30 cm (12”) outboard of the leading edge of the module. The maximum excursion of the bag was 61 cm (24”) at the mid point.

**Figure10 - Deployed front right air bag.**

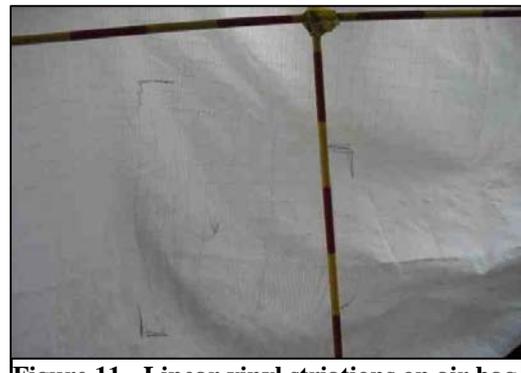
Subtle vertically oriented striations were present on the left lower third of the face of the bag which measured 25 cm (10”) in height and 17 cm (6.75”) in width (**Figure 11**). These striations resulted from expansion of the air bag within the module as its expansion was restricted by the out-of-position front right passenger. There was no occupant contact evidence (tissue and/or body fluid) on the air bag.

**Figure 11 - Linear vinyl striations on air bag membrane.**

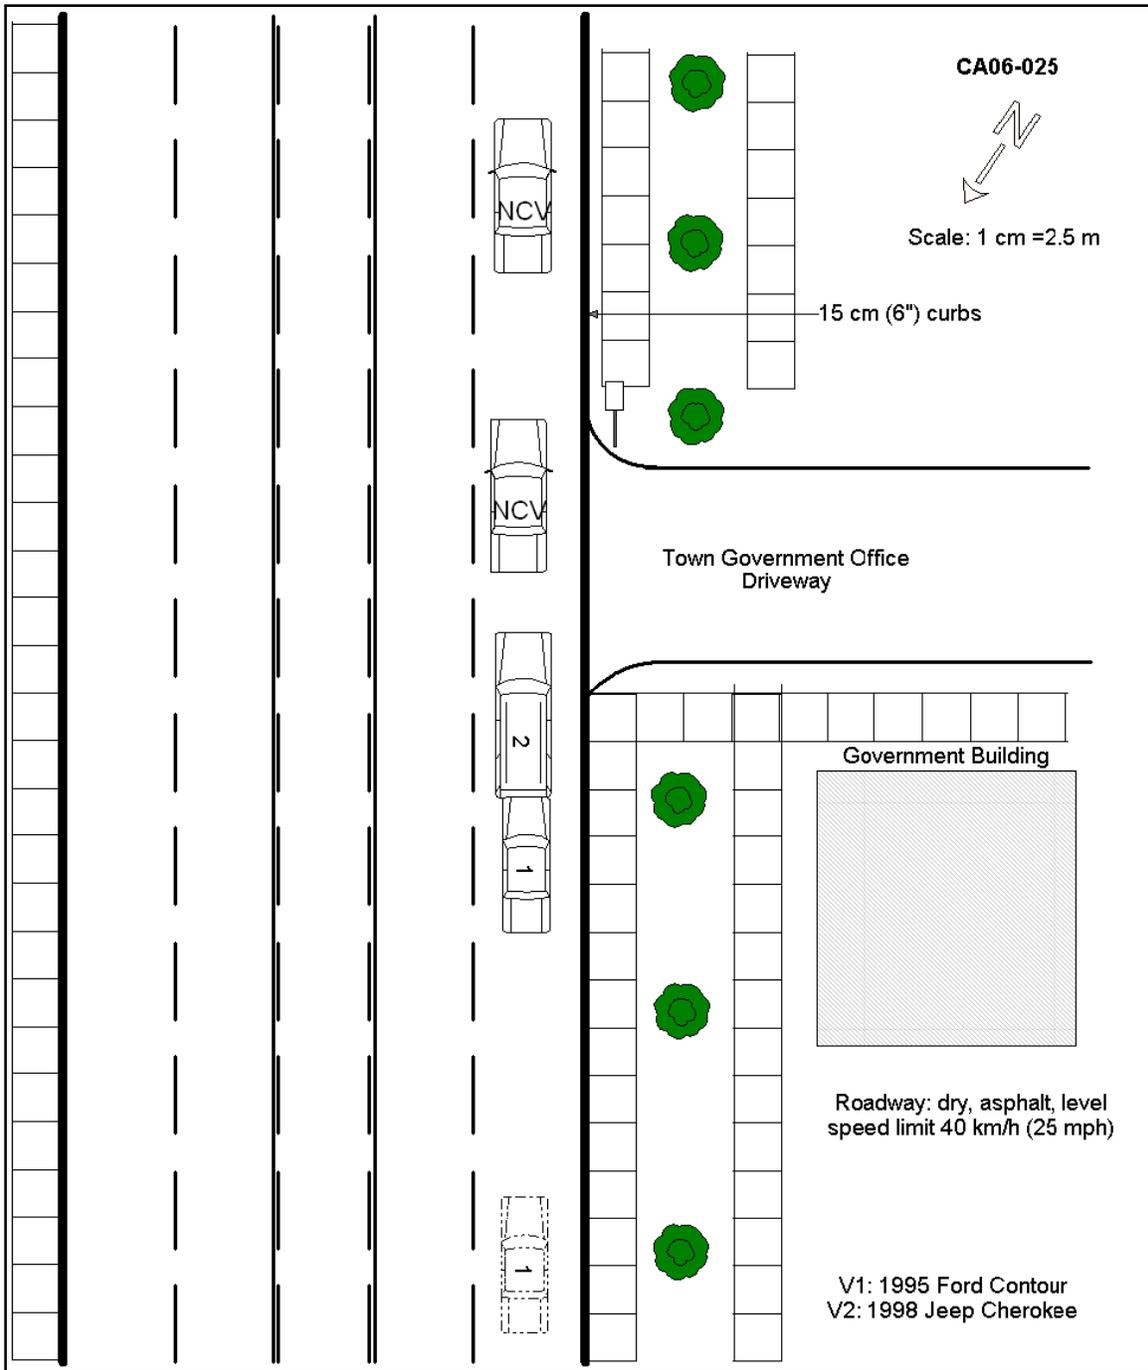
**Figure 12 – Crash Schematic**

This crash occurred on a five lane U.S. Route in an urban area during nighttime hours. The roadway consisted of two travel lanes in each direction and a dual center left turn lane. The asphalt road surface was straight and level and bordered by 15 cm (6") barrier curbs. The weather conditions were overcast with light rain and the road surface was wet. Illumination was provided by artificial lighting from light poles and area businesses. The crash site was located several hundred meters north of a signalized four-leg intersection. Traffic had backed up from the intersection to the location of the crash. The posted speed limit was 40 km/h (25 mph). The Crash Schematic is attached as **Figure 12** at the end of this narrative report.
