## ON-SITE SIDE INFLATABLE OCCUPANT PROTECTION INVESTIGATION

CASE NUMBER - IN-06-029

VEHICLE - 2005 KIA SPECTRA EX

CRASH DATE - July 2006

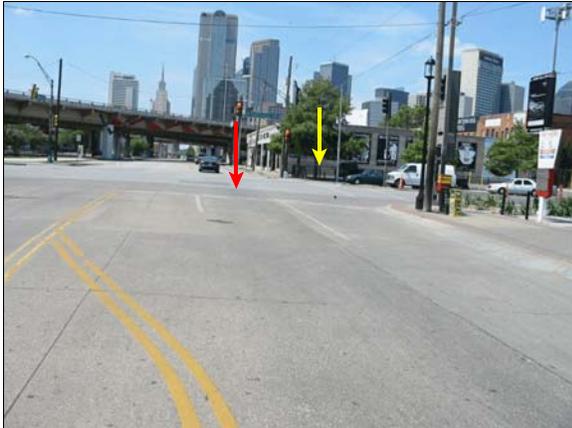
**Pre-Crash:** The case vehicle was traveling westbound in the left through lane (**Figure 1** below) approaching the intersection. The driver was intending to continue straight through the intersection. The Nissan was traveling northbound in the center through lane also approaching

**Figure 1:** Approach of case vehicle to intersection in left through lane, red arrow shows area of initial impact, yellow arrow shows location of case vehicle's subsequent impact with fence, Nissan approached from left

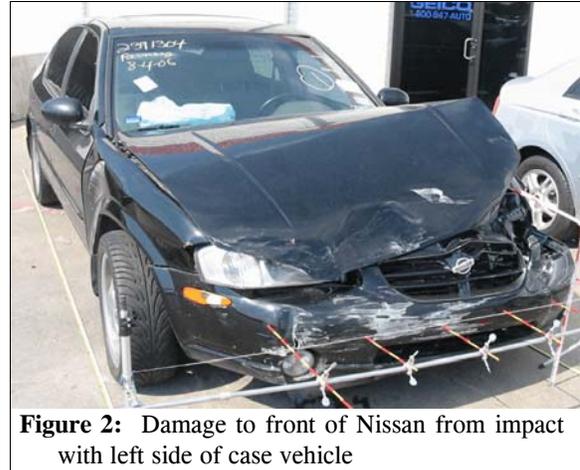
**Figure 2:** Damage to front of Nissan from impact with left side of case vehicle

**Crash:** The police crash report indicated that the case vehicle entered the intersection on a red light as the Nissan was entering the intersection. The front of the Nissan (**Figure 2**) impacted the case vehicle's left side (event 1, **Figure 3**) causing the case vehicle driver's seat back-mounted side impact air bag and left side curtain air bag to deploy. The Nissan's driver and front right passenger air bags also deployed. As both vehicles rotated counterclockwise, the right fender of the Nissan (**Figure 4**) impacted the case vehicle's left rear bumper corner (event 2). The case vehicle continued to rotate counterclockwise and traveled northwest through the intersection and departed the northwest corner of the intersection with the back end leading. The back of the case vehicle then impacted a metal fence (event 3, **Figure 5** below).

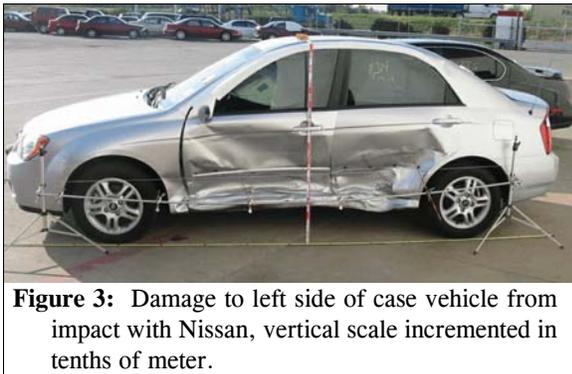
**Figure 3:** Damage to left side of case vehicle from impact with Nissan, vertical scale incremented in tenths of meter.

**Exterior Damage:** The case vehicle’s impact with the Nissan involved the left side. The left front door and left rear door were directly damaged and crushed inward. Both doors were jammed shut. The direct damage ended 21 centimeters (8.3 inches) forward of the left rear axle and extended 201 centimeters (79.1 inches) forward along the left side. The residual maximum crush was measured as 26 centimeters (10.2 inches) occurring at C<sub>3</sub>. The table below shows the case vehicle’s left side crush profile.

The case vehicle’s wheelbase was unchanged. Induced damage involved the left fender, upper portions of the left side doors and the left quarter panel.

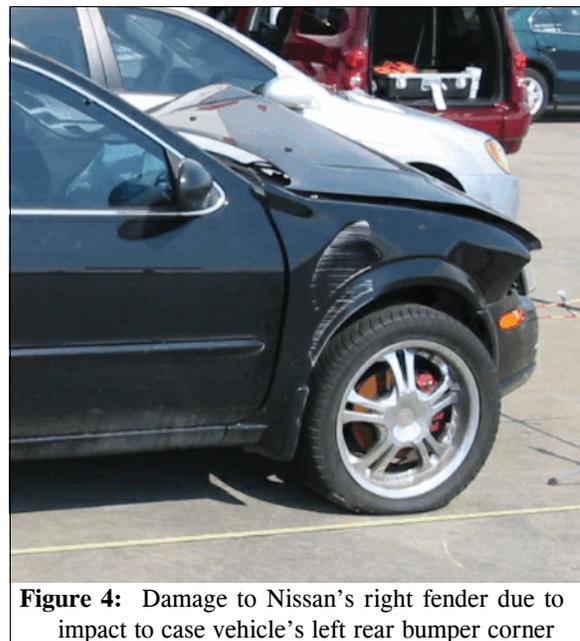
**Figure 4:** Damage to Nissan's right fender due to impact to case vehicle's left rear bumper corner

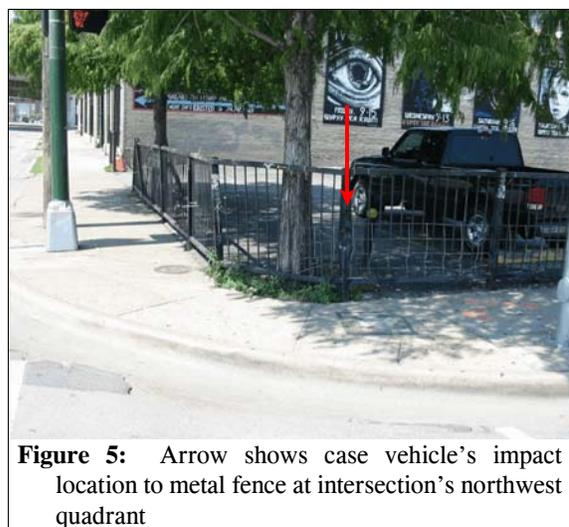
**Post-Crash:** The case vehicle came to final rest with the back of the vehicle against the metal fence heading southeast (**Figure 5**). The police crash schematic did not depict the rest position of the Nissan, and no evidence of its rest position was found during the scene inspection. Given the crash dynamics, the Nissan rotated counterclockwise and most likely traveled northwest through the intersection and came to rest in the northwest quadrant of the intersection heading northwest.

**Figure 5:** Arrow shows case vehicle’s impact location to metal fence at intersection’s northwest quadrant

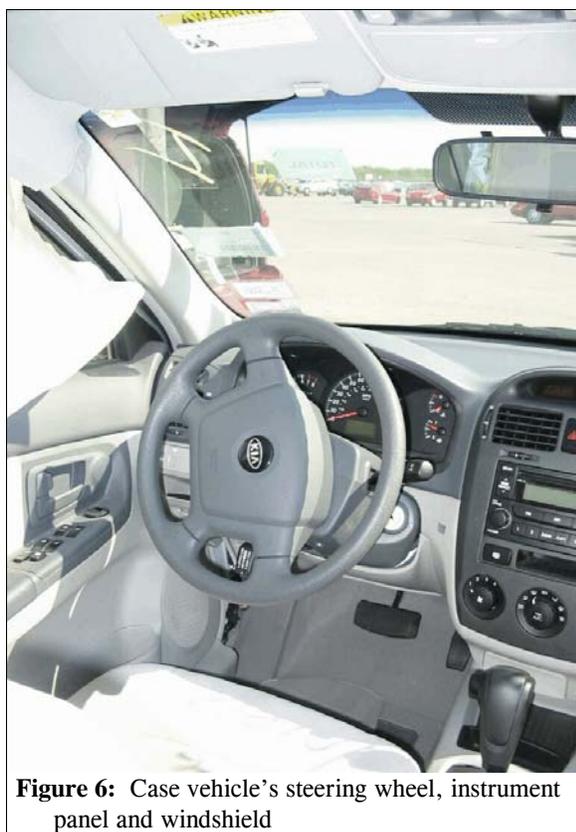
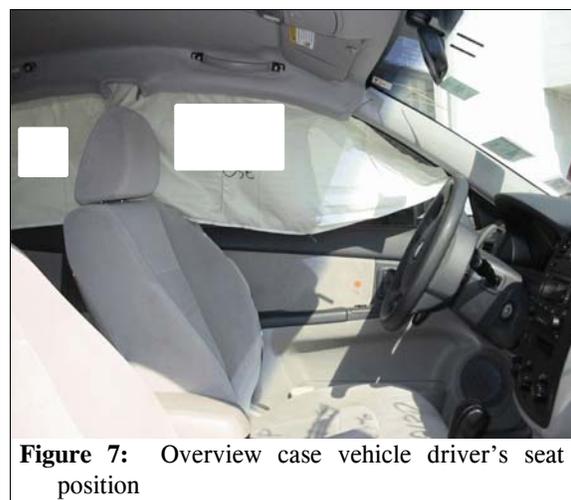
**Vehicle Interior:** Inspection of the case vehicle’s interior (**Figures 6 and 7**) revealed an unidentified transfer on the driver’s door adjacent to the door lock button. No other occupant contact evidence on any interior surfaces was observed. The vehicle sustained 5 centimeters (2 inches) of lateral driver’s door intrusion into the driver’s seat position and 14 centimeters (5.5 inches) of lateral left rear door intrusion into the back left seat position. There was no deformation to the steering wheel rim or compression of the energy absorbing steering column.

**Figure 6:** Case vehicle’s steering wheel, instrument panel and windshield

**Figure 7:** Overview case vehicle driver’s seat position

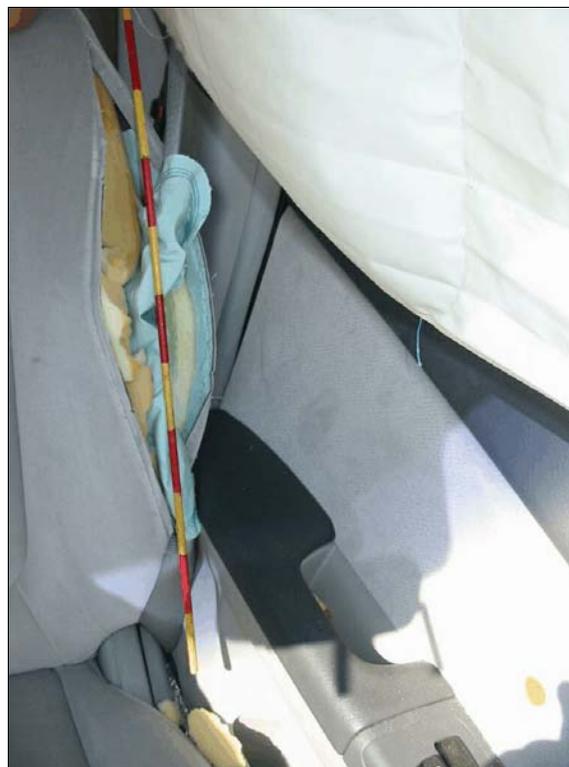
The case vehicle driver's seat back-mounted side impact air bag was located in the outboard side of her seat back (**Figure 8**). The air bag deployed through a tear seam in the seat back. There was no evidence of damage to the air bag due to deployment. The air bag was designed without tethers and was rectangular in shape. The air bag (**Figure 9**) was approximately 23 centimeters (9.1 inches) in length and approximately 32 centimeters (12.6 inches) in height. There was no evidence of occupant contact to the air bag.

**Figure 8:** Driver's seat back-mounted side impact air bag located in outboard side of driver's seat back

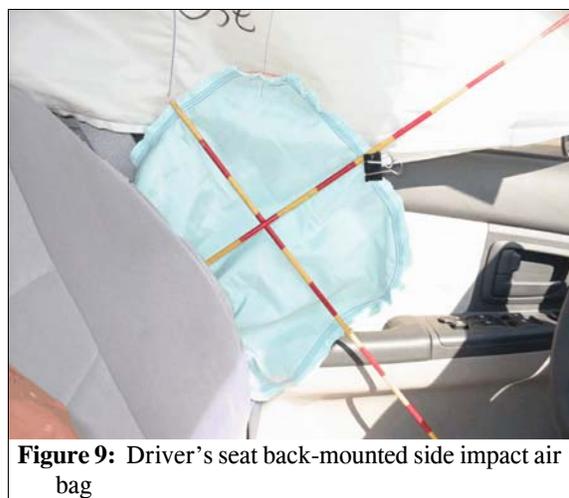
**Figure 9:** Driver's seat back-mounted side impact air bag

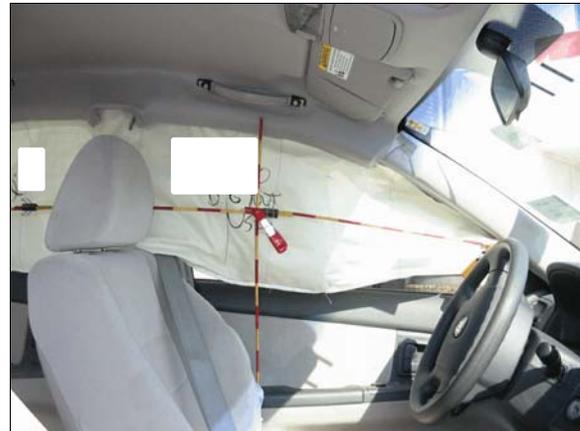
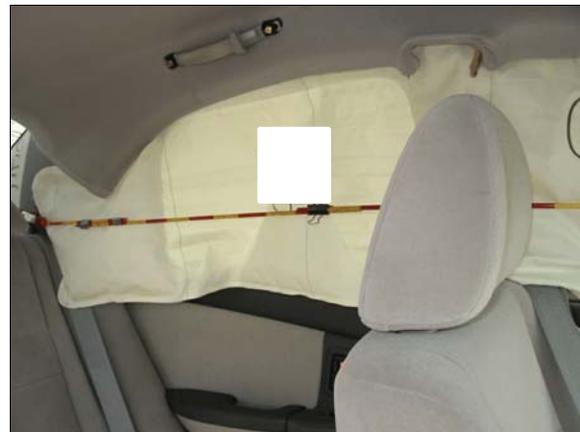
The left side curtain air bag was located along the left roof side rail (**Figures 10 and 11** below) inside the headliner and extended along the driver and back left seat positions. The air bag was anchored to the left A-pillar. The cloth anchor was triangular-shaped, integral to the curtain air bag and was approximately 42 centimeters (16.5 inches) in length. The total length of the side curtain air bag was approximately 171 centimeters (67.3 inches) and was approximately 32 centimeters (12.6 inches) in height. It was designed without tethers and had a large inflation

chamber adjacent to the front left seat and a smaller inflation chamber adjacent to the back left seat back. There was no evidence of damage to the air bag due to deployment and no evidence of occupant contact.

**Figure 10:** Overview of case vehicle driver's side curtain air bag

**Figure 11:** Overview of case vehicle's back left side curtain air bag

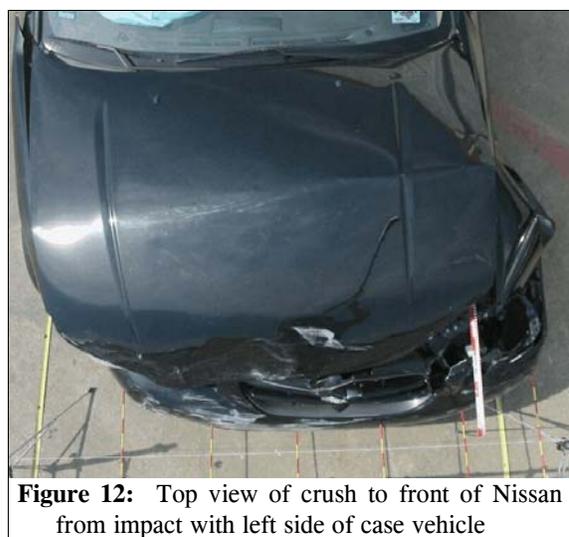
**Figure 12:** Top view of crush to front of Nissan from impact with left side of case vehicle

**Exterior Damage:** The Nissan’s impact with the case vehicle involved the front plane. The front bumper, grille and hood were directly contacted, crushed rearward and displaced to the left [stubframe shift did not exceed 10 centimeters (4 inches)]. Direct damage began at the front right bumper corner and extended 151 centimeters (59.4 inches) along the front bumper. Crush measurements were taken at the bumper and the maximum residual crush (**Figure 12**) was measured as 11 centimeters (4.3 inches) occurring at C<sub>2</sub>. The table below shows the Nissan’s front crush profile.
