Certified Advanced 208-Compliant Air Bag/Rollover Investigation
Dynamic Science, Inc. / Case Number: DS06031
2006 Subaru Impreza
Colorado
November 2006

Dynamic Science, Inc.
Crash Investigation
Case Number: DS06031

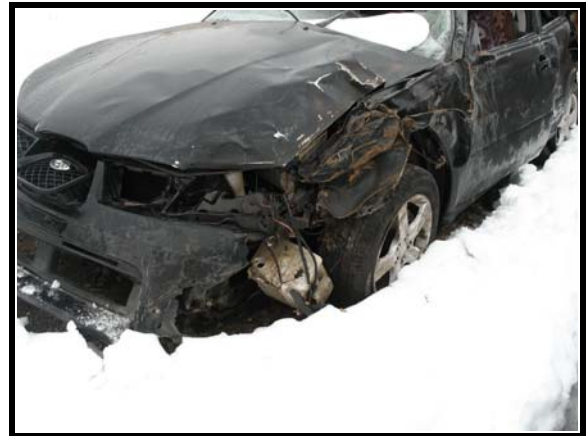
The 2006 Subaru Impreza sustained moderate frontal damage as a result of the impact with the rear of the Chevrolet Cobalt. The direct damage began at the left front bumper corner and extended 29.0 cm (11.4 in) laterally across the front of the bumper. The direct damage extended 89.0 cm (35.0 in) rearward along the left side plane. The left wheelbase was shortened by 8.0 cm (3.1 in). Six crush measurements were documented at the bumper level: C1 = 29.0 cm (11.4 in), C2 = 8.0 cm (3.1 in), C3 = 17.0 cm (6.7 in), C4 = 12.0 cm (4.7 in), C5 = 0 cm (0 in), C6 = 0 cm (0 in).

The Collision Deformation Classification (CDC) for the impact with the Cobalt was 12FLEE5.

Figure 3. Left front bumper corner damage, Subaru Impreza

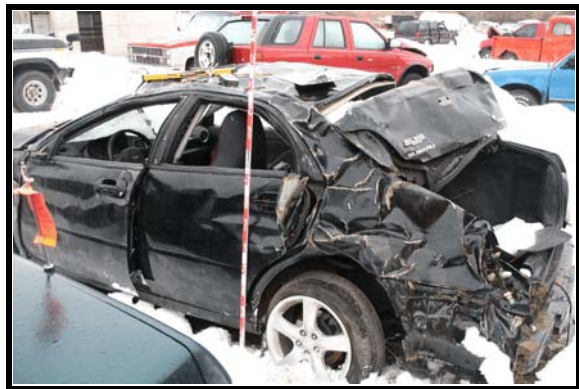
There was direct contact damage along the left side plane, right side plane, on the roof near the windshield header and along the left roof rail that occurred during the vehicle rollover. There was 5.0 cm (1.9 in) of vertical crush and 9.0 cm (3.5 in) of lateral crush at the left A pillar. There was 20.0 cm (7.9 in) of vertical crush at the windshield header. There was 47.0 cm (18.5 in) of lateral crush at the left rear quarter panel. The trunk lid opened during the crash and the rear bumper fascia had come off. The right rear tire and right front tire were canted to the left from lateral loading. The CDC for the rollover was 00TDDO3.

Figure 4. Left side damage, Subaru Impreza

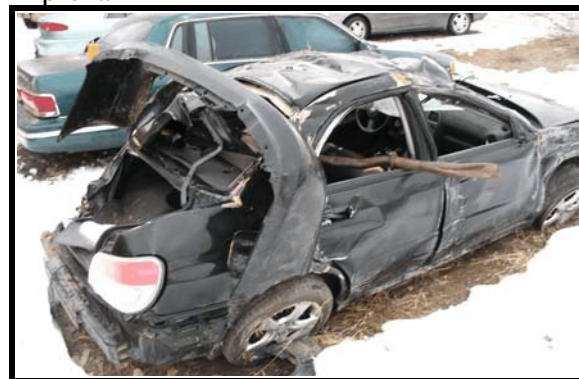
It has been reported that during the rollover sequence the case vehicle struck a roadside pole with its right side. It is not clear where the pole was impacted and what kind of pole was involved. There is some damage above the right rear wheel that might be related to a pole impact. An unknown CDC of 99R99999 was assigned to this impact.

Figure 5. Right side damage, Subaru Impreza

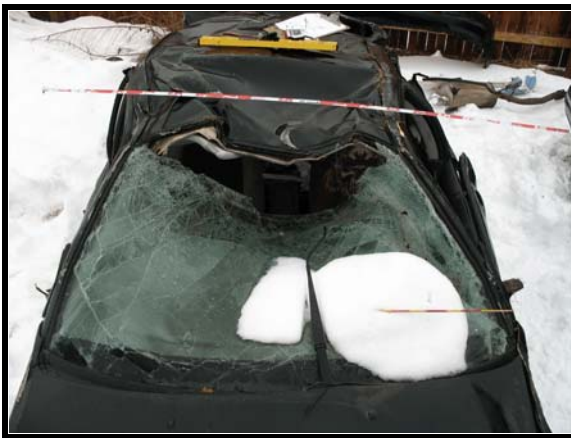
Figure 6. Overview of roof crush

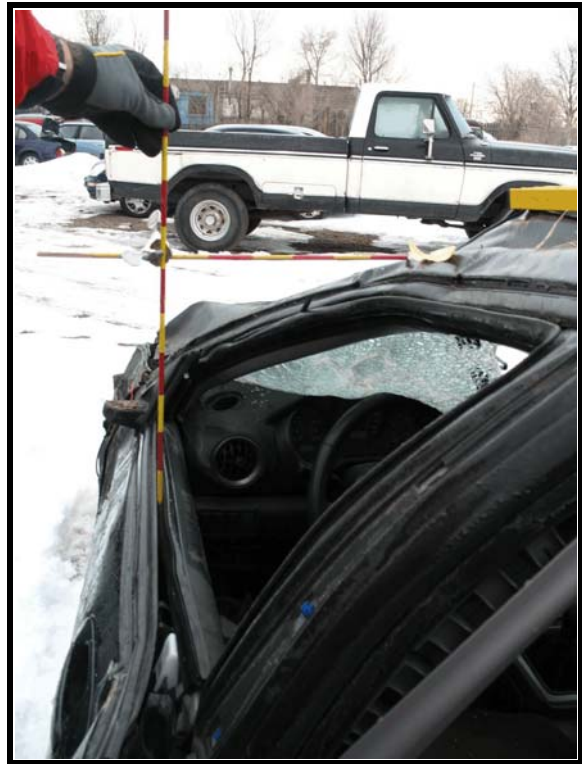
Figure 7. Left side A pillar crush

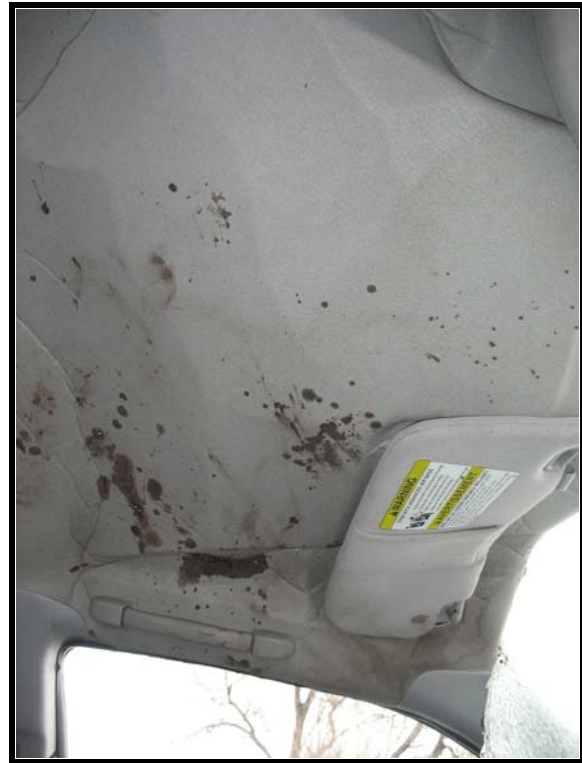
The Subaru Impreza sustained moderate interior damage as a result of passenger compartment intrusion. The left side roof, roof rail, and A pillar sustained vertical intrusion. Both right side doors were jammed shut. Side glass for the right and left side windows was disintegrated. The backlight was also disintegrated. The windshield was damaged during the rollover. At the time of inspection, there was a gap between the windshield header and the glass, but this may have been related to sag. There was blood found on the interior roof in a dropping type pattern. There was a smeared blood stain on the left hand rail. The driver's seat belt had been cut by EMS personnel. There were loading marks located on the seat belt webbing.

Figure 8. Blood stain pattern and left A pillar movement

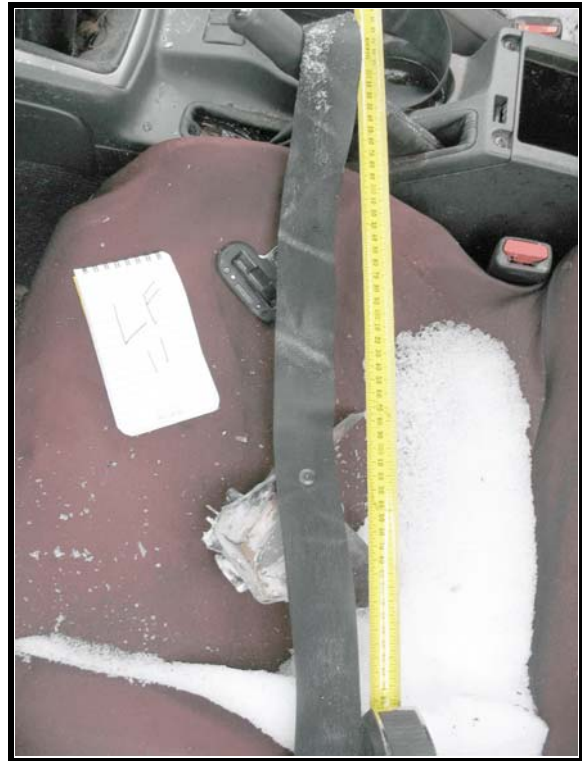
The 2006 Subaru Impreza was configured with manual 3-point lap and shoulder belts for each of the five seating positions. Both front seat safety belts were equipped with retractor pretensioners and adjustable D rings that were in the full down position. The pretensioners did not actuate during the crash. Both rear outboard seats were also equipped with adjustable D rings that were in the full down position. The driver's safety belt was configured with a sliding latch plate and an Emergency Locking Retractor (ELR). Rescue personnel had cut the webbing. There were indications of loading on the webbing.

Figure 9. Driver's seat belt

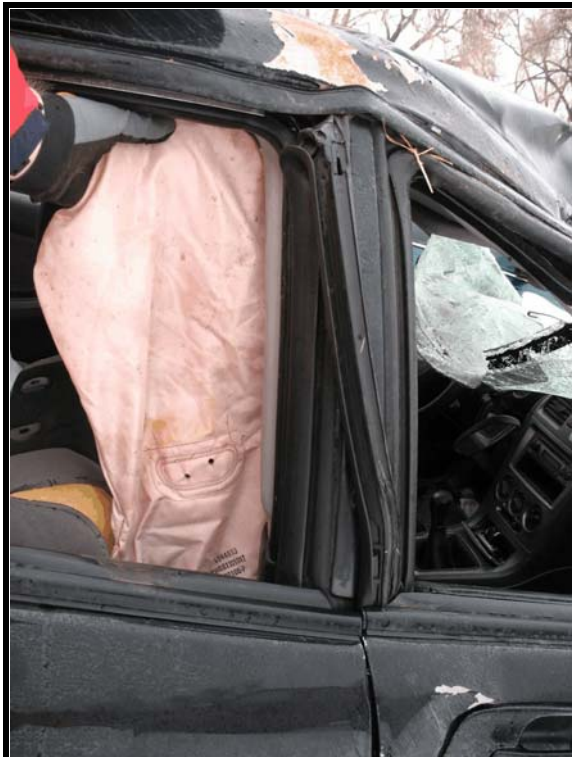
The frontal air bags did not deploy. The front right passenger's side air bag did deploy—possibly due to the pole impact. The air bag deployed vertically from the seat back. The air bag measured 55.0 cm (21.7 in) high by 24.0 cm (9.4 in) wide. There were two vent ports on the outside and two vent ports on the inside.

Figure 10. Front right passenger side air bag (exterior view)

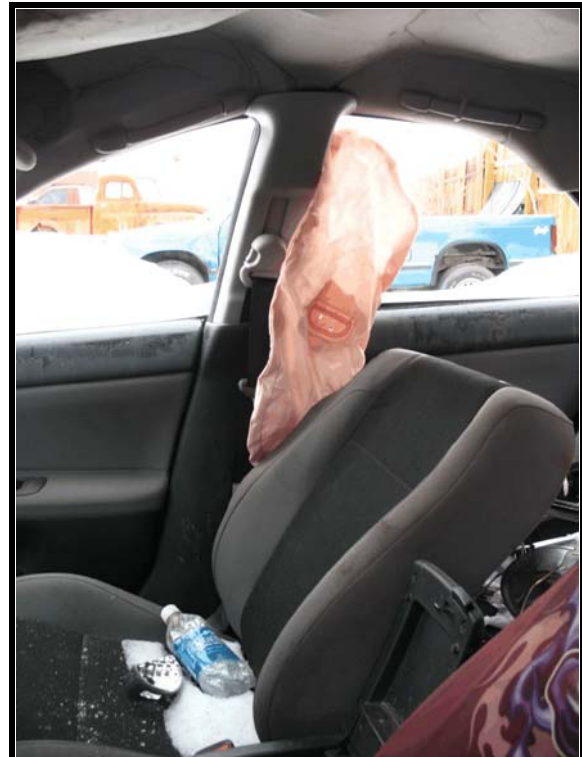
Figure 11. Front right passenger side air bag (interior view)

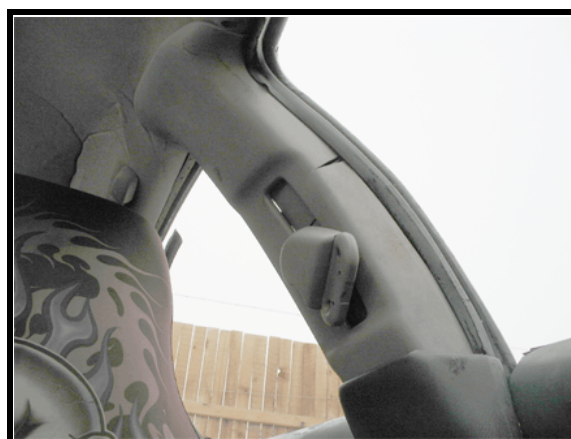
<u>Injury</u>	<u>OIC Code</u>	<u>Injury Mechanism</u>	<u>Confidence Level</u>
Lethargic, Stuporous, Obtunded on Admission or Initial Observation at Scene; unconsciousness known to be less than one hour	160610.2,0	B pillar	Possible
Multiple abrasions, scalp	190202.1,9	B pillar	Possible
Contusions, bilateral, periorbital area	290402.1,1 290402.1,2	Unknown	Unknown
Fracture, left clavicle	752200.2,2	Seat belt webbing	Probable
Contusion, right lung, with pneumothorax	441406.3,1	Unknown	Unknown
Fracture, open, comminuted, left distal radius (wrist)	752804.3,2	Door panel	Possible
Fracture, comminuted, left distal ulna (wrist)	753204.3,2	Door panel	Possible
Laceration, minor (1 cm), left wrist	790602.1,2	Door panel	Possible

Figure 12. Possible contact to B pillar
