On-Site Child Safety Seat Investigation
Dynamic Science, Inc. (DSI) / Case Number: DS07004
2005 Dodge Grand Caravan
Oregon
January 2007

1. Report No. DS07004	2. Government Accession No.		3. Recipient Catalog No.	
4. Title and Subtitle On-Site Child Safety Seat Investigation			5. Report Date May 8, 2008

Dynamic Science, Inc.
Crash Investigation
Case Number: DS07004

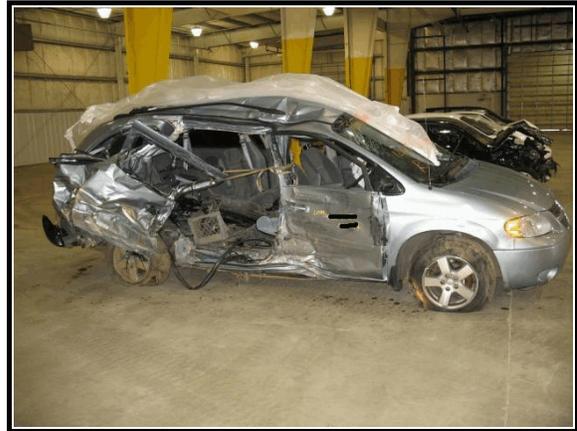
Figure 1. 2005 Dodge Grand Caravan, right side damage

The Dodge Caravan sustained right side damage as a result of the impact with the Ford F350. The direct damage began 182 cm (71.7 in) aft of the right front axle, and extended forward 112 cm (44.1 in). The right rear door locking mechanisms were damaged from the force of the impact, and the door was peeled rearward, resulting in passenger compartment integrity loss. The right wheelbase was lengthened by 2 cm (0.8 in). The left wheelbase was lengthened by 1 cm (0.4 in).

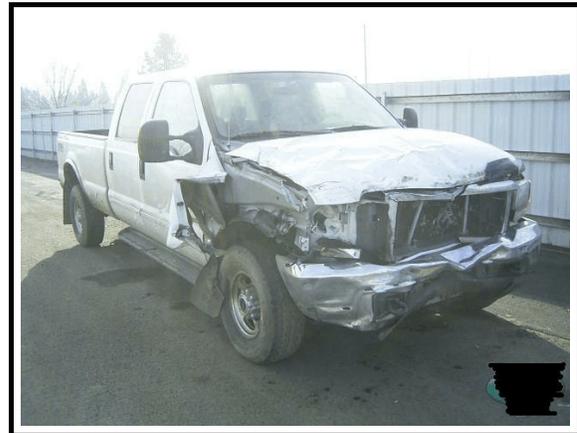
Figure 2. 2004 Ford F350 Super Duty pickup, front/right damage

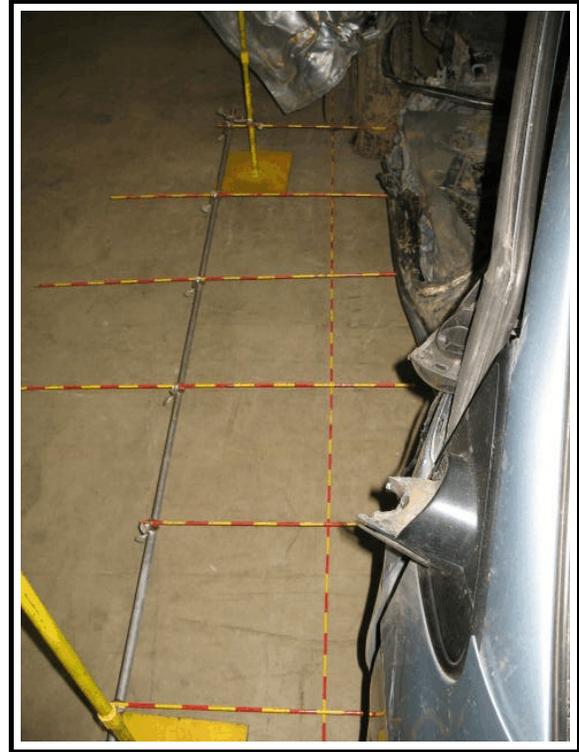
Six crush measurements were documented at the right sill level, beginning 262 cm (103.1 in) aft of the right front axle, and extending forward 205 cm (80.7 in) (**Figure 6**). The crush measurements were as follows: C1=10 cm (3.9 in), C2=4 cm (1.6 in), C3=5 cm (2.0 in), C4=12 cm (4.7 in), C5=11 cm (4.3 in), C6=5 cm (2.0 in). The maximum lateral crush at the sill level measured 12 cm (4.7 in) and was located at C4.

Figure 6. Right side crush profile (sill level)

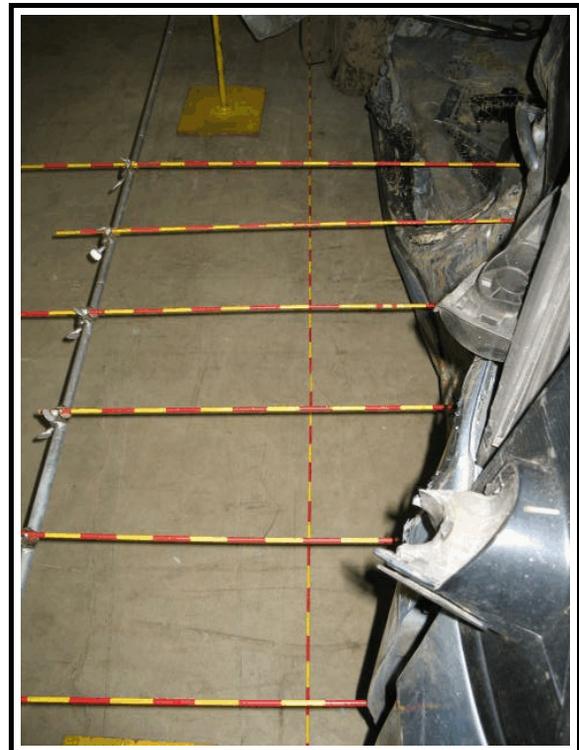
Six crush measurements were documented at the mid-door level, beginning 164 cm (64.6 in) aft of the right front axle, and extending forward 110 cm (43.3 in)(**Figure 7**). The crush measurements were documented at this level as follows: C1=41 cm (16.1 in), C2=33 cm (13.0 in), C3=27 cm (10.6 in), C4=16 cm (6.3 in), C5=8 cm (3.1 in), C6=0 cm. The maximum lateral crush at the mid-door level measured 41 cm (16.1 in) and was located at C1.

Figure 7. Right side crush profile (mid-door level)

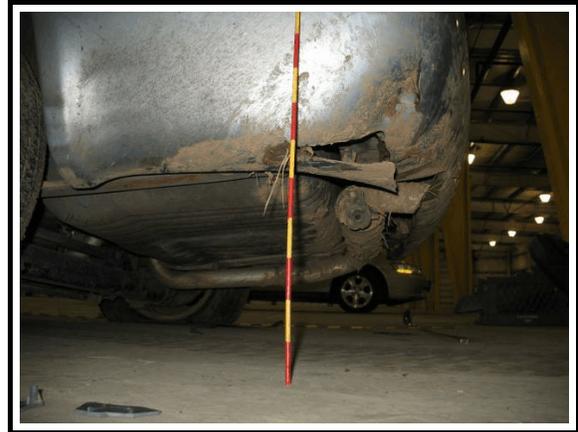
The Dodge Caravan sustained minor undercarriage damage as a result of the impact between the left rear undercarriage and the ground (**Figure 8**). The direct damage began 371 cm (146.1 in) aft of the left front axle and extended 23 cm (9.1 in) rearward. The maximum vertical crush was located 394 cm (155.1 in) aft of the left front axle. There was 2 cm (0.8 in) of vertical crush at this location. The CDC for this impact was 00UBDW2.

Figure 8. Dodge Caravan - undercarriage damage

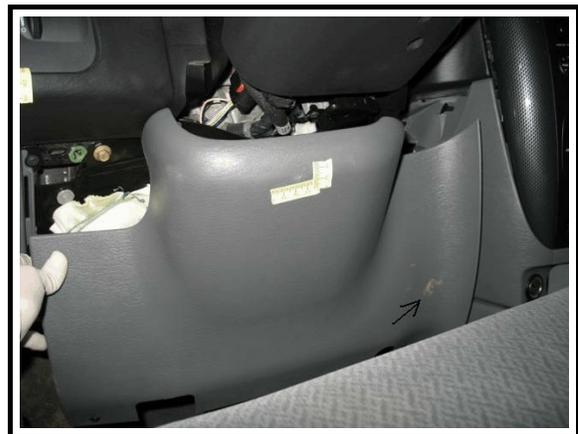
There were scuffs found on the plastic knee bolster cover, likely due to contact with the driver's knees and lower legs (**Figure 9**). There was a faint scratch on the left instrument panel, possibly due to contact from the driver's left hand. There was a faint scuff found on the second row right seat head restraint. A blonde hair was found in the same area as the scuff.

Figure 9. Scuffs to lower left instrument panel/knee bolster cover

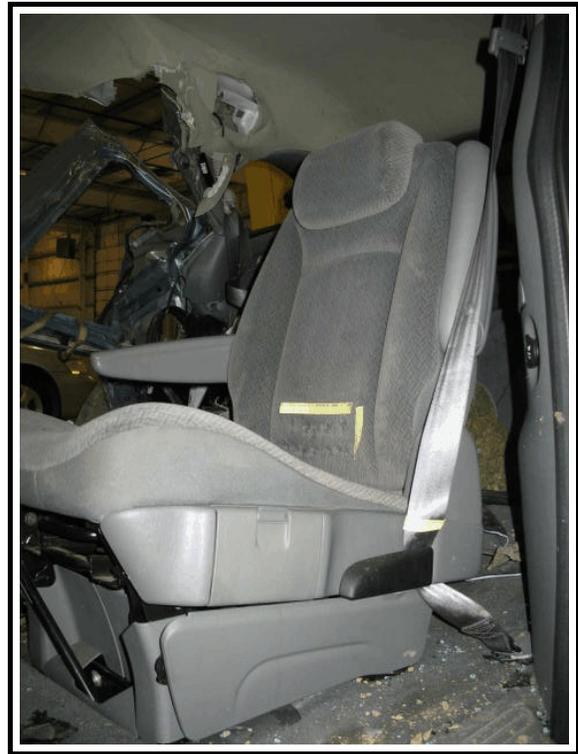
The second row left and right seat belts were used to secure the two child safety seats (**Figures 10-11**). According to investigating officers, both child safety seats were properly secured at the time of the crash. The lower portion of the second row left seat belt was found routed through the seat back adjustment lever. The belt showed signs of damage indicating that the belt webbing had been routed this way at the time of the crash.

Figure 10. Second row left seat belt found routed through seat back adjustment lever

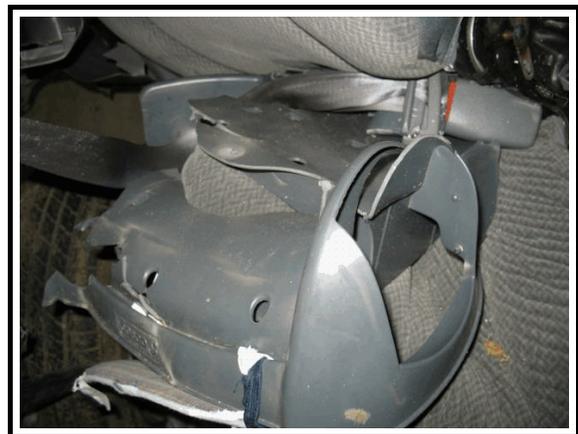
Figure 11. Second row right safety belt and child seat

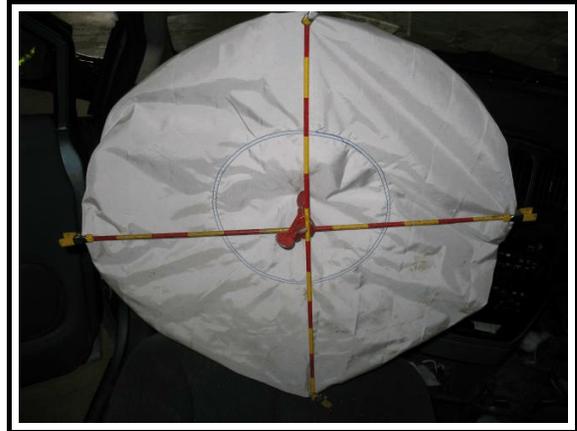
Figure 12. Deployed driver front air bag

The deployed air bag was circular in shape and measured 65 cm (25.6 in) in diameter in its deflated state (**Figure 12**). The maximum excursion of the deflated front air bag measured 26 cm (10.2 in) from the module face. The air bag had one internal tether. There were two vent ports located on the back of the bag at the 11 and 1 o'clock positions. There was no damage to the air bag or the air bag module cover flaps. There was dirt found on the lower right quadrant on the front of the air bag face and on the upper and lower areas on the back of the bag. Some of the scene debris had been placed in the driver's seating area and dried mud was found on the steering wheel and left front door panel. The mud and dirt were likely transferred during post-crash activities.

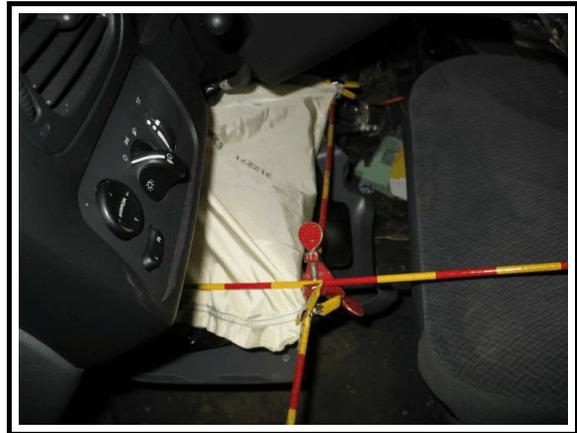
Figure 13. Deployed driver inflatable knee bolster

The driver's inflatable knee bolster was mounted below the steering column. As it inflated, the bolster knocked the plastic cover 32.0 cm (12.6 in) into the driver's lower leg area (**Figure 13**). The air bag was rectangular in shape and measured 48.0 cm (18.9 in) wide by 36.0 cm (14.2 in) high. The top of the knee bolster was attached to the base of the steering column by two tether straps (**Figure 14**) and the bottom of the bolster was attached to the lower left instrument panel plastic cover by two tether straps. There was no damage or sign of occupant contact to the inflatable knee bolster.

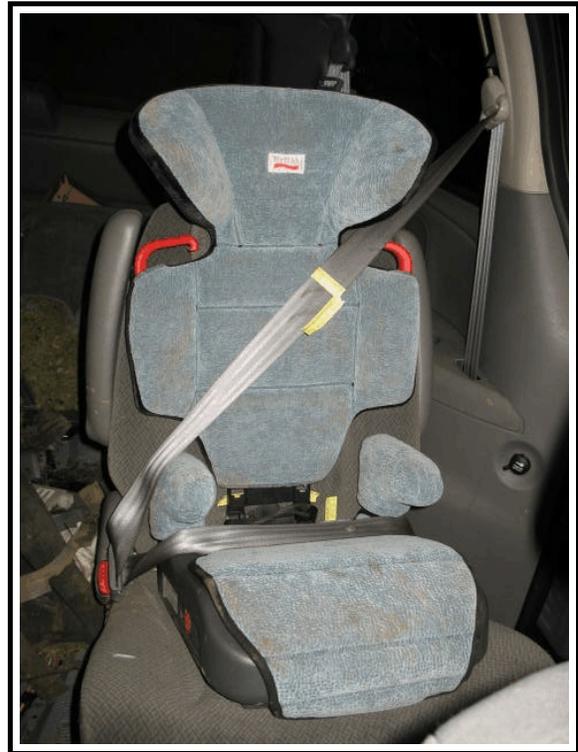
A forward facing Britax Starriser Comfy belt positioning booster seat was positioned in the Caravan's second row left seating position (**Figure 15**). The model number was E900336 and the date of manufacture was March 17, 2006. The seat was configured with a height adjustable seat back and a padded head rest. On the outer right section of the headrest, there was a small section of damaged foam that measured 3 cm (1.2 in) wide by 1 cm (0.4 in) high. The seat back on the booster seat was found to be bent slightly to the right, but there were no visible cracks or stress marks found anywhere on the seat.

Figure 15. Britax booster seat in second row left seat

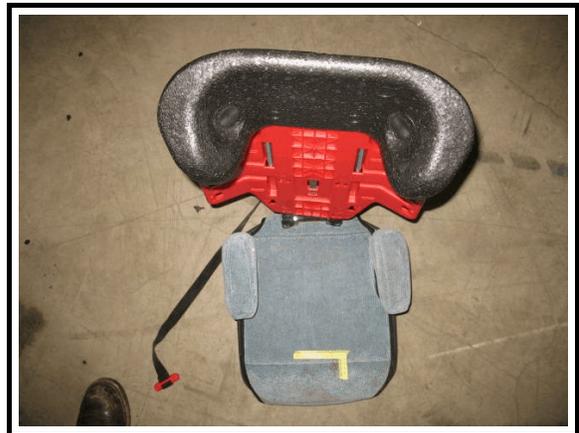
Figure 17. Britax booster seat showing seat back angle and blood on seat padding

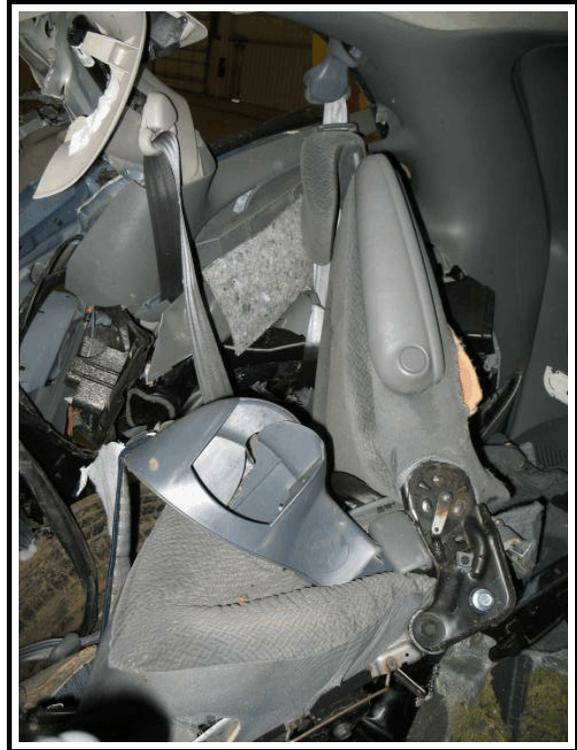
At the time of the vehicle inspection, this booster seat was found on the second row right seat bottom, with the back end partially wedged between the damaged seat back and seat bottom, and the front end tilted upward (**Figure 18**). According to the police report, an off-duty paramedic found the 4-year-old occupant pinned upside down. She reportedly was still in her car seat, which was entangled within the vehicle's damaged components.

Figure 18. Cosco Dorel booster seat as found in the vehicle

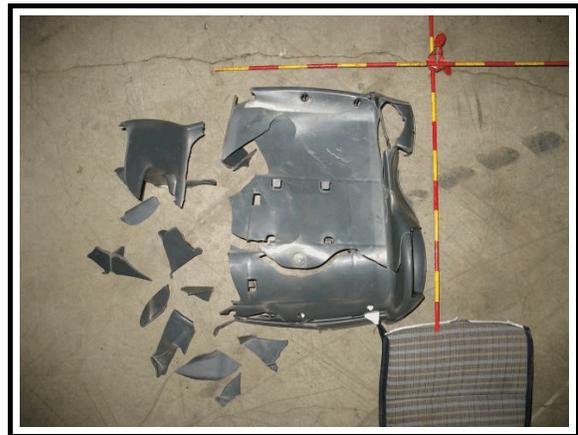
There were two small tears to the seat cushion fabric that appeared to be related to this crash. The right side of the child seat was broken into several pieces (**Figure 19**). Pieces of the damaged child seat were found on the floorboard in the area of the displaced second row right seat.

Figure 19. Cosco Dorel booster seat, showing damage

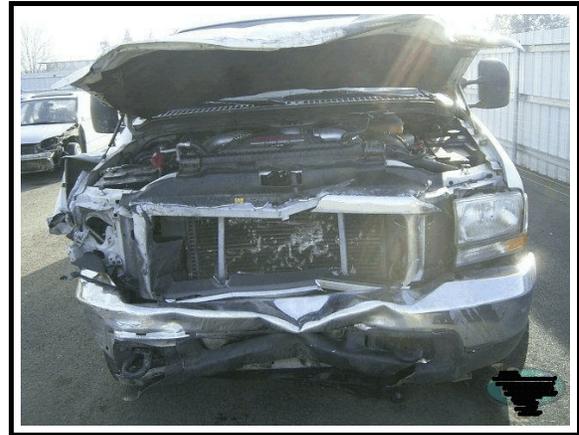
The Ford F350 sustained moderate front end damage as a result of the impact with the Dodge Grand Caravan (**Figure 21**). The front end of the Ford had been partially dismantled by a repair facility prior to the inspection. The damaged front bumper, grille and right front quarter panel were found inside the truck's cargo bed. A front end crush profile could not be obtained. The vehicle sustained 141 cm (55.5 in) of direct damage beginning 58 cm (22.8 in) left of the vehicle's pre-crash center point, extending along the front bumper to the right. The maximum longitudinal crush for this impact measured 18 cm (7.1 in) and was located 8 cm (3.1 in) left of the vehicle's pre-crash center point. The right front tire was damaged and restricted. The CDC for the Ford's damage was 12FDEW1.

Figure 21. 2004 Ford F350, front view

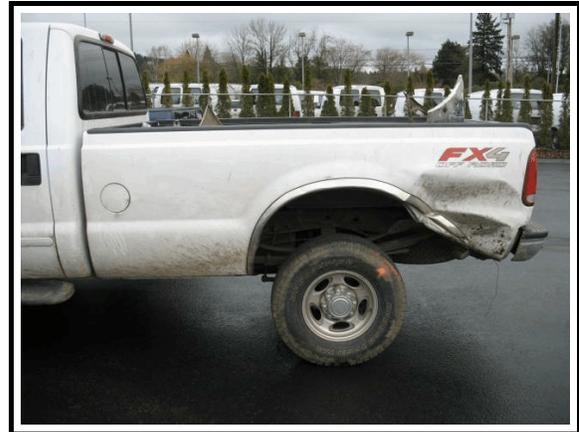
Figure 22. Left rear intra-unit contact damage

The Ford F350 sustained left side damage as a result of intra-unit contact with the horse trailer, which jack-knifed during the crash (**Figure 22**). The direct damage from this event began 81 cm (31.9 in) aft of the left rear axle, extending forward 15 cm (5.9 in). The maximum lateral crush for this impact measured 20 cm (7.9 in) and was located 76 cm (29.9 in) aft of the left rear axle. The CDC for the intra-unit contact was 08LBEN2.

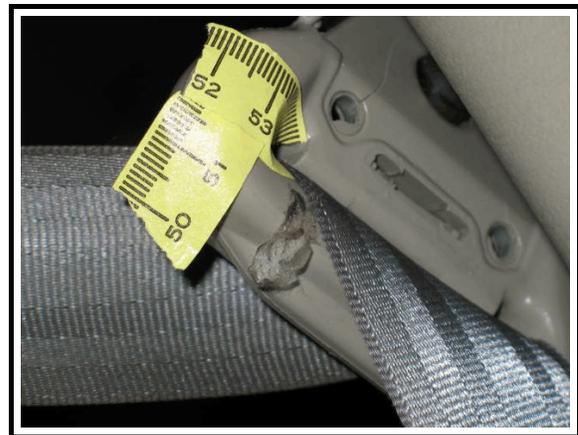
Figure 23. Driver's seat belt, frayed webbing fibers on D-ring
