**CALSPAN ON-SITE CHILD SAFETY SEAT CRASH INVESTIGATION
CENTURY CONVERTIBLE CHILD SAFETY SEAT
SCI CASE NO: CA07-006**

**VEHICLE: 1991 PLYMOUTH VOYAGER
LOCATION: TENNESSEE
CRASH DATE: JANUARY, 2007**

Contract No. DTNH22-07-C-00043

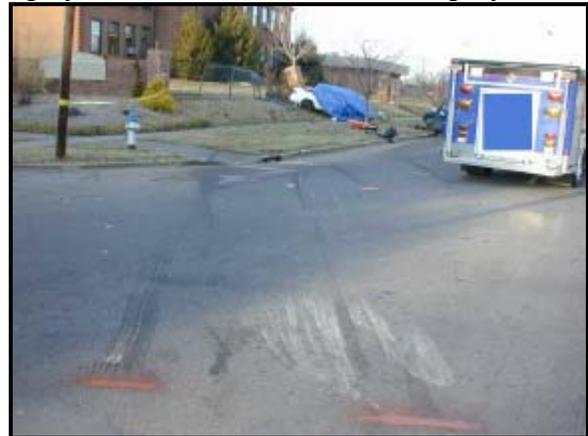
Figure 5: Point of impact and post-crash vehicle trajectories.

Both vehicles departed the impact with the northeast trajectory and a counterclockwise rotation. The highly dynamic impact event was evidenced by numerous tire marks that documented the post-impact trajectories of the vehicles and by multiple minor secondary events to each vehicle. **Figure 5** is a northeastward view at the point of impact along the post-crash trajectories of the vehicles.

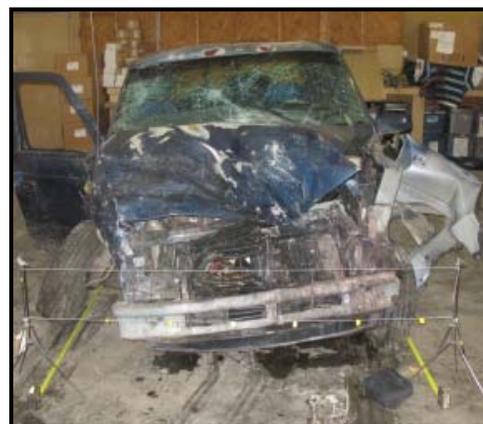
Figure 6: Front view of the Plymouth.

Figure 6 is the front view of the Plymouth. The front plane of the Plymouth sustained 152 cm (60 in) of direct contact damage that extended across its entire front end width. The front bumper fascia was separated during the impact. The residual crush profile was documented across the front bumper reinforcement and was as follows: C1 = 41 cm (16.1 in), C2 = 30 cm (11.8 in), C3 = 29 cm (11.4 in), C4 = 22 cm (8.7 in), C5 = 15 cm (5.9 in), C6 = 12 cm (4.7 in). The maximum crush was located at C1, the front left bumper corner. The left front fender was buckled and deformed outboard. The

residual damage profile was biased to the left consistent with the lateral momentum of the Contour during the impact. White paint transfer was observed on the right front fender and extended rearward to the mid aspect of the right front door. The paint transfer to the right front door occurred as the vehicles rotated during separation. The right front door was opened by rescue personnel evidenced by extrication damage. The right rear door was removed during the rescue operations. The left front door was jammed shut. The left wheelbase dimension was unchanged. The right front suspension was damaged during the crash and the right drive axle dislodged from the transmission. The right wheelbase measured 255 cm (100.5 in) at inspection; a 30 cm (11.8 in) reduction. This reduction was not consistent with the impact damage and a portion of this reduction was related to the post-crash towing of the vehicle based on a review of the on-scene photographs. The roof of the Plymouth was buckled above the driver's portion. The lower aspect of the windshield was fractured from the exterior crash force and the right and center aspects were fractured by occupant contact. The Collision Deformation Classification (CDC) of the frontal impact (Event 1) was 01-FDEW2.

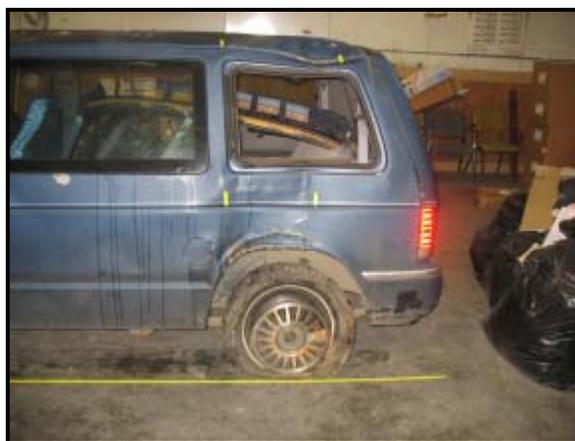
Figure 7: Left rear tree impact damage.

The left side of the Plymouth sustained three localized regions of damage as a result of the impacts to the tree, guy wire and utility pole (Events 7 - 9). The rear aspect of the Plymouth's left side sustained 56 cm (22 in) of direct and induced damage as a result of contact to the tree (**Figure 7**). The damaged region began 28 cm (11 in) forward of the rear axle and was centered on the axle. The maximum deformation measured 6 cm (2.3 in). The damage extended vertically to the 145 cm (57 in) height of the roof. The damage was consistent with the damage observed to the tree during the scene inspection. The CDC of this impact was 09-LBAW-3.

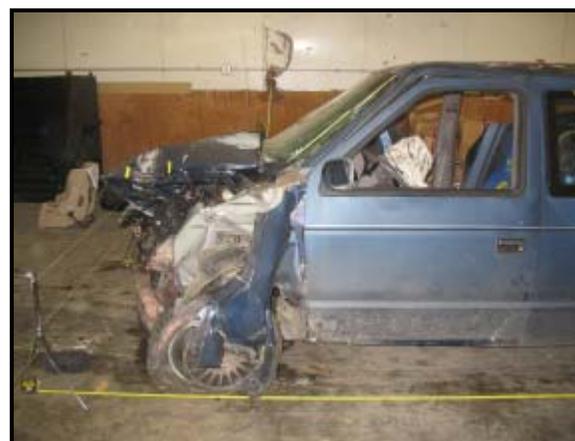
Figure 8: Forward left side damage.

Evidence of contact to the guy wire (Event 8) was noted to the aft lower aspect of the left front door 152 cm (60 in) forward of the rear axle. This damage consisted of paint removal. Refer to **Figure 8**. Its location on the vehicle was consistent with the physical dimension between the tree and the guy wire determined during the scene inspection. The CDC of the impact was 09-LPEN1. The forward aspect of the left plane impacted and sheared the wooden utility pole as the vehicle rotated away from the tree (Event 9). The damage was evidenced by a creosote transfer to the left front wheel rim and pocketing damage to the left side of the deformed hood. **Figure 8** is a left view of the Plymouth depicting the guy wire and utility pole damages. The pole CDC was 09-LFEW1.

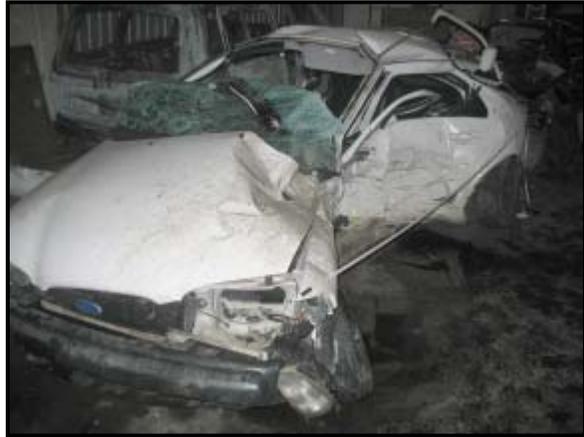
Figure 9: Left front oblique view of the Ford.

The Ford sustained severe left side damage as a result of the intersection impact with the Plymouth. **Figure 9** is a left front oblique view of the Ford Contour. The direct contact damage began 20 cm (8 in) rearward of the left front axle and extended rearward 180 cm (71 in). The force of the crash resulted in severe bowing of the vehicle. Due to the bowing, the front right corner of the Contour was displaced (shifted) laterally leftward approximately 38 cm (15 in). The length of the left side of the vehicle (corner to corner) measured 378 cm (149 in). The deformation and bowing reduced the length of the left side approximately 58 cm (23 in). The left wheelbase was reduced 35 cm (13.8 in). The right wheelbase lengthened 16 cm (6.2 in). The left side crush was measured by establishing a string line from left corner to the undeformed left rear quarterpanel which was broken into six equal zones to locate the crush measurements. A secondary string line was then established from deflection point to deflection point of the direct damaged region. The average lateral offset of the two string lines was then used to develop a bow constant, K, which was then added to the measured crush to account for the energy absorbed by bowing. The average bowing constant K measured 36 cm (14 in). The left side crush profile (inclusive of the K constant) was as follows: C1 = 33 cm (13.0 in), C2 = 61 cm (24.0 in), C3 = 130 cm (51.2 in), C4 = 112 cm (44.1 in), C5 = 65 cm (25.6 in), C6 = 32 cm (12.6 in). The maximum crush was located at the left B-pillar location (C3). The static residual crush measured 94 cm (37 in). This measurement does not include the bowing constant. The left side seating positions were nearly eliminated by the impact. The left front and rear doors were jammed shut by deformation. The right side doors remained closed during the impact and were jammed shut by body distortion. The right doors were removed during the rescue operations. The windshield was fractured. The backlight and all the side glazing had disintegrated. The CDC of the damage was 90-LYEW7. Note, the 10 o'clock direction of force was incremented by 80 to denote the left end bowing.

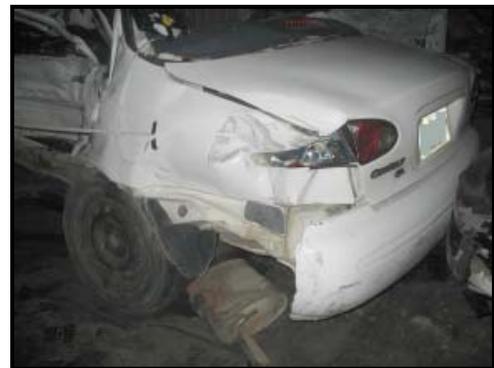
Figure 10: Left rear quarterpanel damage.

The entire end width of the back plane impacted and deformed the aluminum fence during the later stages of the crash sequence (Event 4). This impact did not result in any residual deformation. The CDC of this contact was 06-BDEW1. The left rear quarterpanel of the Ford sustained 61 cm (24 in) of direct and induced damage as a result of its impact with the brick column (Event 5). The damage began at the left rear corner and extended forward. The direct contact damage measured 38 cm (15 in). The maximum lateral crush measured 15 cm (6 in) and was located at the left rear corner. The CDC of this contact was 09-LBEN2. **Figure 10** is a view of the damaged left rear quarterpanel.

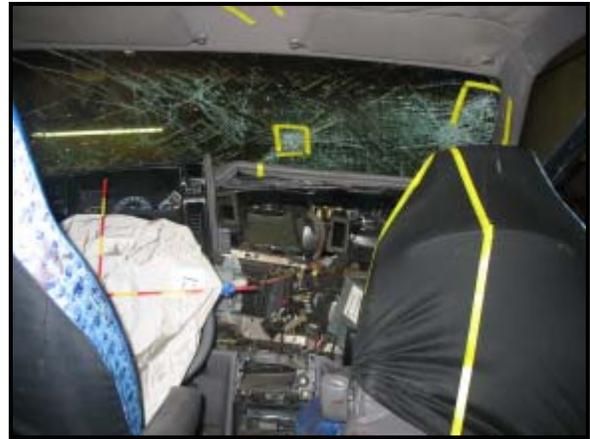
Figure 11: Forward interior view.

The interior damage to the Voyager consisted of minor left toe pan intrusion, and numerous occupant contacts. The only restrained occupant in the vehicle was the 11 month old male in the child safety seat. **Figure 11** is an overall view of the front interior contacts within the Plymouth.

The top half of the two-spoke steering wheel rim was deformed forward. The deformation measured 9 cm (3.5 in). The driver loaded the deployed driver air bag, deformed the rim, and completely separated the steering column from

The steering column had dropped and was resting on the top aspect of the lower instrument panel. Evidence of lower extremity contact was evidenced on the knee bolster. The bolster was cracked and scuffed 13 cm (5 in) right of the steering column centerline. The outboard aspect of the driver's toe pan had intruded an estimated 15 cm (6 in).

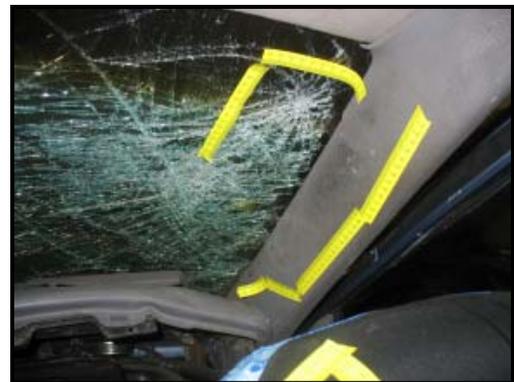
Figure 12: Right windshield fracture and A-pillar contact.

The right aspect of the windshield was fractured by the front right occupant. The fracture site was located 5 cm (2 in) left of the A-pillar and 8 cm (3 in) below the header. Hair was observed within the fracture. The adjacent A-pillar trim was scuffed over an 8 cm x 29 cm (3 in x 11.5 in) area. Refer to **Figure 12**. The top forward aspect of the right front door panel was scuffed over an 8 cm x 46 cm (3 in x 18 in) area. The grab handle located within this region was deformed forward. The outboard corner of the instrument panel at the air conditioner vent was scuffed over an 8 cm x 10 cm (3 in x 4 in) area. Hair and blood were observed within this contact. The outboard aspect of the lower bolster was cracked.

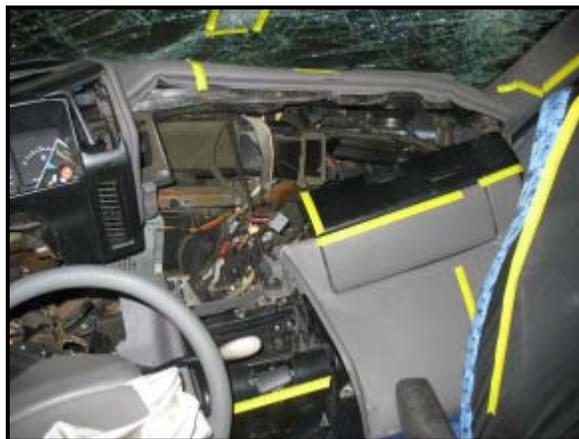
Figure 13: Center instrument panel contacts.

Contacts to the center instrument panel were attributed to the female passenger seated in the right side of row 2 displaced forward by the crash. The center instrument panel was deformed forward and upward. The top edge of the instrument panel was scuffed over a 25 cm (10 in) length. The scuff began 38 cm (15 in) left of the right A-pillar and left to the approximate

centerline of the vehicle. Hair and blood were noted within this contact. Immediately above this region was a focused windshield fracture. This contact measured 7 cm (2.8 in) in diameter and caused the windshield to bulge outward approximately 1 cm (0.5 in). The fracture site was located 57 cm (22.5 in) left of the right A-pillar and 8 cm (3 in) above the deformed instrument panel. The trim surrounding the center instrument panel was fractured and separated. The glove box door was scuffed over a 32 cm x 13 cm (12.5 in x 5 in) area. Vertical oriented scuff marks were observed throughout the area. The center ash tray was scuffed over an 18 cm (7 in) wide region and the tray's latch was broken. Directly above these contacts, a 15 cm (6 in) long longitudinally oriented scuff was observed to the headliner. **Figure 13** is a view of the center instrument panel contacts.

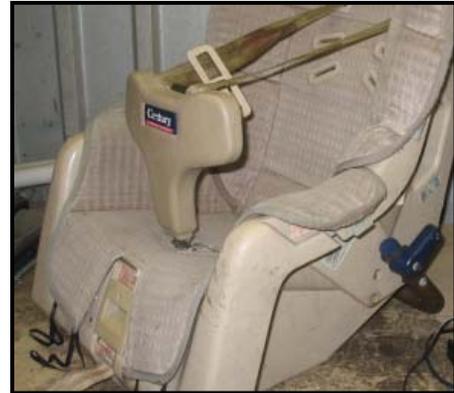
Figure 15: View of the buckled and deformed T-shield.

Examination of the T-shield revealed that the shield was deformed forward due to occupant loading. Refer to **Figure 15**. The T-shield was in a vertical position at inspection. The latch plate was bent at its exit from the buckle (**Figure 16**). The top of the T-shield measured 25 cm (10 in) forward of the shell. It was estimated that the distance between the top of the undeformed T-shield and shell would have been 17 cm (6.5 in). These measurements indicated

the shield deformation allowed 8 cm (3.5 in) of ride down during the crash. This deformation allowed the child to effectively ride down the crash by reducing peak deceleration. Examination of the harness straps revealed 8 cm (3.5 in) of loading evidence along the straps at their respective contact to the back of the shell. **Figure 17** is a close-up view of the loaded right strap. The creased edge of the strap was frayed.

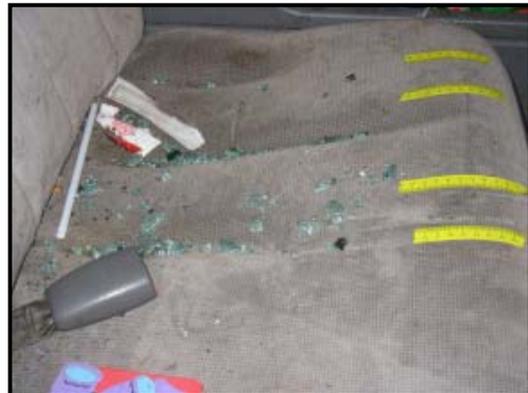
Figure 19: Abrasions to the seat cushion of row 2.

The CSS was installed in a forward-facing mode as depicted in **Figure 18**. With the seat in this position, the horizontal distance between the CSS back to the driver seat back measured 56 cm (22 in). There was no contact evidence identified to the driver seat back. Given the survival space between the CSS seat back and driver seat back, it was unlikely that the child contacted the front seat back. The loading evidence of the vehicle's manual restraint was consistent with the forward facing belt path of the CSS. Examination of the seat cushion of row 2 revealed four linear abrasions consistent with the base of the CSS shell. The seat was abraded by the bottom of the CSS as the CSS and occupant rode down the force of the crash. Refer to **Figure 19**. There was no crash related damage to the CSS shell.
