ON-SITE NOT-IN-TRAFFIC SURVEILLANCE BACK OVER INVESTIGATION

CASE NUMBER - IN-07-010

VEHICLE - 2001 CHRYSLER TOWN & COUNTRY

INCIDENT DATE - March 2007

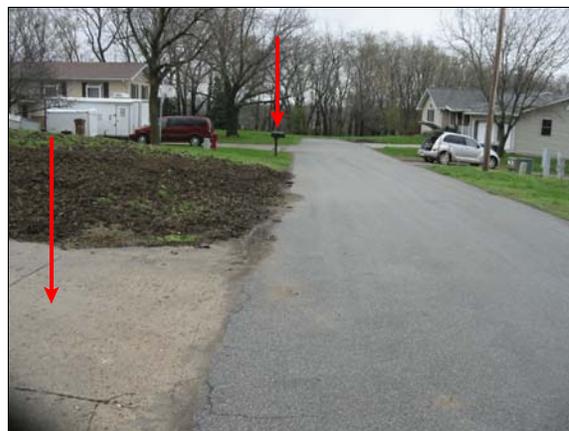
Figure 1: View east, arrows show mailbox the Chrysler backed from to driveway where impact occurred

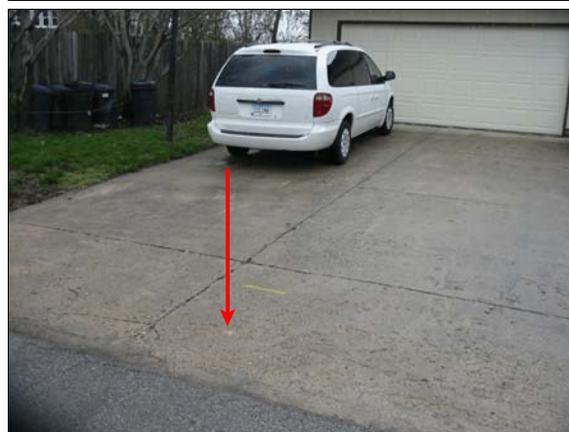
Figure 2: Pedestrian ran from garage to area of impact (arrow)

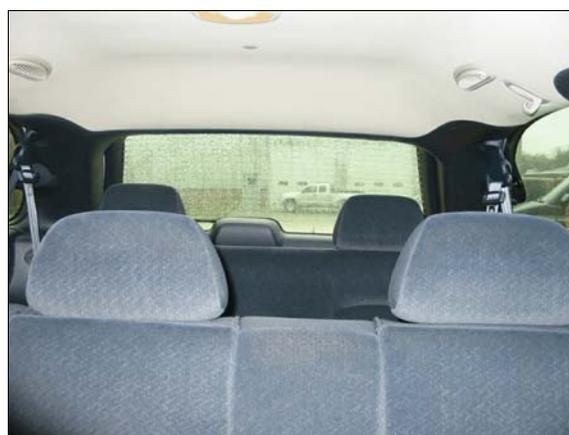
Figure 3: Driver's view out of backlight, note view obstructions by center high mounted stop lamp, head restraints and "D"-pillars

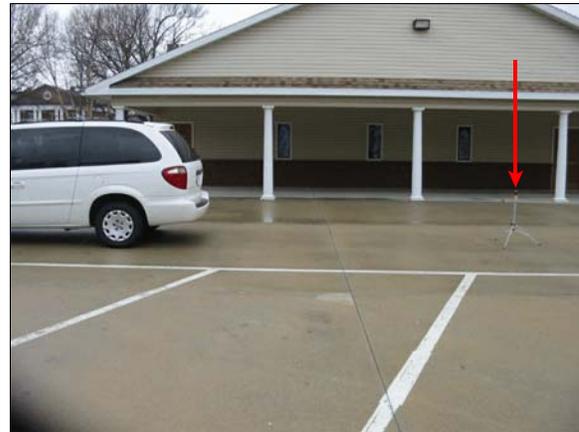
center high-mounted stop lamp and moved rearward until the target came into the driver's view (**Figure 4** below). It was necessary to move the target rearward from the back of the vehicle 4.7 meters (15.4 feet) before the driver could see it. The target was then moved to the right and was

Figure 4: Arrow shows location where target first came into driver's view while looking out backlight

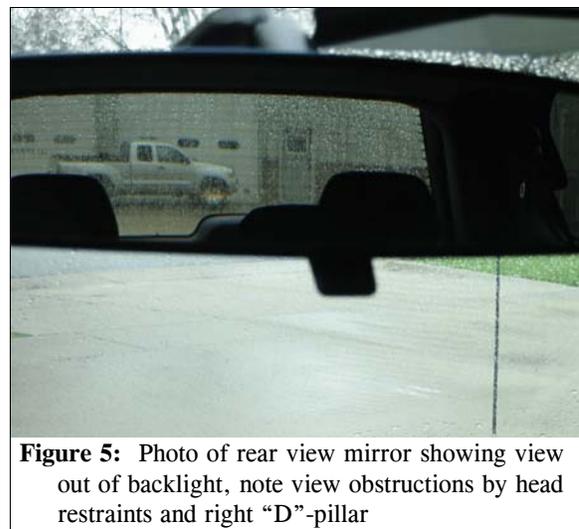
Figure 5: Photo of rear view mirror showing view out of backlight, note view obstructions by head restraints and right "D"-pillar

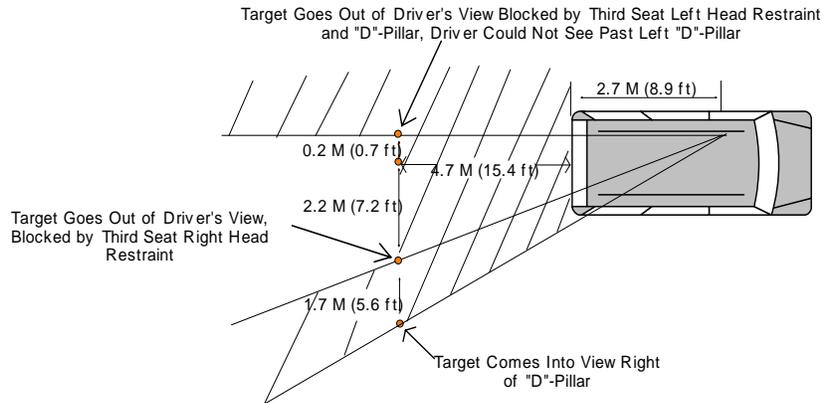
2. Blind Zone Behind Chrysler, Driver Looking Over Right Shoulder Left of Center
High Mounted Stop Lamp

immediately obstructed by the center high-mounted stop lamp. The target was then moved to the right from the Chrysler's approximate centerline 2.2 meters (7.2 feet) before the driver's view of the target was obstructed by the third row right head restraint (**Figure 3** above). The target was not visible to the driver again until it was moved to the right an additional 1.7 meters (5.6 feet) where it came back into the driver's view on the right side of the right "D"-pillar. When the target was moved 30 centimeters (12 inches) to the left from the Chrysler's center line, it became obstructed by the third row left head restraint (**Figure 3** above). The depth of the blind zone behind the center high-mounted stop lamp and the third row head restraints was in excess of 4.7 meters; however, the approximate depth of these areas was not assessed. See the nominal visibility diagram at the end of this report for a depiction of the blind zone behind the Chrysler.

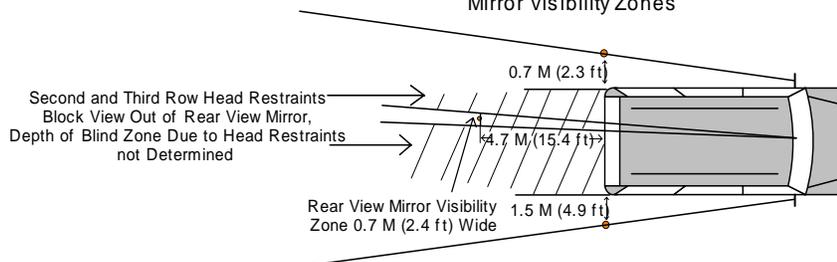
3. Side View Mirror and Rear View
Mirror Visibility Zones

The driver was then asked to look behind the Chrysler through the rear view mirror. The target was positioned to the left of the center high-mounted stop lamp and moved rearward approximately 4.7 meters from the back of the Chrysler before coming into the driver's view. The target was then moved to the right and was immediately obstructed by the center high-mounted stop lamp. As the target was moved further to the right, it was obstructed by the second row right head restraint, the third row right head restraint, and finally the right "D"-pillar (**Figure 5**), never coming back into view again. When moved laterally to the left 70 centimeters (27.5 inches) from the Chrysler's center line, the target became visible before being obstructed by the third row left head restraint and did not come back into view. See the nominal visibility diagram at the end of this report for a depiction of the rear view mirror visibility zone. The side mirror visibility zones were also assessed and are included in the nominal visibility diagram.
