ON-SITE CERTIFIED ADVANCED 208- COMPLIANT VEHICLE INVESTIGATION

CASE NUMBER - IN07021

VEHICLE - 2007 ISUZU I-290 EXTENDED CAB

CRASH DATE - June 2007

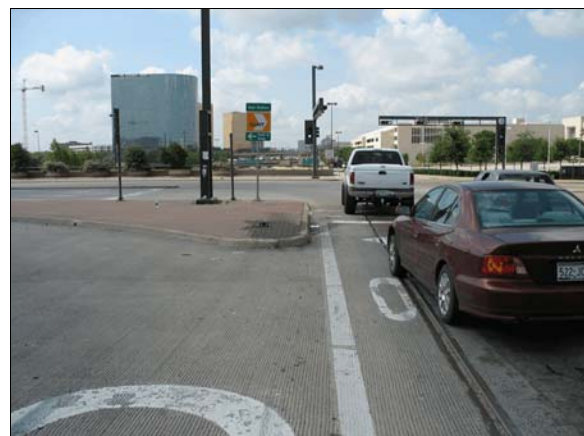
Crash Environment: The trafficway on which the Isuzu was traveling was a six-lane, one-way, undivided, service road to a U.S. highway. The Isuzu was traveling in a southerly direction approaching a four-leg intersection (**Figure 1**). On the northern leg of the intersection, the roadway had a right turn/southbound through lane, two southbound through lanes, a left turn/southbound through lane, a left turn lane, and a U-turn lane that was separated from the through lanes by a traffic island. Each lane was nominally 3.4 meters (11.2 feet) in width. On the southern

Figure 1: Case Vehicle approach to first traffic island in crash sequence.

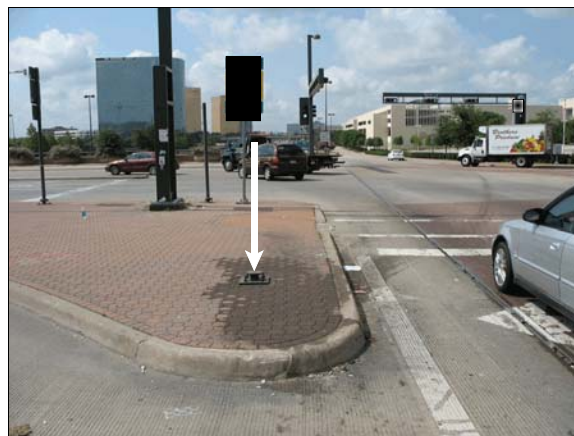
Crash: The left front wheel of the Isuzu impacted the curb at the north end of the north U-turn traffic island (**Figure 2**) followed by the left rear wheel impact to the same curb (events 1 and 2). The front left of the Isuzu then impacted a street sign (event 3) on the same island (**Figure 2**). The Isuzu continued southeast across the intersection, and both front wheels impacted the curb at the second U-turn traffic island (**Figure 3**, events 4 and 5). The Isuzu traveled across the traffic island and the U-turn lane and both front wheels impacted the south curb of the U-turn lane (**Figure 4**, events 6 and 7). Finally, the Isuzu's front end (**Figure 5**) impacted a concrete bridge rail (**Figure 4**, event 8). The damage to the left front wheel indicated that the driver's air bag deployed as a result of one of the curb impacts. It is probable that it deployed during the first curb impact.

Figure 2: Isuzu's left front and rear wheels impact curb of first traffic island followed by front left impact with sign, arrow shows base of impacted sign.

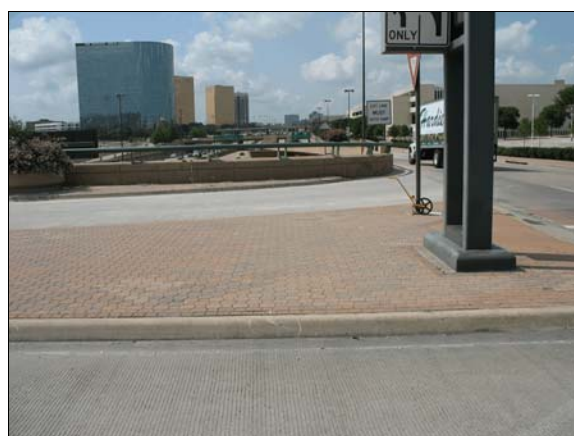
Figure 3: Both of Isuzu's front wheels impacted curb on second U-turn traffic island

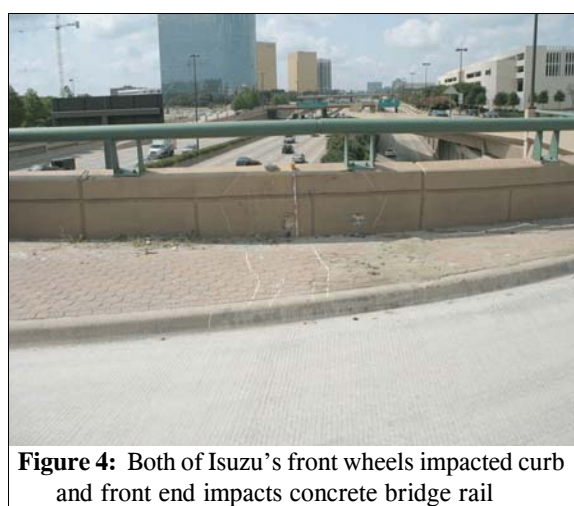
Figure 4: Both of Isuzu's front wheels impacted curb and front end impacts concrete bridge rail

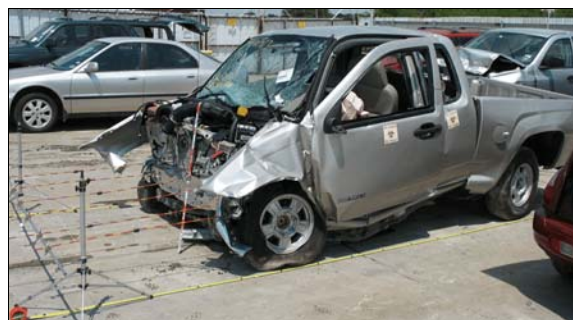
Figure 5: Front left view of damage to front of Isuzu due to impact with the concrete bridge rail; each stripe on the rods is 5cm (2in)

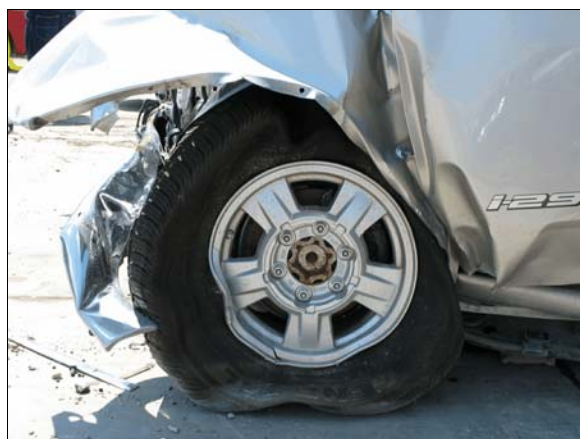
Exterior Damage: The Isuzu I-290's curb impacts involved the front wheels (**Figures 6 and 7**). The Isuzu's impact with the sign post involved the left portion of the front plane, but the specific location of the impact is unknown due to overlapping damage from the concrete bridge rail impact. The Isuzu's impact with the concrete bridge rail involved the entire front plane (**Figure 5 and Figure 8**). The front bumper, hood, grille, headlamp/turn signal assemblies and front of the fenders were directly damaged and crushed extensively rearward.

Figure 6: Left front wheel damage due to curb impacts

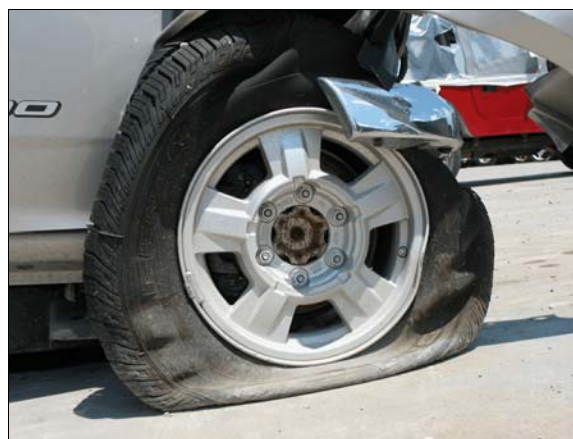
Figure 7: Right front wheel damage from curb impacts.

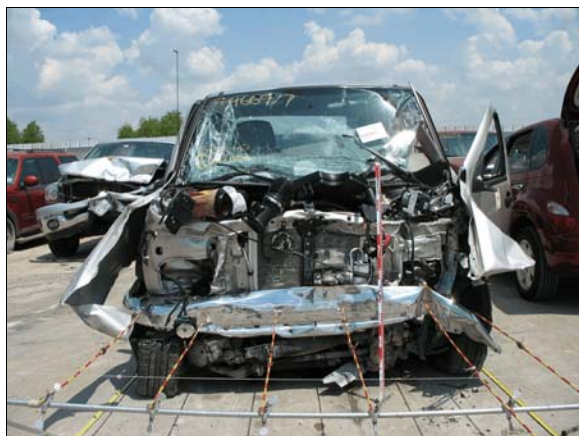
Figure 8: Overview of full front damage due to impact with the concrete bridge rail

Induced damage included both fenders, the windshield, both A-pillars, the roof, all doors, the truck bed, and rear axle. The Isuzu's left side wheelbase was shortened 62 centimeters (24.4 inches) while the right side was shortened 77 centimeters (30.3 inches).

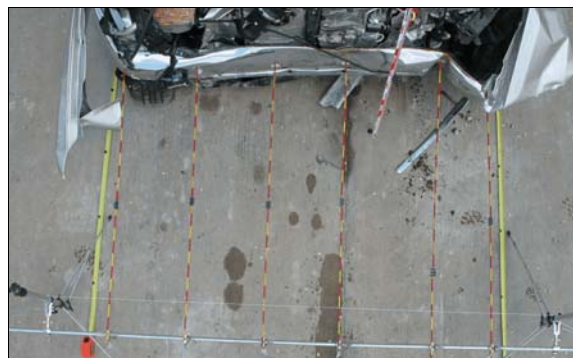
The front crush measurements were taken along the front bumper. The direct damage length was measured as 152 centimeters (59.8 inches). The residual maximum crush was measured as 102 centimeters (40.2 inches) occurring at C_3 (**Figure 9**). The table below shows the Isuzu's front crush profile.

Figure 9: Top view of crush to front of Isuzu due to impact with the concrete bridge rail

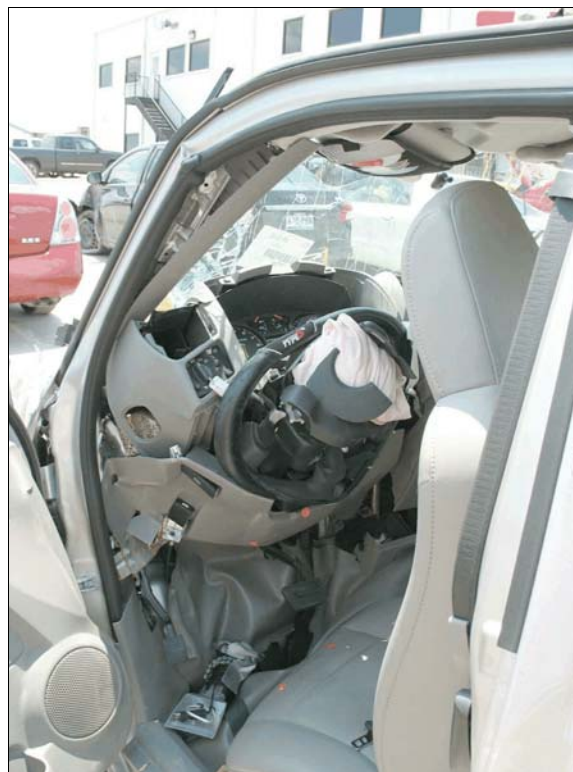
Vehicle Interior: Inspection of the Isuzu's interior revealed occupant contact to the driver's air bag, steering wheel (**Figure 10**), safety belt, seat back, and knee bolster. Significant intrusions were noted at the left and right toe pans, which were intruded longitudinally 34 and 26 centimeters (13.4 and 10.2 inches) respectively. The left instrument panel (**Figure 10**) was displaced 30 centimeters (11.8 inches) vertically and 17 centimeters (6.7 inches) longitudinally.

Figure 10: Intrusion of Isuzu's left toe pan and instrument panel and deformation of steering assembly

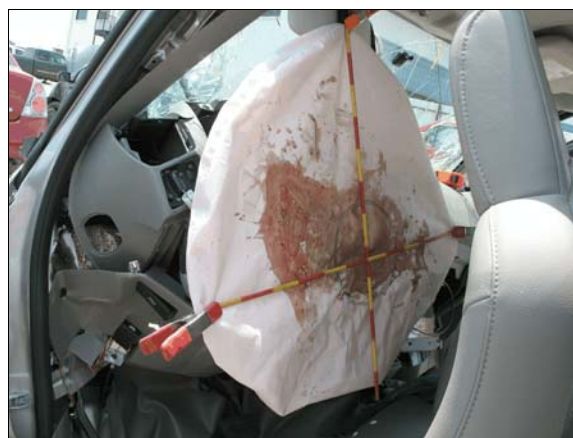
The Isuzu I-290's driver air bag was located within the steering wheel hub. An inspection of the air bag module cover flaps and the air bag's fabric revealed that the cover flaps opened at the designated tear points, and there was no evidence of damage during the deployment to the air bag or the cover flaps. The driver's air bag was designed with two tethers, each approximately 7 centimeters (~3 inches) in width. The driver's air bag had two vent ports, each approximately 2.5 centimeters (~1 inch) in diameter, located at the 1 and 11 o'clock positions. The deployed driver's air bag was round with a diameter of 62

Figure 11: Driver air bag

centimeters (24.4 inches). An inspection of the driver's air bag fabric revealed a copious amount of blood on the front of the air bag (**Figure 11**). There were also some small blood spots on the back of the air bag near the bottom. The driver air bag was otherwise unremarkable. The front right passenger's air bag was located in the middle of the instrument panel. This air bag did not deploy in this crash because there was no front right passenger seated in the Isuzu.

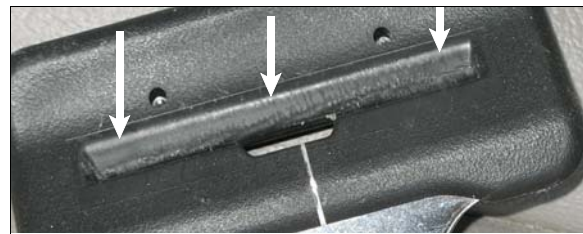
Based on the vehicle inspection, the Isuzu's driver was restrained by the lap-and-shoulder, safety belt system. There were loading abrasions on the driver's sliding latch plate and D-Ring (**Figures 11** and **12**). Furthermore, the driver's safety belt was cut by rescue personnel as part of the extrication of the driver from the Isuzu.

Figure 11: Arrows shows safety belt webbing load abrasions on Isuzu driver's latch plate

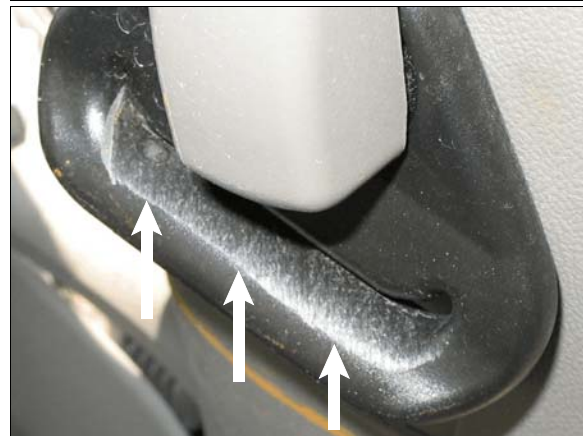
Figure 12: Arrows show safety belt webbing abrasions on Isuzu driver's "D"-ring

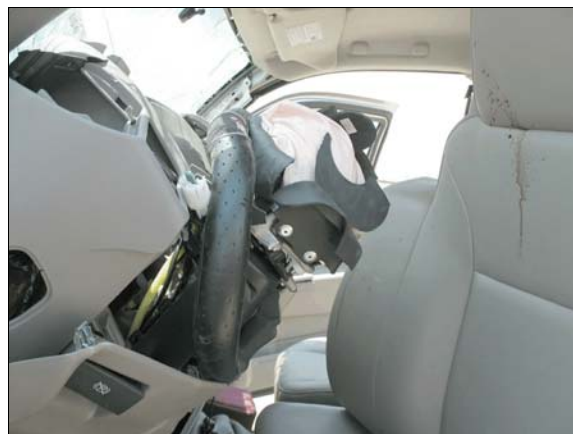
Figure 13: Left side view of deformation to Isuzu's steering assembly due to driver contact
