ON-SITE CHILD SAFETY SEAT INVESTIGATION

CASE NUMBER - IN07032
LOCATION - ILLINOIS
VEHICLE - 2006 HYUNDAI SONATA GL
CRASH DATE - August 2007

September 30, 2008

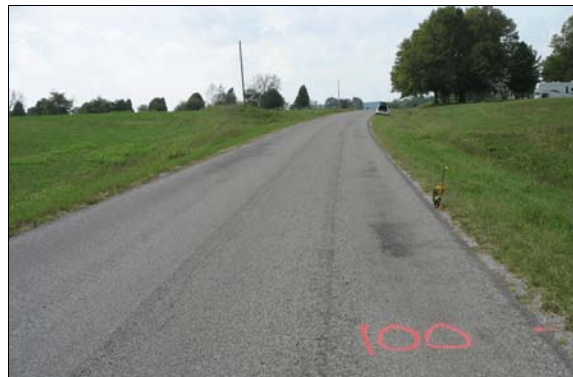
Figure 1: Hyundai's uphill approach (grade: 4.2% positive to east) heading into right-hand curve

Pre-Crash: The Hyundai was traveling west, up the grade (4.2% grade positive to the west), in the westbound lane, and the driver intended to continue ahead while negotiating the curve (**Figure**

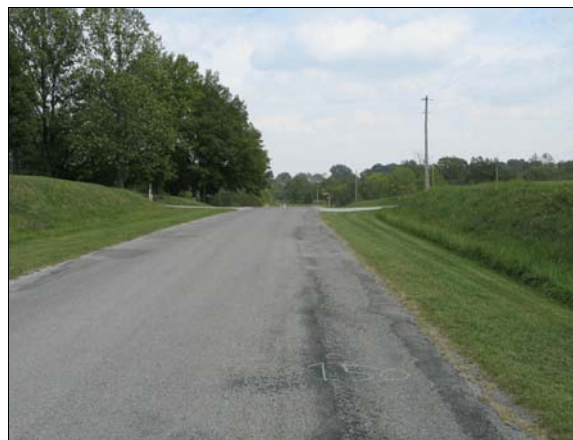
Figure 2: Dodge's eastward, uphill, travel path in eastbound lane approaching hill crest; Note: point of impact lies over crest of hill

1). The Dodge had been traveling east, up the grade, in the eastbound lane and intended to continue straight ahead (**Figure 2**). The Dodge had just crested a hill and began traveling down a grade just prior to the crash (3.1% negative to the east–**Figure 3**). According to the Police Crash Report, the Hyundai's driver leaned over to pick up an item dropped on the floor. Apparently, when the driver was retrieving this item, the Hyundai traveled across the centerline into the eastbound lane (**Figure 4**). According to the Police Crash Report, the Hyundai's driver made no mention of any avoidance maneuvers. The driver of the Dodge probably braked just prior to impact. The crash occurred in the eastbound lane of the roadway, just east of the hill crest (**Figures 5 and 6**).

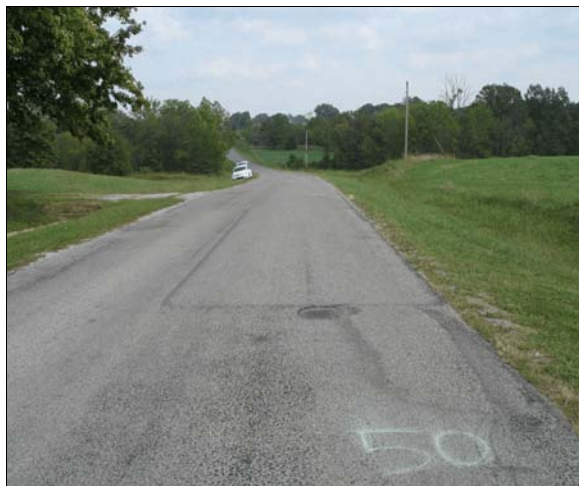
Figure 3 Dodge's downhill approach (grade: 3.1% negative to west) heading toward left-hand curve

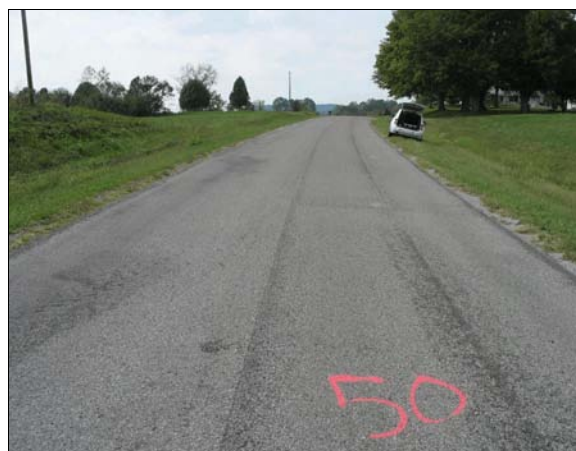
Figure 4: Hyundai drifts leftward toward centerline along uphill approach in right-hand curve

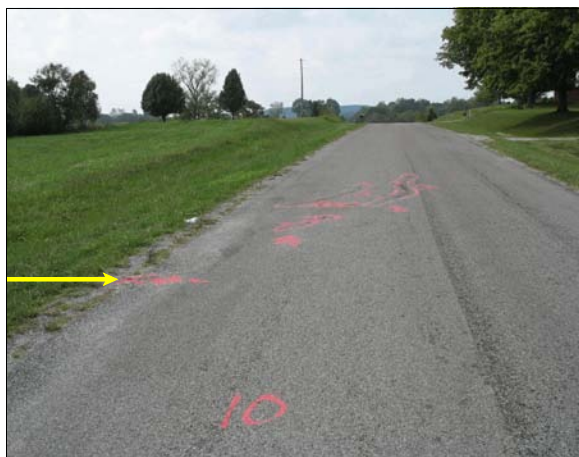
Figure 5: Hyundai's uphill westward travel path in eastbound lane just prior to impact; Note: arrow indicates final rest position of right rear tire

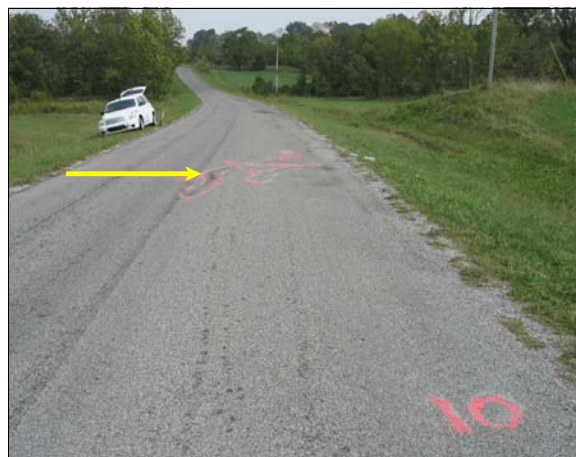
Figure 6: Dodge's downhill travel path just prior to impact with Hyundai; Note: arrow indicates impact scuff from Dodge's left front tire

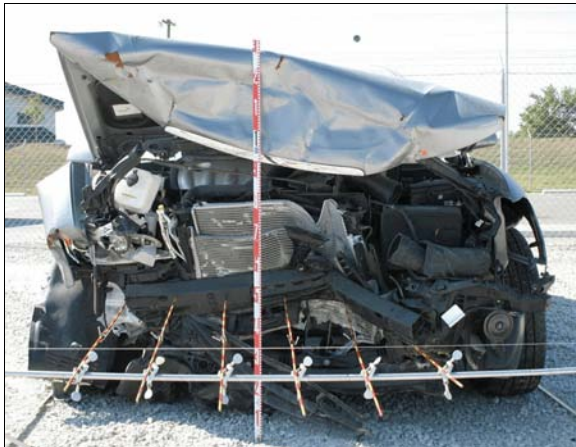
Crash: The front of the Hyundai (**Figure 7**) impacted the front of the Dodge (**Figure 8**), slightly offset toward each vehicle's right side, causing the Hyundai's driver air bag to deploy. It is unknown whether more than one stage of the Hyundai's multi-stage air bag was activated. The front right passenger air bag did not deploy during the crash sequence. However, the right side curtain air bag also deployed (**Figure 9**). As a result of the impact, the Hyundai rotated

Figure 7: Hyundai's frontal damage with contour gauge set at bumper level

Exterior Damage: The Hyundai's contact with the Dodge involved the entire front with the damage distributed across the entire frontal plane (**Figures 7, 11, and 12**). The direct damage began at the front right bumper corner and extended 107 centimeters (42.1 inches), along the front

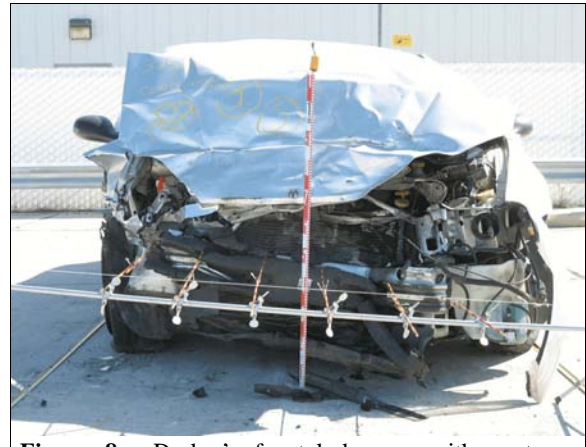
Figure 8: Dodge's frontal damage with contour gauge set at bumper level

Exterior Damage: The Dodge's contact with the Hyundai involved the entire front with the damage distributed across the width of the bumper (**Figures 8 and 33**). The direct damage began on the front left bumper corner and extended 105 centimeters (41.3 inches), along the front bumper. The residual maximum crush was measured as 69 centimeters (27.2 inches) at C₄. The table below shows the Dodge's crush profile.

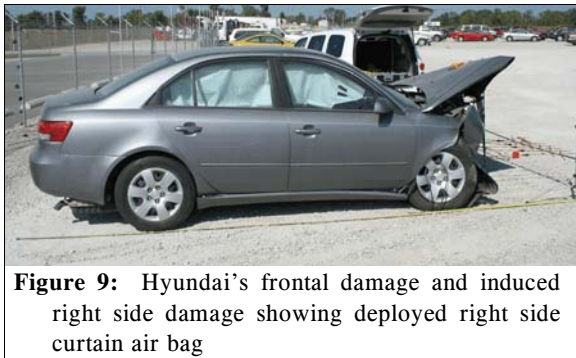
Figure 9: Hyundai's frontal damage and induced right side damage showing deployed right side curtain air bag

The vehicle manufacturer's recommended tire size was P215/60R16, and the Hyundai tires were the recommended size. The Hyundai's tire data are shown in the table below. In addition, the Hyundai's right front wheel was rotated outward from the crash (**Figure 9**).

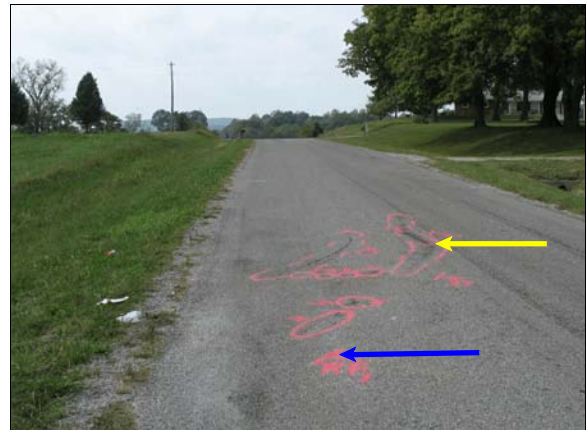
Figure 10: Westerly view showing Dodge's path to impact; Note: back arrow indicates impact scuff and point of deflection for left front tire, and front arrow indicates final rest position of Hyundai's right front tire

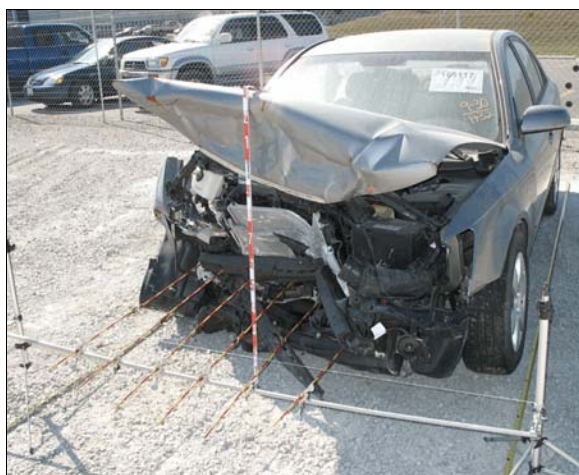
Figure 11: Hyundai's frontal damage viewed from left of front; Note: measurement location of C₆ and rightward movement of crush profile

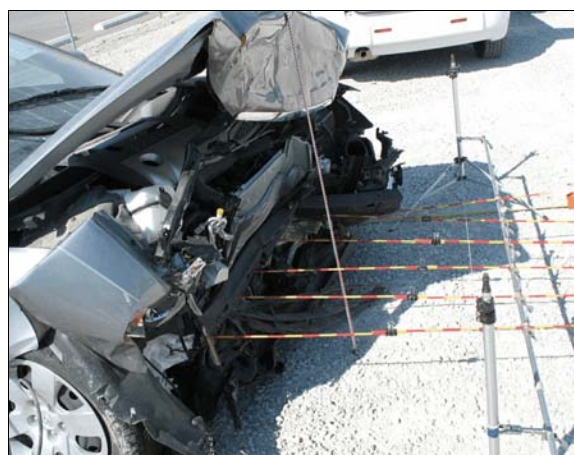
Figure 12: Hyundai's frontal damage viewed from right along stringline; Note: restriction of right front tire from crush

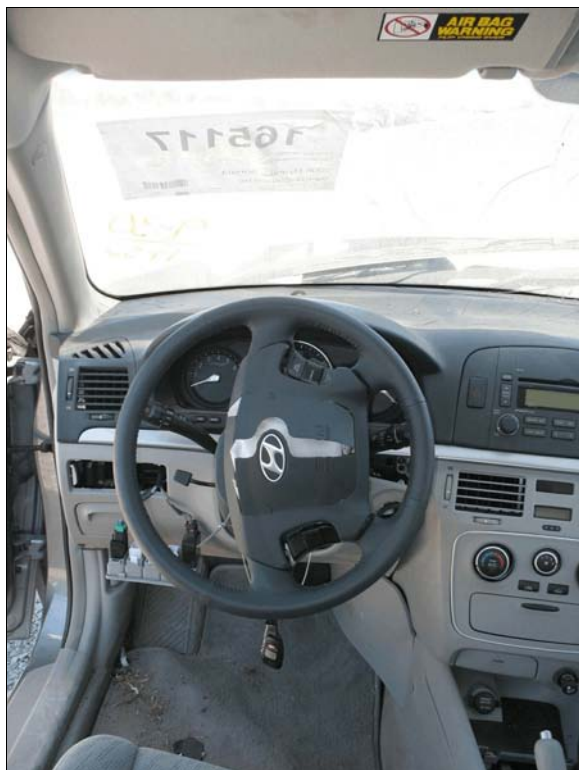
Interior Damage: Inspection of the Hyundai's interior revealed no evidence of occupant contact on the front interior surfaces (**Figures 13 and 14**). However, there was deformation to the back surface of the front right seat back from loading by the second row right passenger and/or child safety seat in the second row right position (**Figures 15 and 16**). In addition, the Hyundai sustained several minor intrusions in this crash. There was a 2 centimeter (0.8 inch) vertical intrusion to the floor pan on the driver's side, a 3 centimeter (1.2 inch) longitudinal intrusion to the toe pan on the front right passenger side, and the center console intruded 3 centimeters (1.2

inches) laterally toward the steering column (**Figure 13**). In addition, all three second row seating positions were intruded forward, longitudinally, probably from unknown cargo in the vehicle's trunk. The largest intrusion was 4 centimeters (1.6 inches) to the second row center position. Finally, there was no evidence of compression of the energy absorbing steering column and no deformation to the steering wheel rim.

Figure 13: Hyundai's driver seating area showing no obvious occupant contacts to front interior surfaces

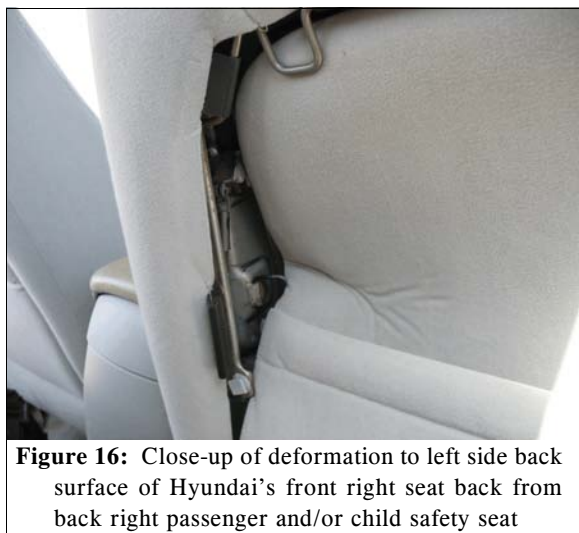
Figure 16: Close-up of deformation to left side back surface of Hyundai's front right seat back from back right passenger and/or child safety seat

As a result of the impact, the second row right passenger loaded the torso belt and his head probably hyper-flexed (bent forward) because his trunk was restrained by the lap belt. Because of the severe nature of the crash, this occupant would have moved upward as well, but his safety belts inhibited this movement. As indicated above, objects in the trunk of the Hyundai loaded the second row seat causing the seat to intrude forward 3 centimeters (1.2 inches). As a result of the intrusion and the dynamic forces of the collision, the occupant and BSS moved forward into the back surface of the front right seat back, deforming it (**Figures 15, 16, and 32**).

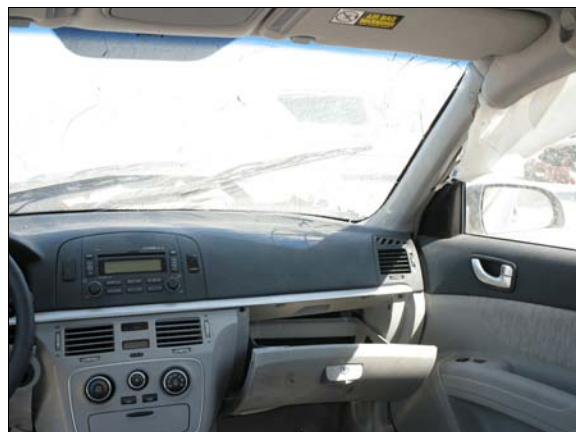
Figure 14: Hyundai's front right seating area showing non-deployed air bag and no evidence of occupant contact; Note: dislodged glove box door

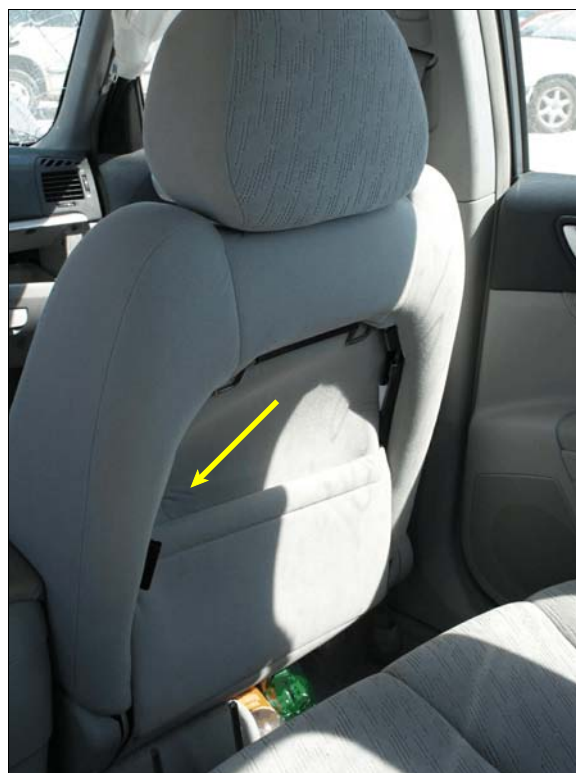
Figure 15: Hyundai's back surface of front right seat back showing contact evidence (arrow) from back right passenger and/or child safety seat

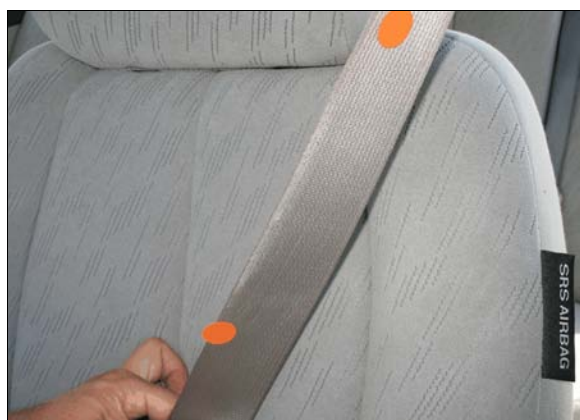
Figure 17: Loading evidence on torso portion of safety belt for Hyundai's driver; Note: tag identifying location of driver's non-deployed, seat back-mounted, side impact air bag

Both front and second row seat belts exhibited indications of historical usage. The inspection of the driver's safety belt webbing, D-ring, and latch plate revealed that the pretensioner had actuated and showed evidence of loading (**Figure 17**). The inspection of the second row right passenger's safety belt webbing, shoulder belt guide, and latch plate revealed evidence of loading on the lap belt portion from the guide in the bight of the second row right seat (**Figure**

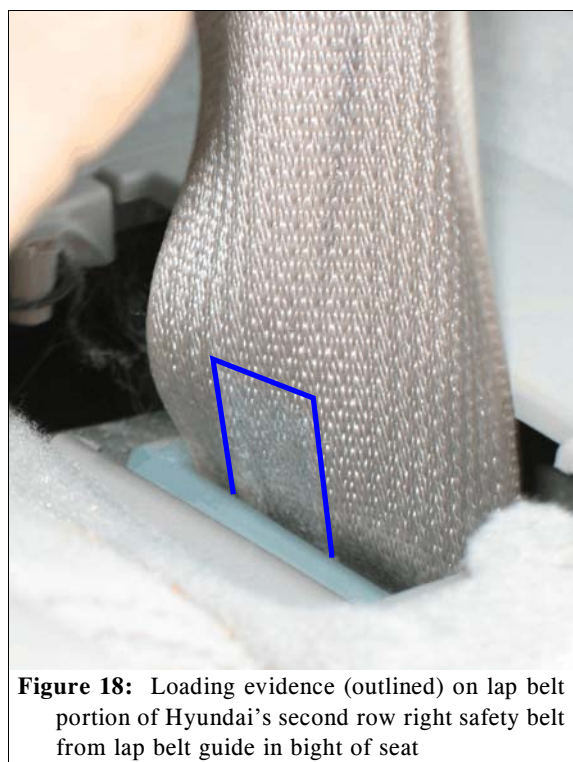
Figure 18: Loading evidence (outlined) on lap belt portion of Hyundai's second row right safety belt from lap belt guide in bight of seat

18). According to the driver, the child's lap belt was across his hips/upper thighs and the shoulder belt was positioned through the child seat's middle guide path.

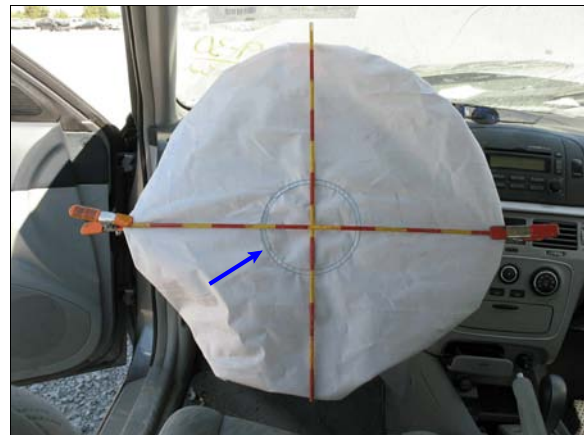
Figure 19: Hyundai's deployed driver air bag showing only minimal evidence of occupant interaction (e.g., arrow indicates a discoloration near the 8 o'clock position of the tether's stitching)

driver's air bag fabric revealed very light deployment scuffs in the left upper quadrant and right half and a faint orangish/yellowish discoloration at the circular tether stitching near the 8 o'clock position (**Figure 19**).

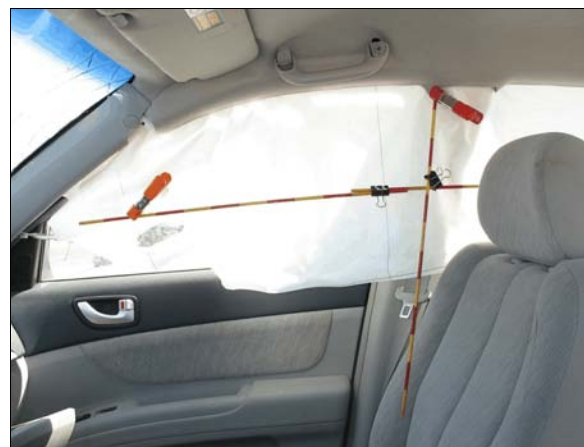
Figure 20: Front portion of Hyundai's deployed right side curtain air bag showing no contact evidence on air bag's interior surface

The Hyundai's right and left side curtain air bags were housed within the A-pillar and the roof side rails under the headliner (**Figures 20 and 21**). The right side curtain air bag extended from the A-pillar to near the C-pillar. It was designed to provide protection to an occupant's head during a side impact. The air bag was attached to the right A-pillar (**Figure 20**) and the right C-pillar (**Figure 21**). There was no tether at either the front or back of the air bag. The right side curtain air bag was rectangular with a length of 170 centimeters (66.9 inches) and a height of 36 centimeters (14.2 inches); however, for the first 30 centimeters (11.8 inches) rearward of the right A-pillar, the height of the air bag was a little shorter in height than the height of the remainder of the air bag (**Figure 20**), and there were two cutouts (see through elliptical areas) in the material (**Figures 9 and 20**). The air bag was designed with 4 U-shaped inflatable chambers adjacent to each seat position. For the front right seating position, the four chambers were all adjacent to one another. For the second row right seating position, three chambers were adjacent to each other while the forward-most chamber was separated from the three rearmost chambers by a non-inflatable area. The air bag chambers were designed without any tethers or vent ports. Inspection of the air bag revealed no deployment damage on either the outboard or inboard surfaces. An inspection of the air bag's fabric revealed no contact evidence on the interior surface of the air bag's fabric.

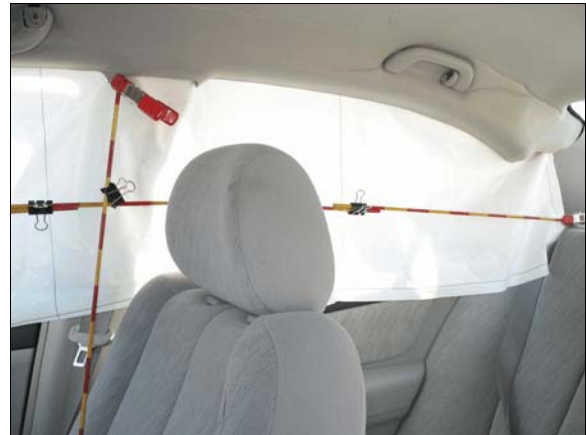
Figure 21: Back portion of Hyundai's deployed right side curtain air bag showing no contact evidence on air bag's interior surface

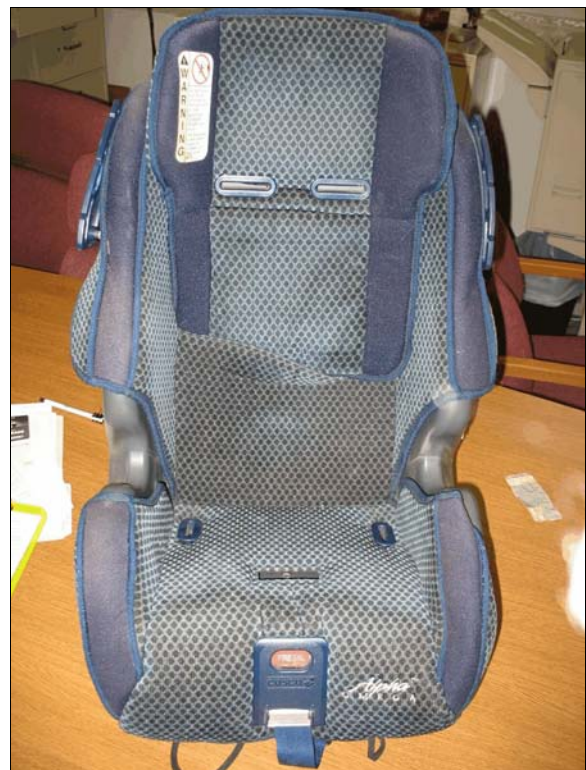
Figure 22: Cosco Alpha Omega, convertible child safety seat used in forward-facing position by Hyundai's second row right passenger as a high-back, belt-positioning booster seat

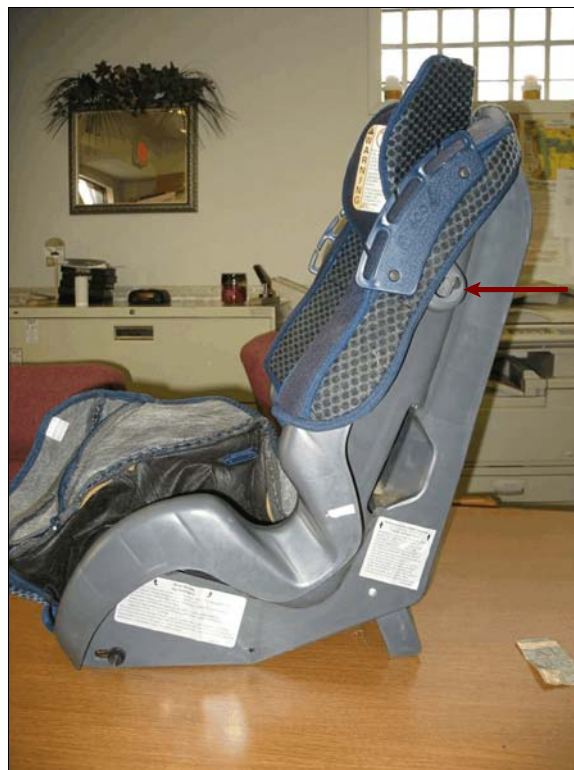
Figure 23: Left (inboard) side of child safety seat used by Hyundai's second row right passenger; arrow denotes location where tray-shield attaches

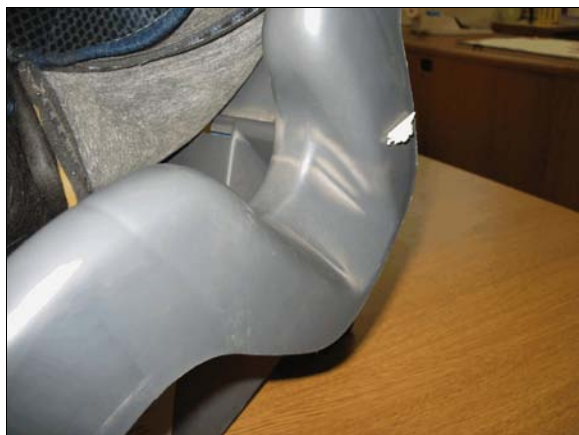
Figure 24: Stress marks on inboard side of Cosco child safety seat's left lap belt guide

An inspection of the CSS revealed no apparent fractures to the seat's shell, but there was damage (stress marks indicating buckling of the plastic) on the seat's left lap belt guide (**Figures 23 through Figure 26**). Furthermore, there was loading evidence (belt scrapes) on the right lap belt guide (**Figures 27 and 28**). In addition, there was damage to the right shoulder belt guide (stress marks indicating buckling of the plastic-**Figure 29**), and one of the guide's fastening screws had been pulled out of its attachment point on the shell (**Figure 30**).

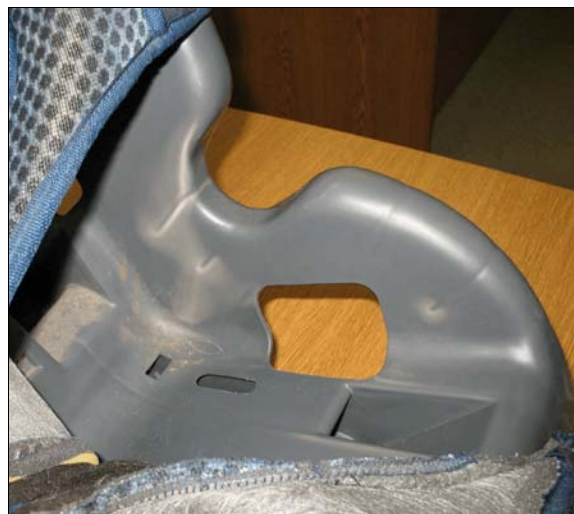
Figure 25: Stress marks on outboard side of Cosco child safety seat's left lap belt guide

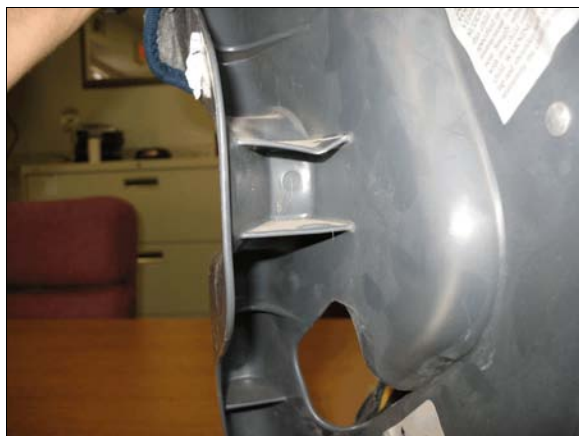
Figure 26: Close-up of stress damage behind left lap belt guide of CSS used by Hyundai's second row right passenger

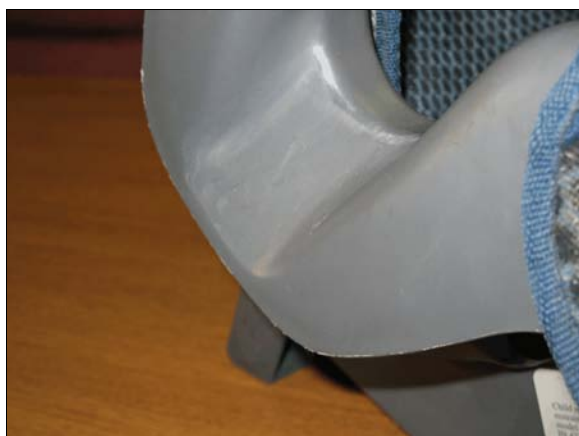
Figure 28: Belt loading marks on CSS's right (outboard) lap belt guide used by second row right passenger

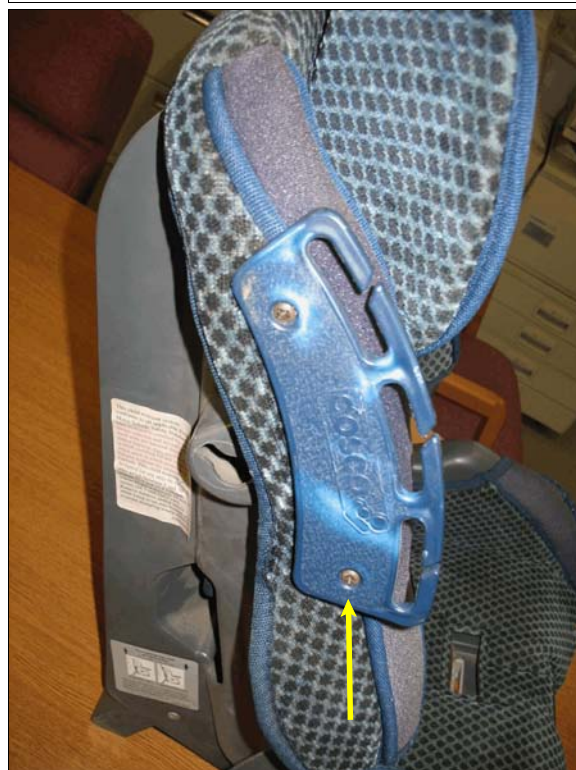
Figure 29: Right (outboard) shoulder belt guide on CSS used by second row right passenger showing white stress marks from loading on guide; Note: screw (arrow) pulled out of seat's plastic frame

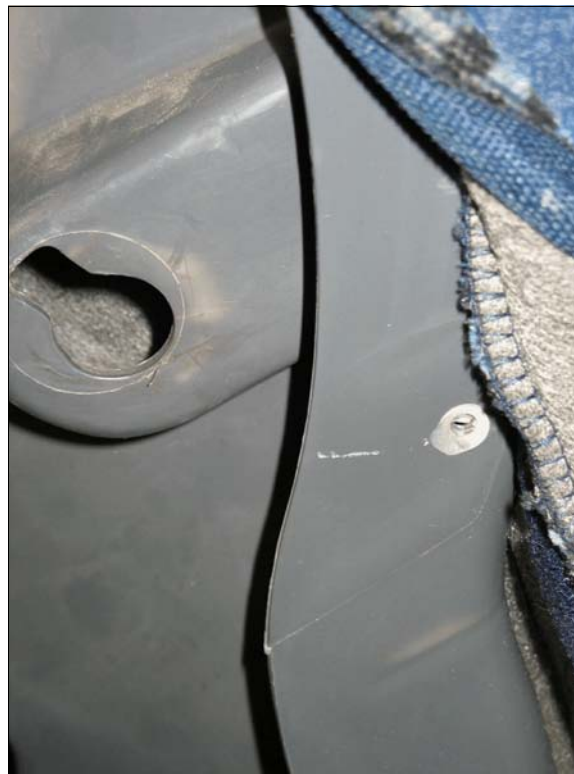
Figure 30: Close-up of location on CSS's plastic frame where screw holding right (outboard) shoulder belt guide pulled out

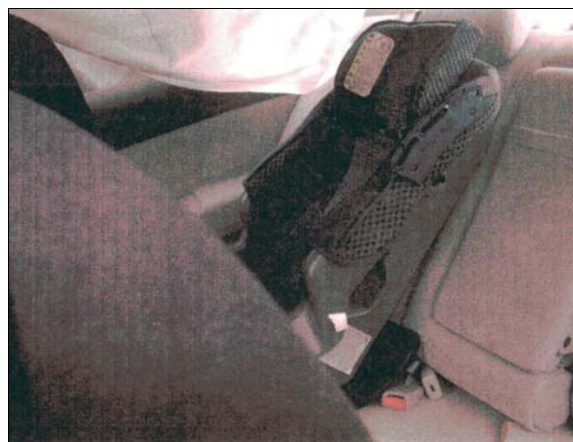
Based on the vehicle inspection, the Hyundai's second row right passenger was restrained in his booster safety seat (**Figure 31**) by his vehicle's safety belts. There was no direct evidence of belt pattern bruising and/or abrasions

Figure 31: On-scene police photo of child safety seat used by Hyundai's back right passenger

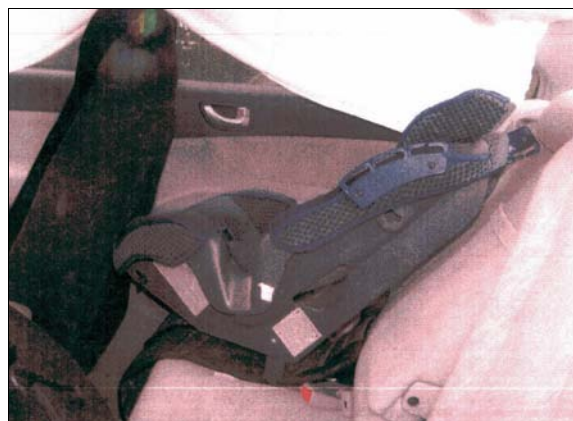
Figure 32: On-scene police photo of child safety seat used by Hyundai's second row right passenger; Note: seat and occupant intruded into back of front right seat back

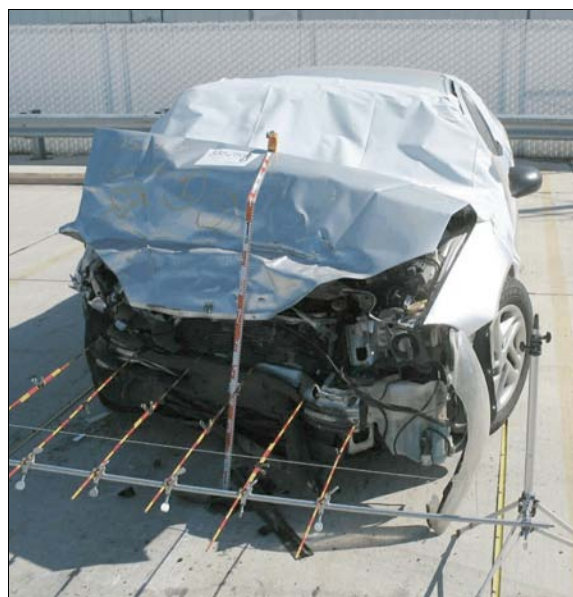
Figure 33: Dodge's frontal damage viewed from left of front; Note: measurement location of C₆ and rightward movement of crush profile
