On Site ODI Tire Tread Separation / Rollover Investigation
Dynamic Science, Inc. (DSI), Case Number DS08003
1999 Ford Explorer XLT
Arizona
May 2007

1. Report No. DS08003		2. Government Accession No.		3. Recipient Catalog No.	
4. Title and Subtitle ODI Tire Tread Separation / Rollover Investigation				5. Report Date March 11, 2009

Dynamic Science, Inc.
Crash Investigation
Case Number: DS08003

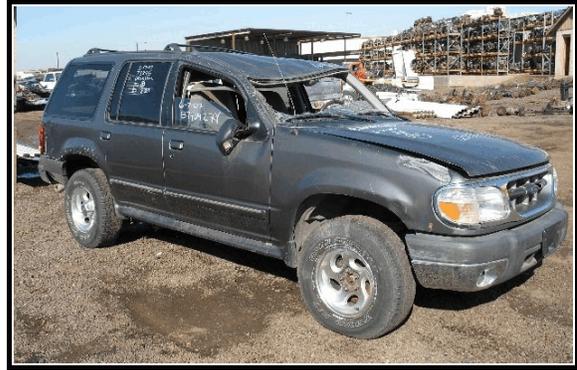
Figure 1. Subject vehicle, 1999 Ford Explorer XLT

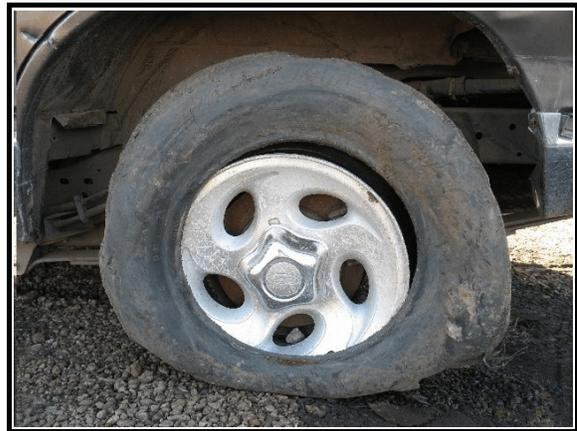
The Ford was traveling northbound at a police estimated speed of 105 km/h (65 mph). The driver stated in the police report that the left rear tire sustained a blowout (**Figure 2**), which caused her to lose control of the vehicle. The Ford initiated a clockwise rotation and traveled across the three travel lanes. The vehicle departed the roadway on the right side; the left side tires engaged and dug into the ground, and the vehicle initiated a trip rollover with its left side leading. It came to rest on its wheels in an unpaved area of ground to the right of the roadway.

Figure 2. Left rear tire sustained tread separation

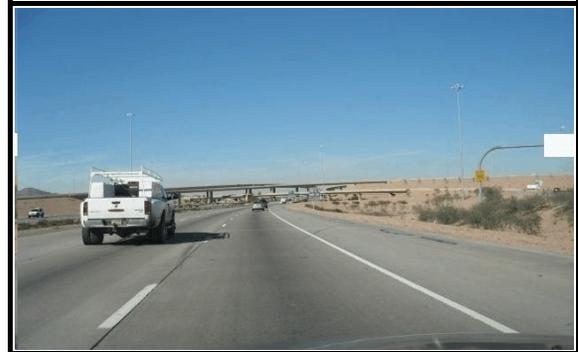
Figure 4. Northbound approach

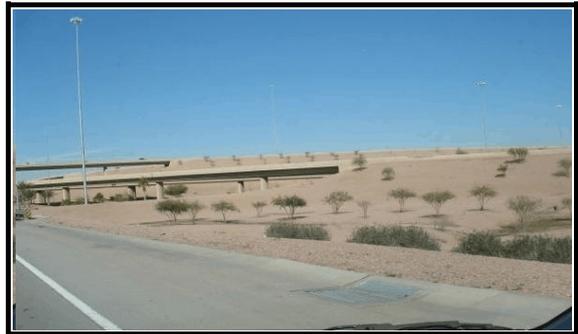
Figure 3. Area of rollover and final rest

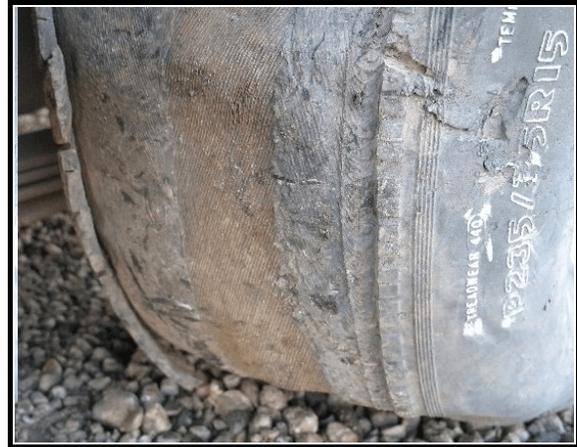
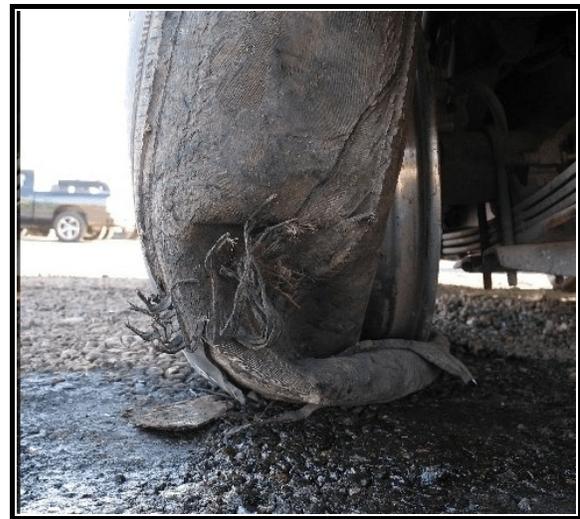
The left rear tire was a Dominator All Season M+S, size P235/75R15. The tire sustained a tread separation (**Figures 5-6**). The tire was de-beaded and the sidewalls were abraded. The carcass and belts were exposed. There was a split parallel to the bead that measured approximately 6 cm (2.3 in) in length. The split began 2 cm (0.8 in) to the right of the valve stem and was 1 cm (0.4 in) from the rim. The tire manufacturer's maximum tire pressure could not be read due to damage. The Tire Identification Number (TIN) was UIHI TUL 0605. The build date was the 6th week of 2005, or February 2005. The tire tread separated prior to the rollover.

Figure 5. Left rear tire, from front

Figure 6. Left rear tire, from back

- The tire had de-beaded from the outer rim flange. Outer surfaces of the rim and sidewall displayed major scuffing. The outer rim flange displayed two major flat spots indicative of radial impacts.

- The tire was missing its tread and outer steel belt and displayed major scuffing damage to its outer sidewall. This damage extended to the rubber that coated the bead region and, in one location, some of the bead wires were exposed.

- The inner liner and upper sidewall exhibited damage (separation, abrasion, and wrinkling) that was indicative of being operated for a short period at high speed with no appreciable air pressure.

- Examination of the inner liner identified two repair patches spaced about 7.6 cm (3 in) apart. Due to post tire failure damage, a failure origin could not be identified and no causal link could be drawn between the road hazard repairs and the tread separation.

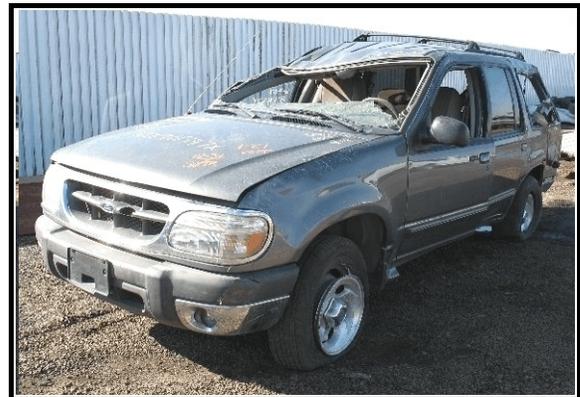
The Ford sustained moderate damage as a result of the rollover (**Figure 7**). The left front and left rear tires were flattened. The front grille was cracked and holed. There was direct damage to the left and right side A-, B- and D-pillars, and the left C-pillar. Direct damage to the left and right sides extended along the entire length of the vehicle. Direct damage to the top began at the leading edge of the hood, extended rearward 413 cm (161.6 in), and ended at the left D-pillar. The lateral aspect of the direct damage was distributed from roof rail to roof rail. The CDC for the rollover was 00TDDO3.

Figure 7. View showing crush to roof

The maximum lateral crush measurement was taken at the right roof rail near the A-pillar and measured 5 cm (2.0 in). The maximum vertical crush measurement was taken at the right windshield header and measured 17 cm (6.7 in).

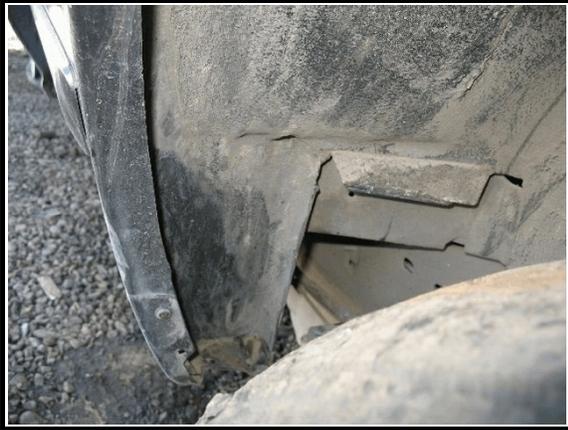
There were several rubber transfers inside the left rear wheel well (**Figure 8**). The left rear wheel well was holed and there was a split in the left rear quarter panel located above the tire. The interior left panel was fractured and displaced into the rear cargo area (**Figure 9**). This damage was probably caused by contact from the loose tire tread as it rotated with the tire.

Figure 8. Rubber transfer to inner wheel well

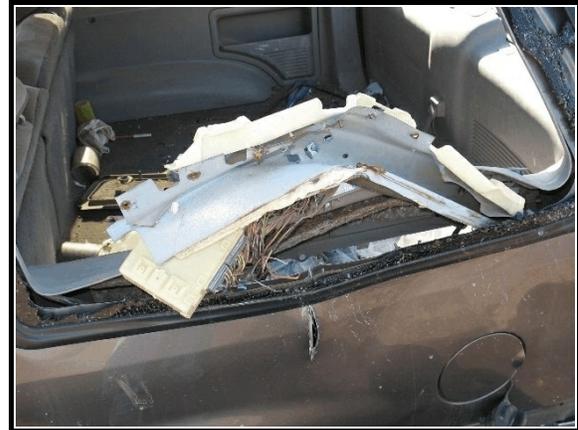
Figure 9. Fracture and displacement of interior left side panel

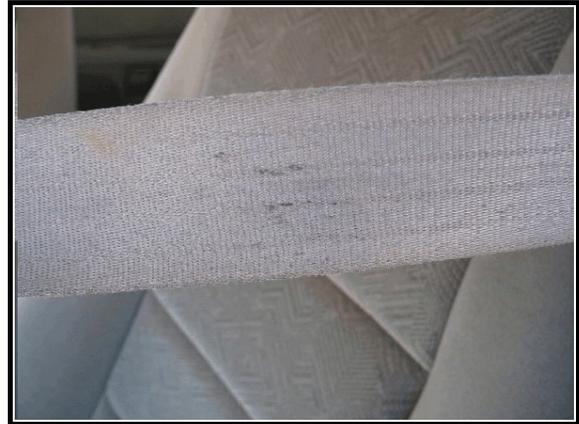
Figure 10. Occupant contact, loading of safety belt webbing

The vehicle traveled off the right side of the road and tripped with its left side leading. The driver was displaced to the left and loaded the safety belt webbing (**Figure 10**). There were load marks that covered an 18 cm (7.1 in) section of belt that were located between the buckle and the stop button. During the rollover, the driver contacted the left side interior hardware with her left shoulder, causing a left shoulder contusion. She contacted an unknown component with her left hand or wrist that resulted in a wrist sprain. There was no contact evidence observed on the steering wheel or column, and those components did not exhibit any deformation. The driver complained of a headache and sustained a cervical strain. There was no evidence that indicated the occupant contacted the roof. It is probable that her cervical injury was a non-contact injury. After the crash, the driver was transported by ambulance to a regional medical center, treated, and released.
