ON-SITE SCHOOL BUS INVESTIGATION

CASE NUMBER - IN08008
LOCATION - Minnesota
VEHICLE - 1999 THOMAS BUILT SCHOOL BUS
(ON AN INTERNATIONAL 3800 BUS CHASSIS)
CRASH DATE - February 2008

January 6, 2009

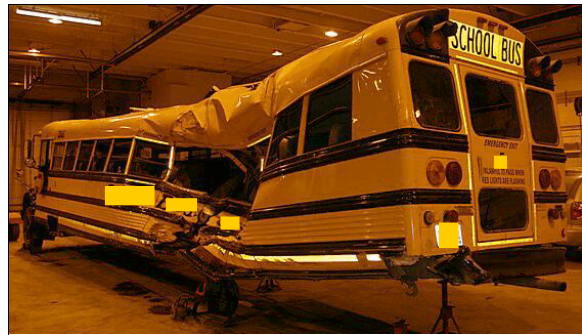
Figure 1: The damaged 1999 Thomas Built school bus

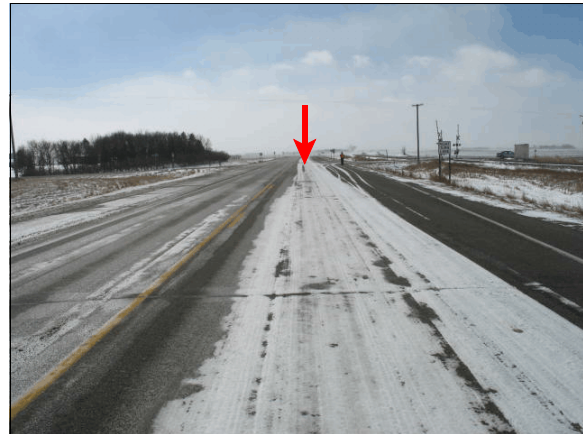
Figure 3: Thomas bus's southwest approach to intersection; arrow shows area of impact between bus and Plymouth

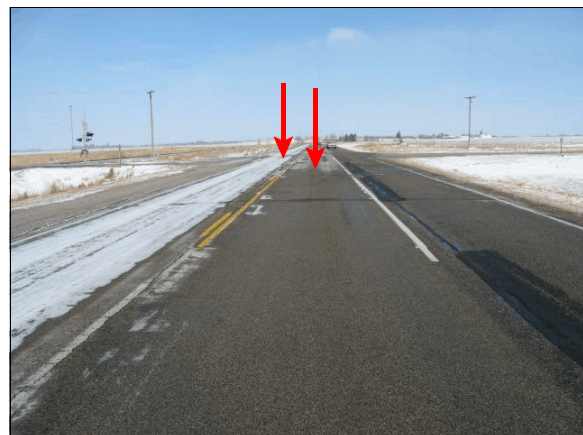
Figure 4: Chevrolet's northeast approach to intersection; left arrow shows area of impact between bus and Plymouth; right arrow shows area of impact between bus and Chevrolet

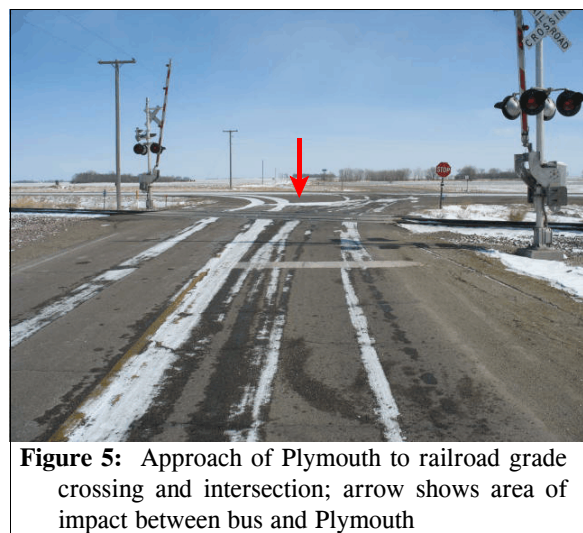
Figure 5: Approach of Plymouth to railroad grade crossing and intersection; arrow shows area of impact between bus and Plymouth

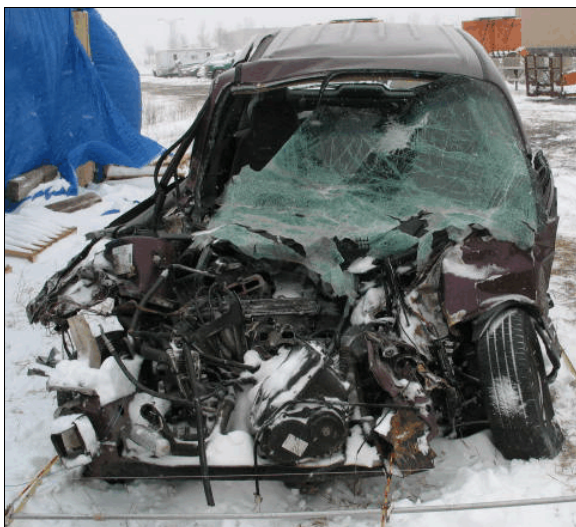
Figure 6: Overview of damage to front of Plymouth from impact with right side of the Thomas bus

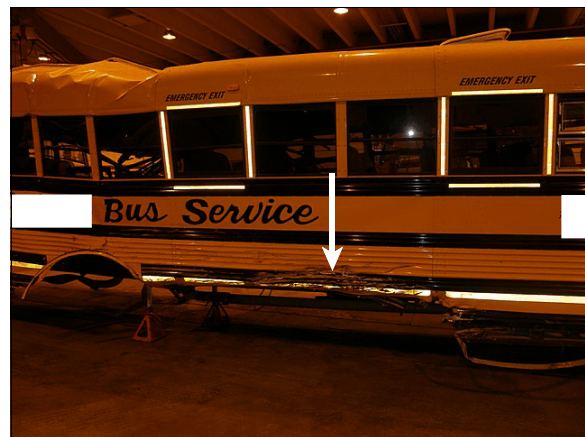
Figure 7: Police photo showing Plymouth's impact location on right side of bus (arrow)

Exterior Damage: The Thomas bus' initial impact with the Plymouth Voyager involved the right side of the bus forward of the right rear wheels and just rearward of the fuel tank (**Figure 8**). The direct damage began 695 centimeters (274 inches) forward of the back of the bus and extended rearward 250 centimeters (98 inches). The direct damage involved the sheet metal primarily at the bottom of the bus body; however, the bus' right frame member was also directly impacted as was the exhaust pipe. There was minimal crush to the bus body from this impact due to the height differential between the side of the bus and front of the Plymouth. As a result, the front of the Plymouth underrode the right side of the bus. The bus' left side impact with the Chevrolet

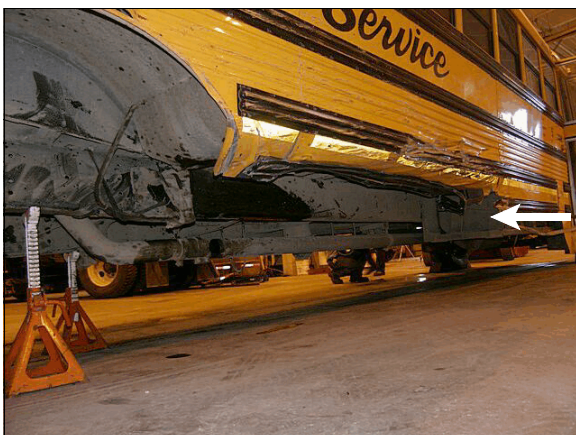
Figure 8: Police photo showing contact to bus' right frame rail; arrow shows location of fuel tank

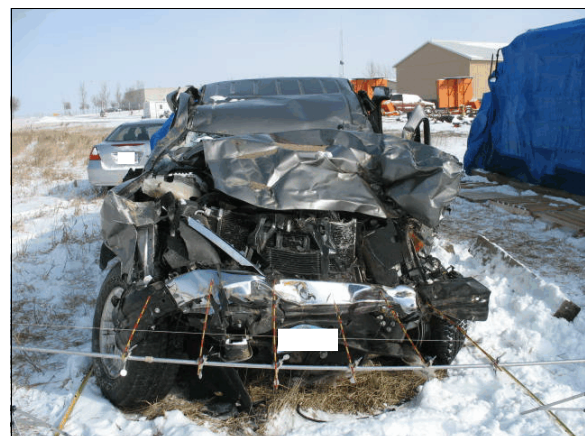
Figure 9: Damage to front of Chevrolet from the impact with the left side of the bus

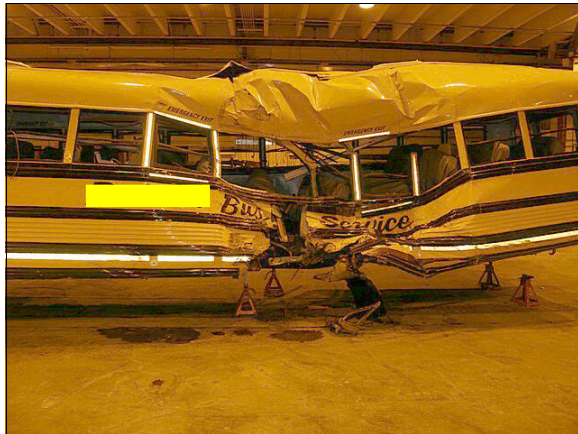
Figure 10: Police photo showing damage to left side of bus from the impact with the Chevrolet

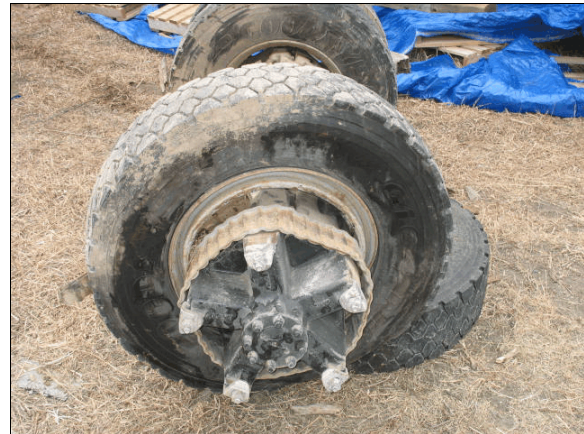
Figure 11: Damage to bus' left rear wheels from impact with the Chevrolet

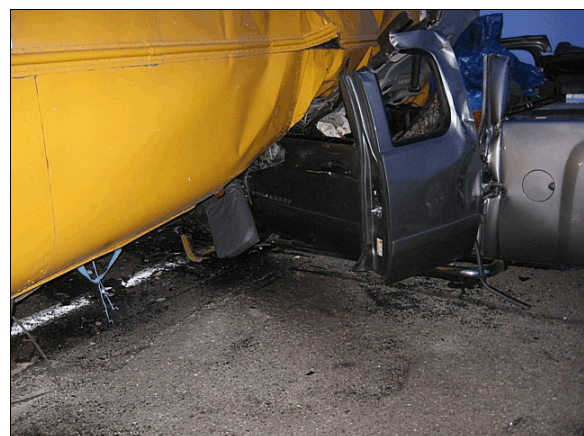
Figure 12: Police on-scene photo showing rest position of Chevrolet under left side of bus

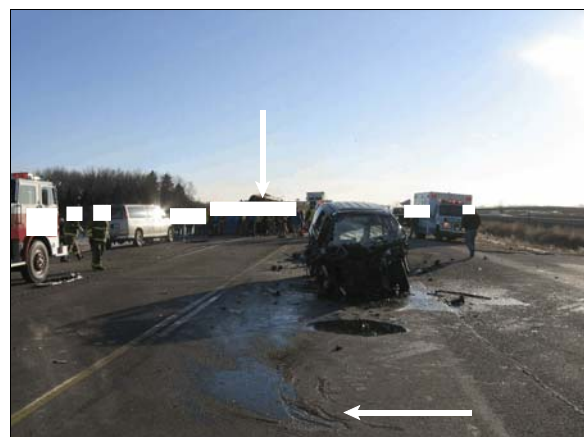
Figure 13: Police on-scene photo; view south to rest position of Plymouth, arrow shows pavement gouges from impact between Plymouth and bus, arrow in background shows rest position of bus

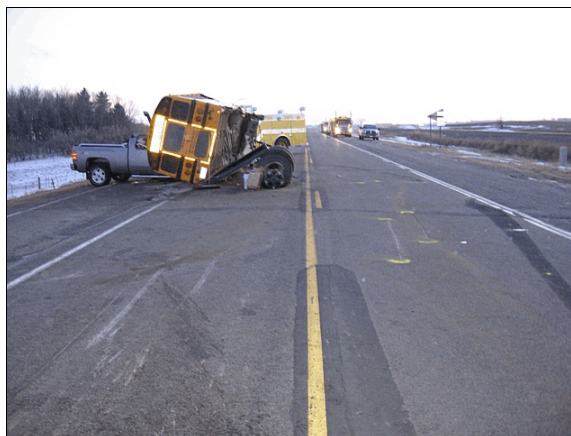
Figure 14: Police on-scene photo; view southwest to final rest position of Chevrolet and bus

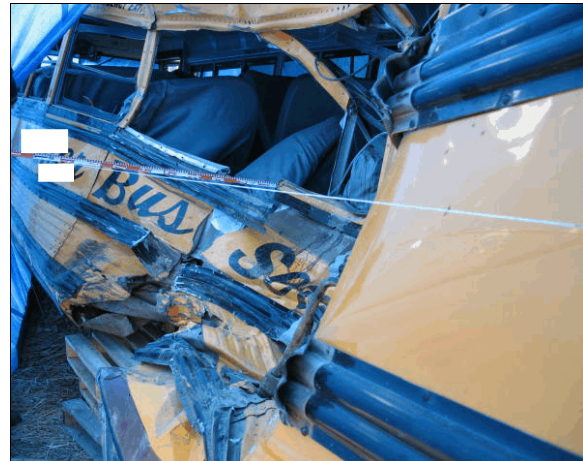
Silverado involved the side structure of the bus as well as the left rear wheels. The bus was rolling over to the left at the time of this impact, so the bus body was significantly engaged above the frame level (**Figure 16**). The direct damage began 217 centimeters (85 inches) forward of the back of the bus and extended 288 centimeters (113 in) forward along the side of the bus. The outer left rear wheel was directly impacted and broken off the rear axle, and the rear axle separated from the bus frame (**Figures 11 and 14**). The left side structure of the bus body was crushed inward to a maximum depth of 86 centimeters (33.8 inches). The maximum penetration occurred at the bottom of the side window adjacent to row 9. The sheet metal was torn apart in this area as a result of the impact (**Figure 17**) and the vertical frame members of the 4th-6th windows from the back of the bus separated from the side structure, and some of the rivets pulled through the sheet metal at the top of the same windows. There was minor direct damage along the left side of the bus due to the rollover. The engagement with the roadway pavement was minimal because the bus rolled on top of the Chevrolet.

Figure 16: Crush to left side of bus due to impact with Chevrolet; tape measure in tenths of meter

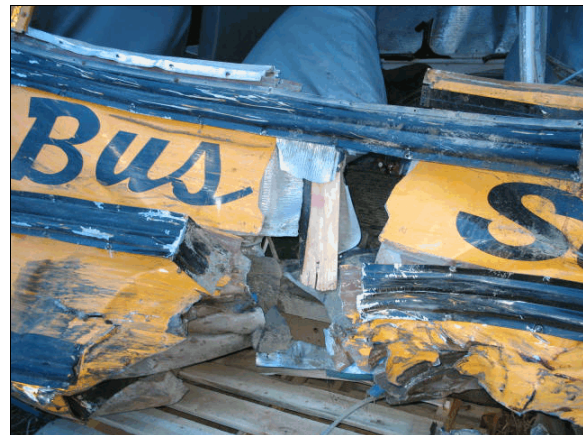
Figure 17: Sheet metal damage to left side of bus

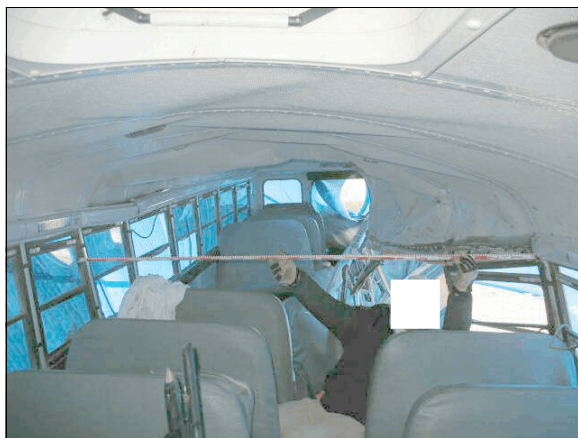
Vehicle Interior: Interior damage, intrusion (**Figures 18 and 19**) and/or occupant contact evidence were observed in the seating rows listed below. A schematic depicting the seating row configuration and row numbers is presented on page 22.

Figure 18: Left side intrusion into bus passenger compartment

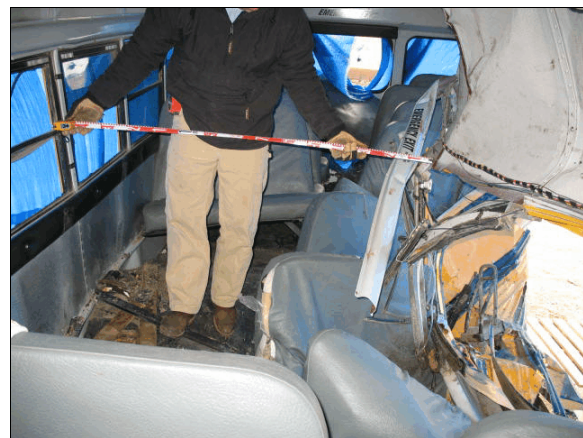
Figure 19: Closer view of left side intrusion involving primarily seat rows 8-11

- Row 9 left: The top and bottom window glazing was disintegrated due to damage. There was hair transfer on the window frame and blood smear on the roof side rail and the roof. The side structure intruded 75 centimeters (29.5 inches) and was torn apart vertically. The window frame separated from the side structure. There was severe deformation of the seat.

- Row 10 left: The top and bottom window glazing was disintegrated due to damage. There was hair transfer on the pillar and heavy blood deposit on the roof. The pillar was separated from the side structure at the roof side rail. The side structure was intruded 84 centimeters (33.1 inches) and the roof was buckled and intruded.

- Row 10 right: The bottom window was disintegrated due to occupant contact. The floor was buckled upward and the roof was slightly buckled.
- Row 11 left: The top and bottom window glazing was disintegrated due to damage. The seat was severely deformed and the side structure was intruded 84 centimeters (33.1 inches) and the roof was buckled and intruded.

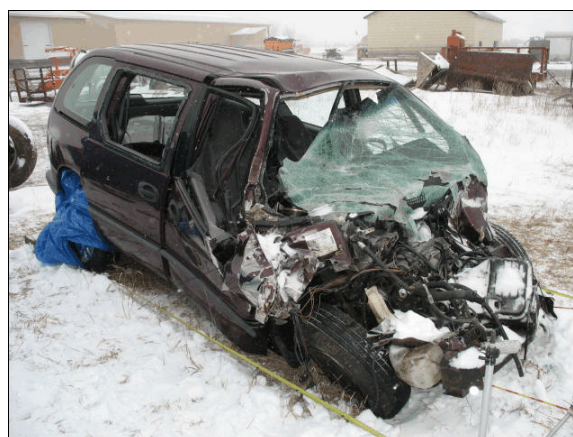
Exterior Damage: The Plymouth's impact with the Thomas bus involved the front of the vehicle (**Figure 20**). The direct damage involved the entire front structure of the Plymouth, including

Figure 20: Overview of damage to front of Plymouth from impact with right side of the bus

the windshield and both A-pillars, which sustained direct damage due to the vehicle’s underride of the right side of the bus. The front bumper had been torn off of the Plymouth during the crash and was not present at the inspection site. It was possible to take only two crush measurements, one at each end of the bumper brackets. Due to the underride, a second set of crush measurement was also taken at the upper radiator support level. The maximum residual crush occurred at the upper radiator support level at C₁ and was 99 cm (39 in). The table below shows the average of the two levels of crush.

Damage Classification: The CDC for the Plymouth was **70-FDAA-7 (290 degrees)**. The 10 o’clock force direction was incremented by 60 because the vehicle’s end structure was shifted right 13 cm (5.1 in). The WinSMASH reconstruction program could not be used to reconstruct the Plymouth’s Delta-V because collisions with buses are out of scope for the program. The WinSMASH program was used to calculate a Barrier Equivalent Speed (BES) based on the vehicle’s front crush, and the BES was 85 km/h (53.4 mph).

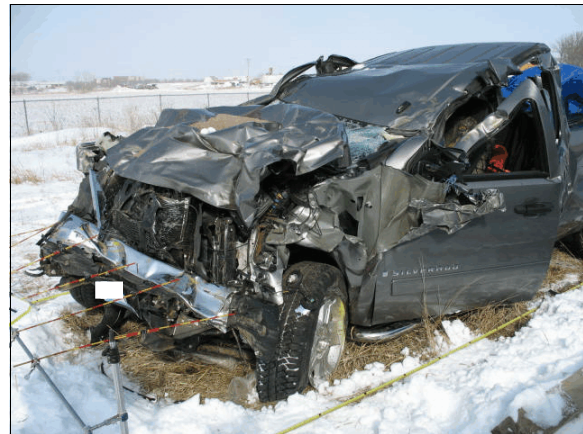
Exterior Damage: The Chevrolet’s impact with the Thomas bus involved the front of the vehicle. The front bumper, both headlamp/turn signal assemblies and the hood were directly damaged. As the bus rolled onto the top of the Chevrolet the top of the hood, the windshield, both A-pillars and the roof also sustained direct damage (**Figure 21**). The direct damage involved the full width of the top plane and extended rearward to the middle of the front doors. The direct damage from the front impact began at the front left bumper corner and extended 150 cm (59 in) across the bumper. The crush measurements were taken at the bumper level and the maximum residual crush was 65 cm (25.6 inches) occurring at C₁. The table below shows the vehicle’s front crush profile.

Figure 21: Front left view of damage to the Chevrolet due to the impact with the left side of the bus

Damage Classification: The CDC for the Chevrolet’s front impact to the left side of the Thomas bus was **12-FDEW-3** (0 degrees). A second CDC was assigned to capture the damage to the top plane as a result of the bus rolling onto the top of the vehicle and was **00-TYDW-4**. The WinSMASH reconstruction program could not be used to reconstruct the Chevrolet’s Delta-V because collisions with buses are out of scope for the program. The Barrier algorithm of the
