On-Site Child Safety Seat Investigation
Dynamic Science, Inc. (DSI), Case Number DS08013
1999 Ford Contour LX
California
April 2008

Dynamic Science, Inc.
Crash Investigation
Case Number: DS08013

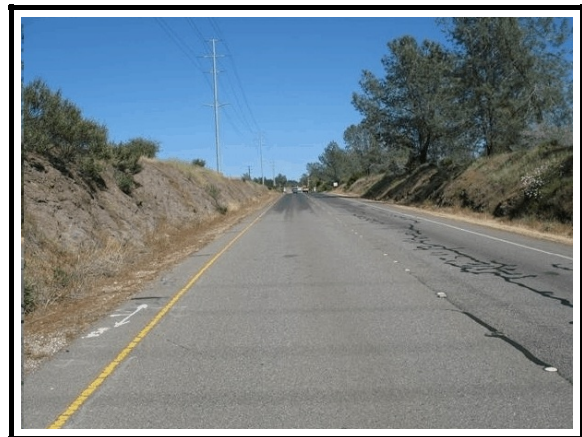
The crash site consisted of a physically divided east/west roadway. The roadway was configured with two eastbound travel lanes that were separated from two westbound lanes by a wide median that ascended above grade. The control loss occurred in the inboard eastbound lane (Figure 2). The roadway was of asphalt composition and was bordered on either side by narrow paved shoulders. Beyond the paved shoulders were ditches and lateral to the ditches were raised embankments. The right shoulder measured 1.3 m (4.4 ft) in width, and the first lane from the right measured 3.81 m (12.5 ft) in width. The second lane from the right measured 3.7 m (12.0 ft) in width, and the right shoulder measured 0.6 m (1.9 ft) in width. The travel lanes were

Figure 2. Crash site, eastbound approach

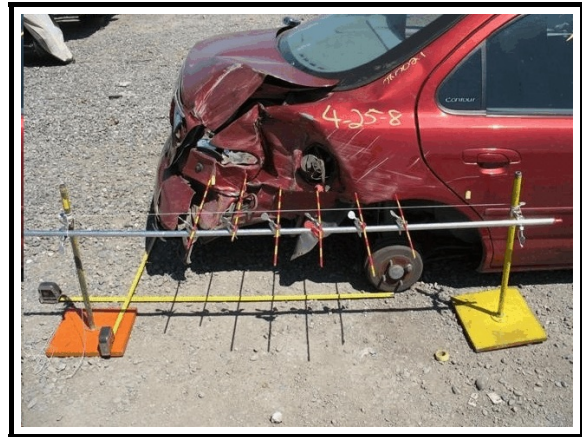
impact with the embankment (**Figure 3**). The direct damage began 24 cm (9.5 in) forward of the rear axle and extended 107 cm (42.1 in) rearward to the rear bumper corner. Six crush measurements were taken at mid-door level as follows: C1 = 10 cm (3.9 in), C2 = 14 cm (5.5 in), C3 = 7 cm (2.8 in), C4 = 7 cm (2.8 in), C5 = 4 cm (1.6 in), C6 = 0 cm. Maximum crush at mid-door level was located at C2 and measured 14 cm (5.5 in). The CDC for the side impact was 04RBEW2.

Figure 3. Right side damage, showing stands

The Barrier algorithm of the WinSmash program computed a Total Delta V of 8.0 km/h (5.0 mph), based on the Ford's right side crush profile. The longitudinal and lateral components were 4.0 km/h (2.5 mph) and -6.9 km/h (-4.3 mph), respectively.

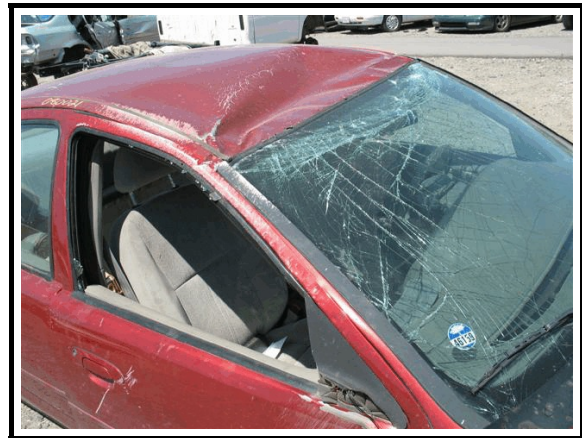
The vehicle sustained moderate damage during the rollover event (**Figure 4**). The windshield was cracked and in place. The first row right window glazing disintegrated. The doors all remained closed and operational. The direct damage to the top plane began on the leading edge of the hood, extended rearward 237 cm (93.3 in), and ended on the roof near the B-pillar. The direct damage to the roof was distributed laterally 110 cm (43.3 in) from roof side rail to roof side rail. The left and right A-pillars sustained direct damage. Direct damage was distributed down the vehicle's entire left side and measured 442 cm (174.0 in) in length. The maximum lateral crush was located at the right A-pillar and measured 5 cm (2.0 in). The maximum vertical crush was located at the right A-pillar and measured 7 cm (2.8 in). The CDC for the rollover event was 00TYDO3.

Figure 4. Roof damage sustained during rollover

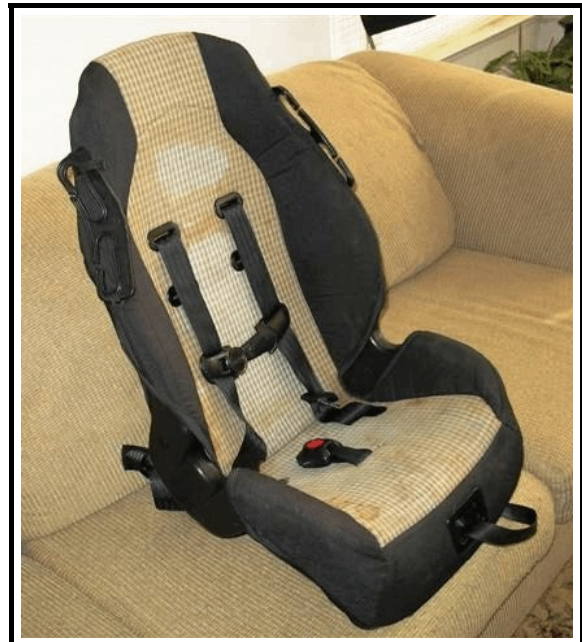
The second row left seat was occupied by a 3-year-old female seated in a Cosco/Dorel High Back Booster CSS (**Figure 5**). The model number was 22-208-MTN and the date of manufacture was 10/27/2005. The CSS was used forward facing and was configured with a 5-point harness and retainer clip. The harness straps were routed through the top set of slots and the retainer clip was fastened. The driver of the subject vehicle was the child's mother and she installed the CSS in the vehicle. The CSS was placed on the bench seat cushion and was secured with the 3-point manual safety belt. The safety belt was routed through the back of the CSS frame through the front facing slots, and she stated that the safety belt retractor was in the ALR mode.

Figure 5. Cosco/Dorel High Back Booster CSS

The 3-year-old child was of an appropriate height, weight and age for the CSS. During the crash, the child and CSS stayed in place. No evidence of occupant contacts were observed on the CSS's harness, cover or shell. The child sustained an abrasion to the chin. The child's mother surmised that the abrasion was the result of the child's chin contacting a zipper on the child's jacket, which she was wearing.

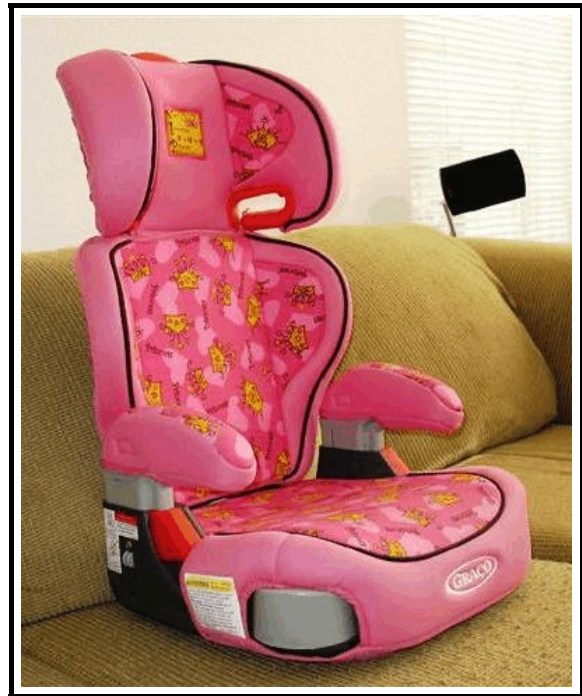
The second row left seat was occupied by a 5-year-old female seated in a Graco TurboBooster CSS (**Figure 6**). The model number was 8E10VIP and the date of manufacture was 11/28/2007. The CSS was used in a forward facing orientation. It was configured without a harness and was designed to be used only as a belt positioning booster seat. The CSS was equipped with adjustable armrests and retractable cup holders. Shoulder belt positioning slots flanked each side of the headrest. The child's mother assisted the child with the safety belt restraint. The retractor was in the ALR mode. The driver stated during the interview that she did not route the shoulder belt webbing through the belt positioning device. Instead, the shoulder belt webbing was placed below the positioning device in an opening between the CSS back and headrest. The safety belt positioned in this manner located the shoulder belt over the child's shoulder, and the shoulder belt was held in place by belt retractor tension.

Figure 6. Graco TurboBooster CSS

The 5-year-old child was an appropriate height, weight and age for the CSS. During the crash, the child and CSS stayed in place. There were no occupant contacts observed on the CSS. The child was not injured.

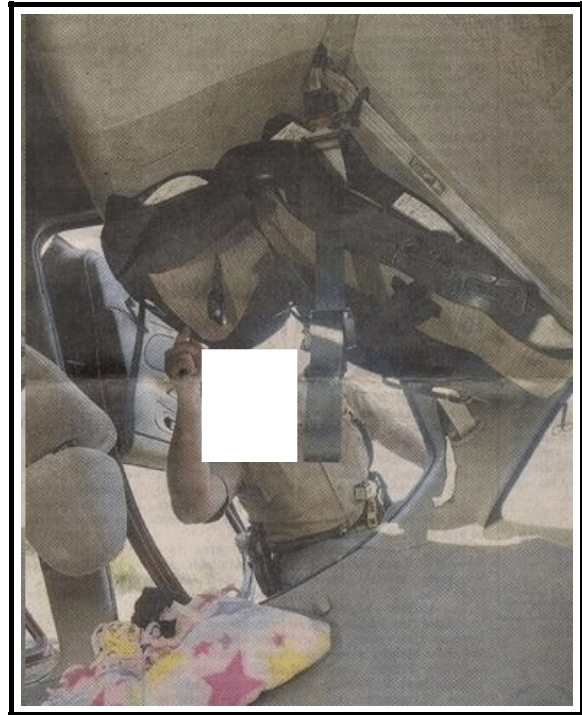
As the driver took evasive actions, the child was displaced slightly left, then right. The vehicle then rotated counterclockwise, and the child continued to be displaced slightly right. The low speed frontal endswipe had minimal effect on the occupant's movement within the CSS. The right rear impact slightly displaced the child rearward and to the right in response to the direction of force. The vehicle initiated a trip rollover left side leading, and the occupant was displaced to the left. The child and the CSS remained in place. The vehicle came to final rest on its roof, and the occupant and the CSS were suspended upside down (**Figure 7**). After the crash, the driver unbuckled the child's CSS harness and assisted her from the CSS and then from the vehicle.

Figure 7. Post-crash view showing Cosco/Dorel CSS, second row left position
