On-Site Rollover Investigation
Dynamic Science, Inc. (DSI), Case Number DS08015
2006 Ford Explorer
Washington
April 2008

Dynamic Science, Inc.
Crash Investigation
Case Number: DS08015

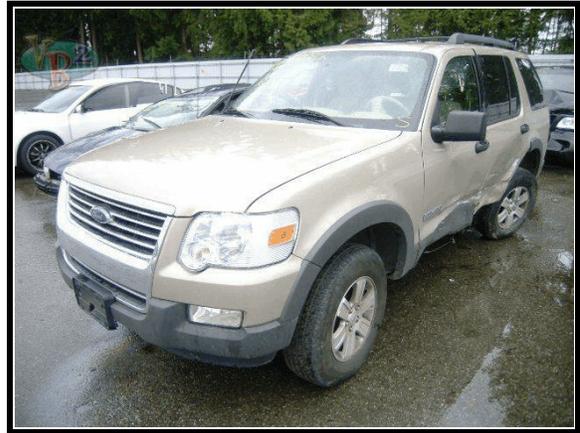
Figure 1. Subject vehicle, 2006 Ford Explorer

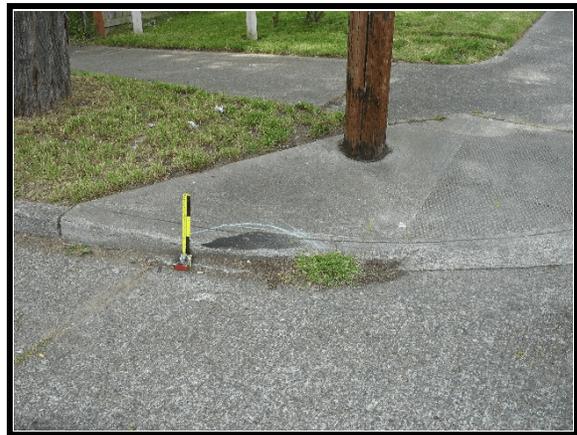
Figure 4. Contact to curb during rotation (area of trip)

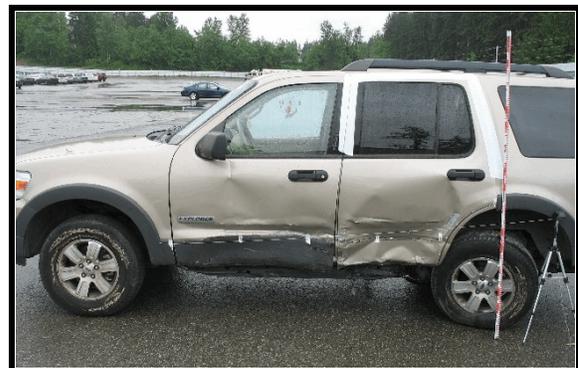
The Ford sustained moderate left side damage as a result of the impact with the Saab (**Figure 5**). The direct damage began 81 cm (31.8 in) aft of the front axle, and extended 195 cm (76.7 in) rearward along the left side plane. The maximum lateral crush was located between C3 and C4 and measured 14 cm (5.5 in). The Field L began 60 cm (23.6 in) aft of the front axle and extended 216 cm (85.0 in) rearward along the left side plane. The left rear tire was twisted in a clockwise direction and the left wheelbase was shortened by 16 cm (6.3 in).

Figure 5. Left side damage from impact with Saab

Six crush measurements were documented at the sill level as follows: C1= 0 cm, C2 = 6 cm (2.4 in), C3 = 13 cm (5.1 in), C4 = 9 cm (3.5 in), C5 = 6 cm (2.4 in), C6 = 0 cm. The Collision Deformation Classification (CDC) for the impact with the Saab was 10LZEW2.

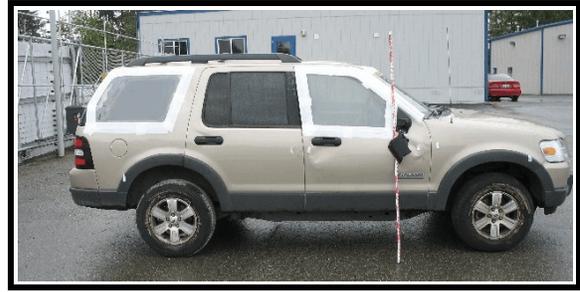
Figure 6. Right side rollover damage

The Ford sustained minor right side damage as a result of the one quarter turn rollover (**Figure 6**). There was 358 cm (140.9 in) of direct contact longitudinally along the right side of the vehicle. The damage extended from the sill level near the rear bumper to the top of the B-pillar. Right side mirror had been knocked off. The maximum lateral crush was located at the right A-pillar and measured 2 cm (0.8 in). The CDC for the rollover was 00RDAO2.

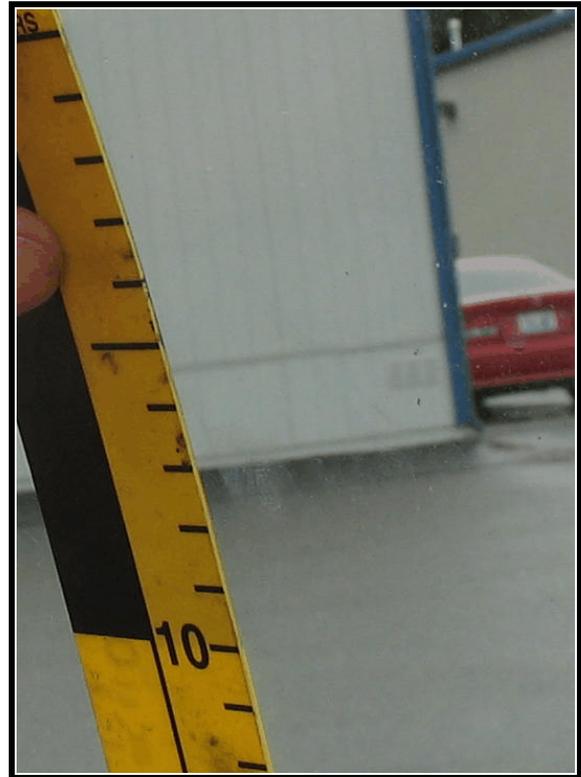
The Ford sustained minor interior damage as result of passenger compartment intrusion from the left side impact with the Saab. The left side B-pillar, sill, and door panel sustained lateral intrusion. The glazing disintegrated at the right front and right rear most windows. The windshield was fractured along the right A-pillar. All the doors remained closed and operational. There was a faint skin/oil transfer located near the center of the driver's side glass (**Figure 7**). The transfer measured 3 cm (1.2 in) by 2 cm (0.8 in).

Figure 7. Contact to driver's side glass

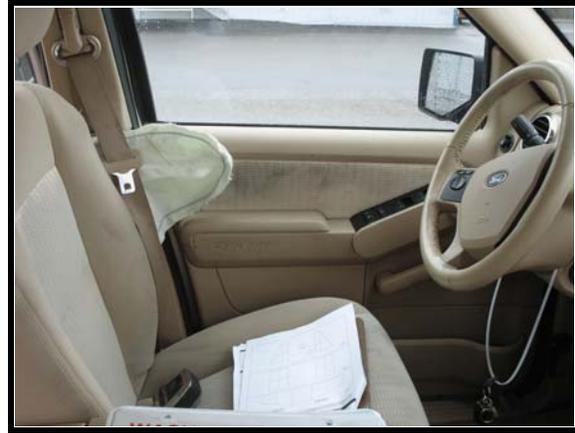
Figure 8. Side air bag, inboard view

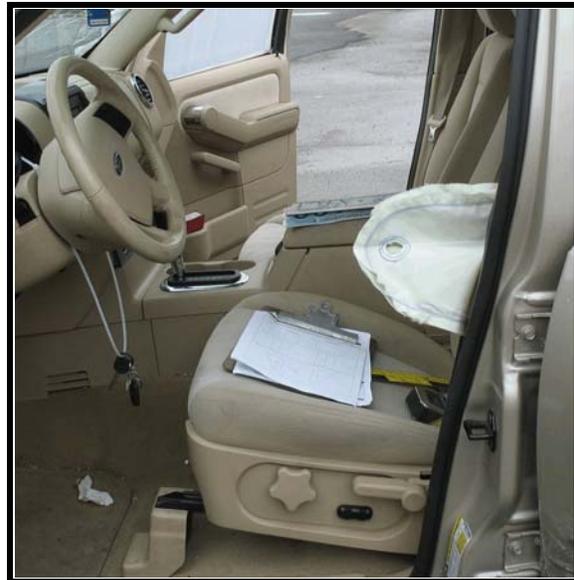
The Ford was equipped with dual-stage frontal air bags and safety belt buckle pretensioners for the driver and front right passenger positions. The Ford was also equipped with seat-mounted side air bags. Side curtain air bags were an option but were not installed in this vehicle. The driver's seat-mounted side air bag deployed and the driver's seat belt pretensioner actuated. The seat-mounted side air bag deployed from a module installed within the seat back (**Figure 8-9**). The deployed air bag measured 28 cm (11.0 in) from the seat back forward and was 19 cm (7.4 in) in height. On the outboard side of the air bag there was a 2.5 cm (0.9 in) circular vent port. There were no indications of damage or occupant contact to the air bag.

Figure 9. Seat-mounted side air bag, outboard view
