ON-SITE ROLLOVER INVESTIGATION

CASE NUMBER - IN08019
LOCATION - MICHIGAN
VEHICLE - 2006 CHEVROLET C1500 SILVERADO
CRASH DATE - February 2008

1. <i>Report No.</i> IN08019	2. <i>Government Accession No.</i>	3. <i>Recipient's Catalog No.</i>	
4. <i>Title and Subtitle</i> On-Site Rollover Investigation Vehicle - 2006 Chevrolet C1500 Silverado Location - Michigan		5. <i>Report Date:</i> February 9, 2009

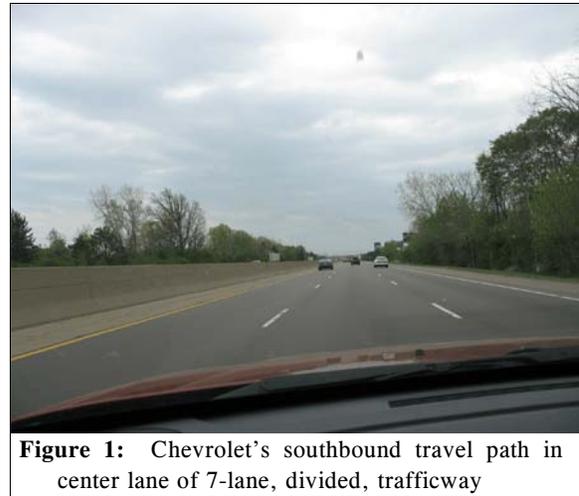
Figure 1: Chevrolet's southbound travel path in center lane of 7-lane, divided, trafficway

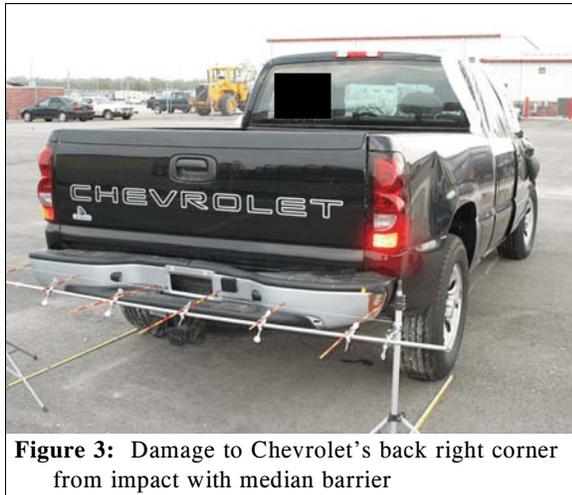
Figure 3: Damage to Chevrolet's back right corner from impact with median barrier

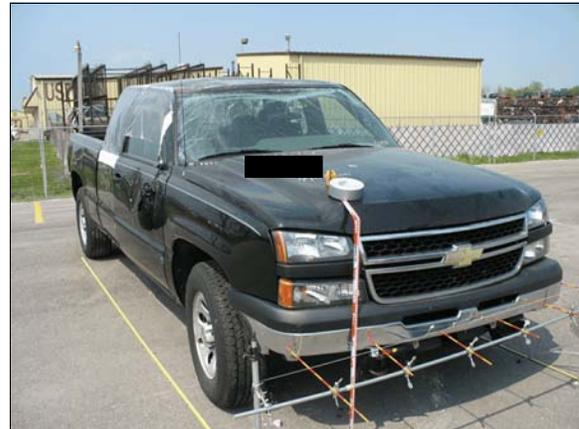
Figure 2: Damage to Chevrolet's front right corner from impact with median barrier

Crash: The front of the Chevrolet traveled up the frozen snow bank and the right portion of the vehicle's front bumper (**Figure 2**) impacted the median barrier (event 1). The vehicle rotated counterclockwise off the barrier and, as it rotated, the back traveled up the frozen snow bank. As a result, the vehicle was leaning to the left when its back right corner (**Figure 3**) impacted the median barrier (event 2). As the vehicle continued rotating counterclockwise off the barrier, it rolled over (event 3) with the left side leading. The vehicle rolled leftward two quarter turns (**Figure 4**), coming to rest on its top (**Figure 5**) in the inside southbound lane facing west-southwest. No air bags deployed during the crash sequence.

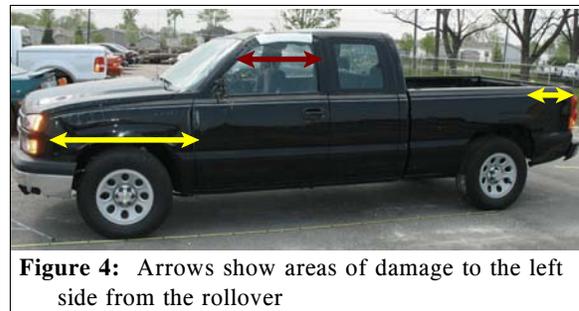
Figure 4: Arrows show areas of damage to the left side from the rollover

the rollover, the direct damage on the left side consisted of scratches on the fender, front door, A-pillar, and roof side rail, and a dent in the left rear side of the truck bed (**Figure 4**). The left outside rearview mirror was also broken off the door (**Figure 10**). The direct damage on the top involved the full length and width of the roof (**Figures 5 and 10**). There was induced damage involving the front and back bumpers, the right side of the truck bed, and the windshield was cracked. When the vehicle was pulled onto its wheels during removal from the scene, the right outside rearview mirror was broken off the door, the right front door and fender were scratched, and the door was dented.

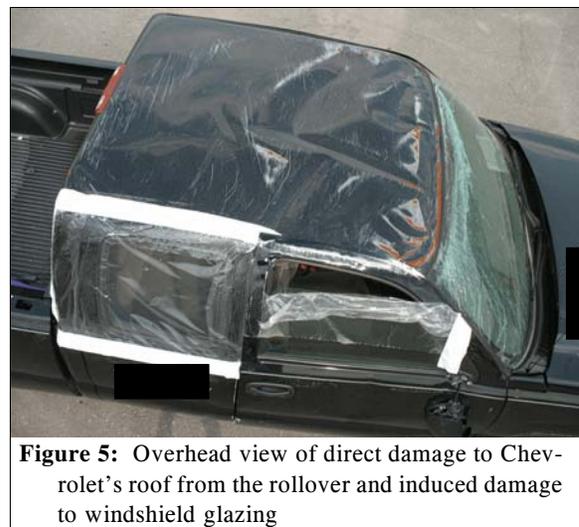
Figure 5: Overhead view of direct damage to Chevrolet's roof from the rollover and induced damage to windshield glazing

The rollover impact (event 3) involved the top and left side. Direct damage occurred to the left side and roof (**Figure 10**). The maximum lateral and vertical crush occurred at the right B-pillar (**Figure 5**). Based on the vehicle inspection and measurements from an exemplar vehicle, the maximum lateral crush was 6 centimeters (2.4 inches), and the maximum vertical crush was 9 centimeters (3.5 inches).

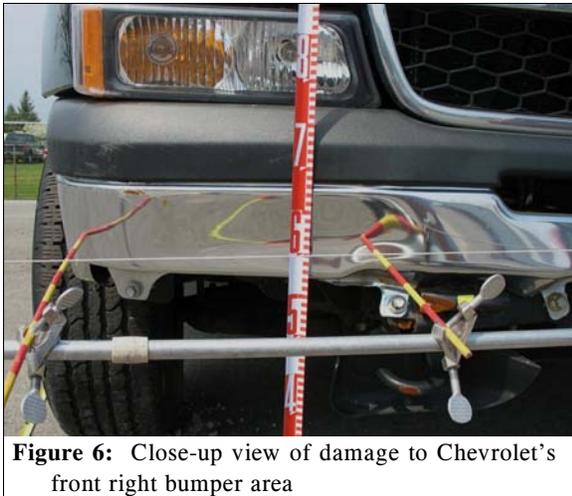
Figure 6: Close-up view of damage to Chevrolet's front right bumper area

Exterior Damage: The Chevrolet's initial impact (event 1) with the median barrier involved the front bumper with the damage distributed on approximately the right portion (**Figure 6**). Direct damage began at the front right bumper corner and extended 46 centimeters (18.1 inches) along the front bumper. Residual maximum crush was measured as 7 centimeters (2.8 inches) at C_6 (**Figure 7**). The second impact (event 2) with the median barrier involved the vehicle's back bumper with the damage distributed on approximately the right portion. Direct damage began at the back right bumper corner and extended 6 centimeters

The wheelbase on the Chevrolet’s left side was unaltered from the crash while the right side was extended 1 centimeter (0.4 inches). For the initial impact, the right portion of the front bumper and a small area of the right turn signal housing were directly damaged (**Figure 6**). The front bumper fascia was crushed rearward, restricting the movement of the right front wheel (**Figure 11**). For the second impact, the back right corner of the bumper fascia was directly damaged and crushed forward (**Figure 8**). During

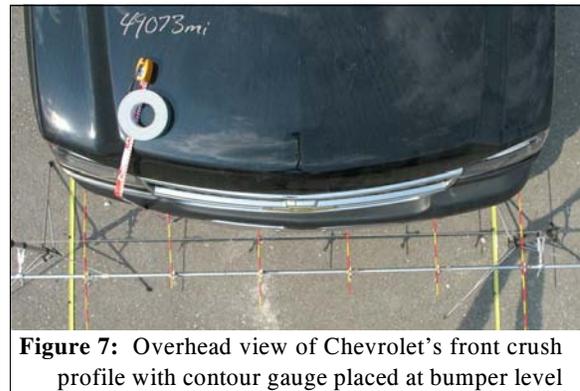
Figure 7: Overhead view of Chevrolet's front crush profile with contour gauge placed at bumper level

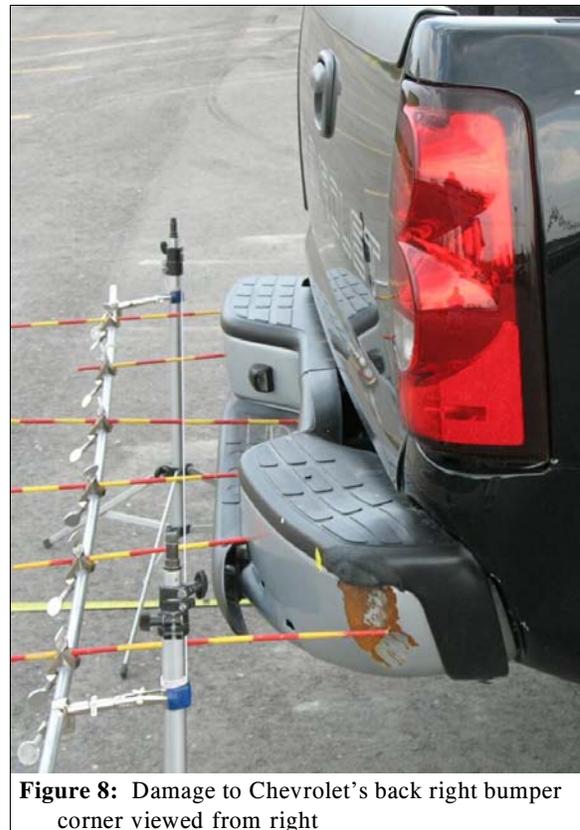
Figure 8: Damage to Chevrolet's back right bumper corner viewed from right

(2.4 inches) to the left (**Figure 8**). Crush measurements were taken on the back bumper and the residual maximum crush was 12 centimeters (4.7 inches) at C₆ (**Figure 9**). The table below shows the vehicle’s crush profiles.

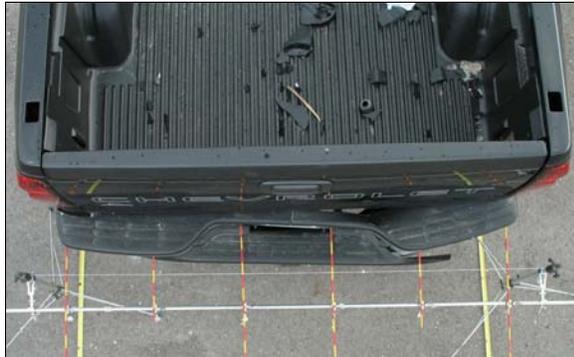
Figure 9: Overhead view of Chevrolet’s back crush profile with contour gauge set a bumper level

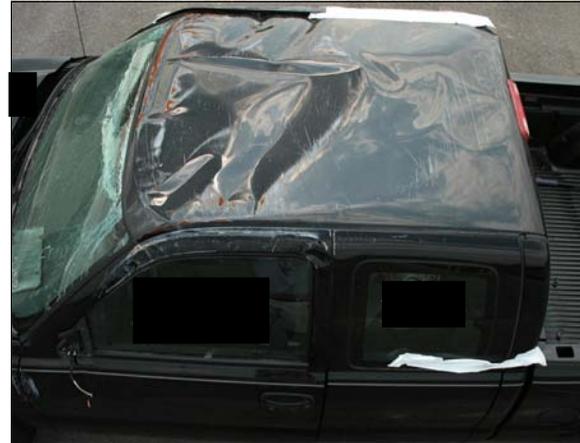
Figure 10: Overhead view from left of rollover damage to Chevrolet’s extended cab and windshield; Note: damaged left outside rearview mirror

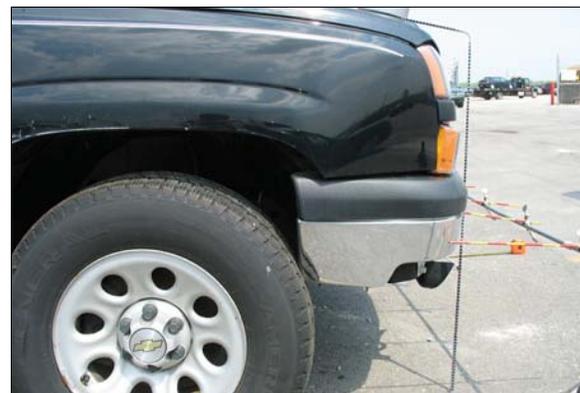
Figure 11: Chevrolet’s right front tire restricted by damaged front right bumper corner

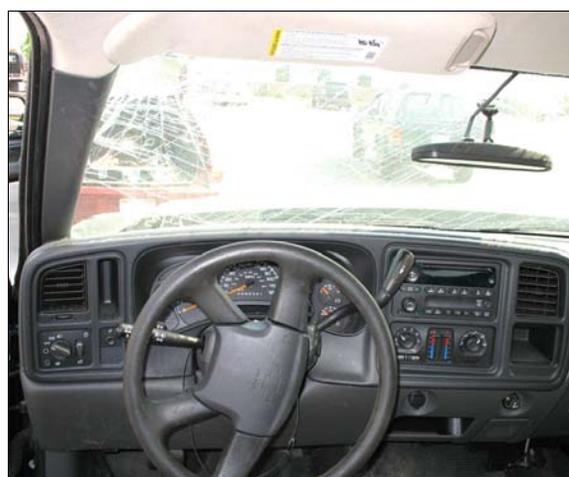
Vehicle Interior: Inspection of the Chevrolet’s interior (**Figures 12 and 13**) revealed only occupant contact evidence on the roof above the driver’s seat (**Figures 14 and 15**), consisting of a few hairs and a light scuff mark. The right B-Pillar intruded 7 centimeters (2.8 inches) laterally, and the roof intruded 6 centimeters (2.4 inches) vertically into the front right interior space. There was no evidence of steering rim deformation (**Figure 13**) or compression of the energy absorbing steering column.

Figure 12: Chevrolet’s driver seating area showing no apparent contact evidence on steering wheel, instrument panel, or greenhouse areas and non-deployment of driver’s air bag

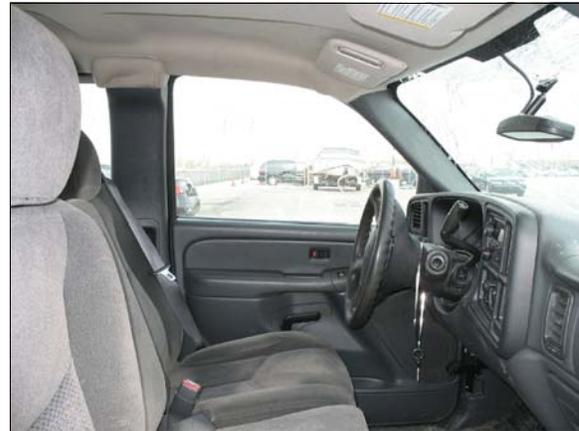
Figure 13: Chevrolet's driver seat area showing undeformed steering wheel rim and inside, windshield-mounted, rearview mirror broken off windshield by impact forces

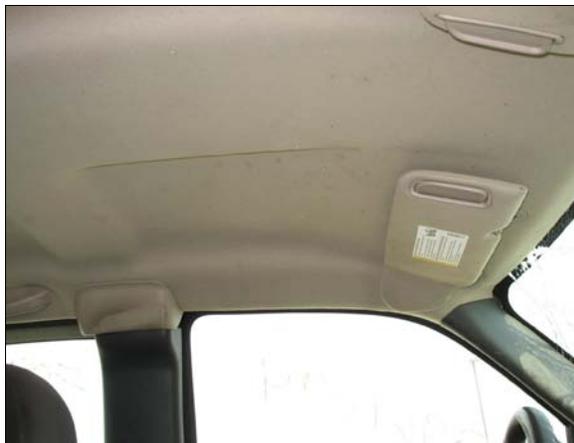
Figure 14: Chevrolet's roof above driver seating area showing evidence (hair, scuff) of occupant contact

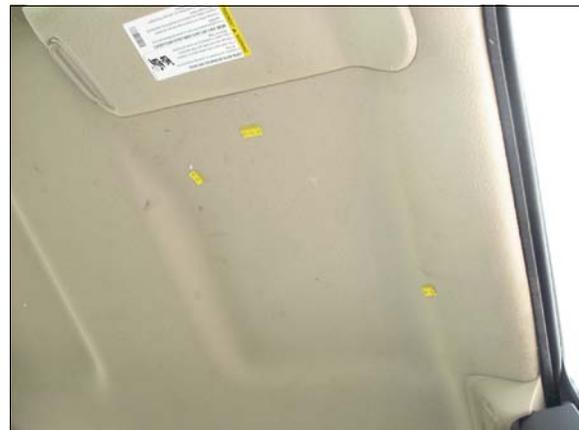
Figure 15: Frontal view of Chevrolet's roof above driver's seat with incremented tape showing area of hair and scuff mark on interior surface

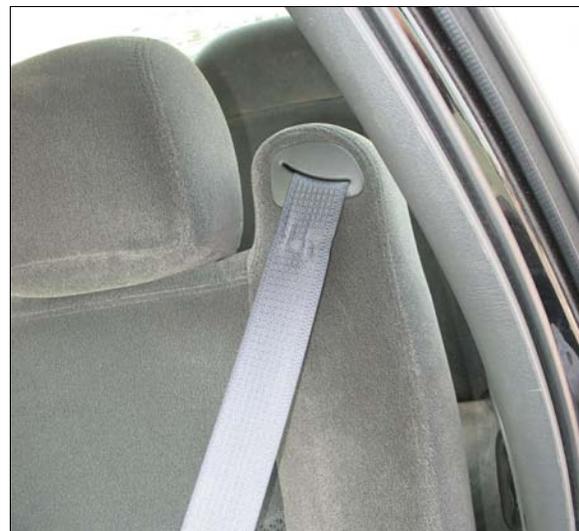
Both front row outboard seat belts exhibited indications of historical usage. The inspection of the driver’s safety belt webbing, shoulder belt guide, and latch plate revealed stretching due to loading as well as a pinch mark where the shoulder belt locked onto the integral belt guide (Figures 16 and 17).

Figure 16: Chevrolet’s driver safety belt webbing showing loading evidence (oblique pinch mark and stretching) near should belt guide

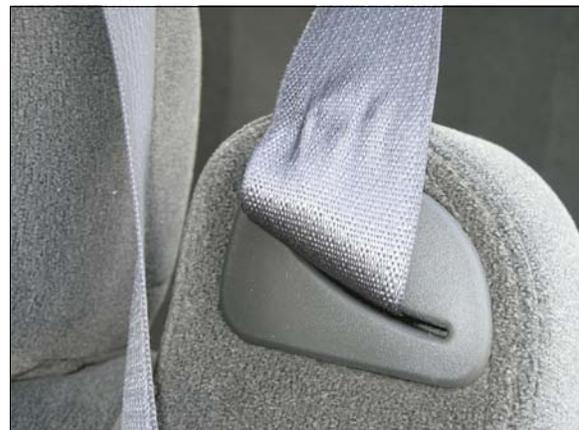
Figure 17: Stretch marks on underneath side Chevrolet’s driver safety belt near shoulder belt guide
