Certified Advanced 208 Compliant Air Bag Investigation
Dynamic Science, Inc. (DSI), Case Number DS08024
2006 Chevrolet Silverado C1500
Oregon
July 2008

**Dynamic Science, Inc.
Crash Investigation
Case Number: DS08024**

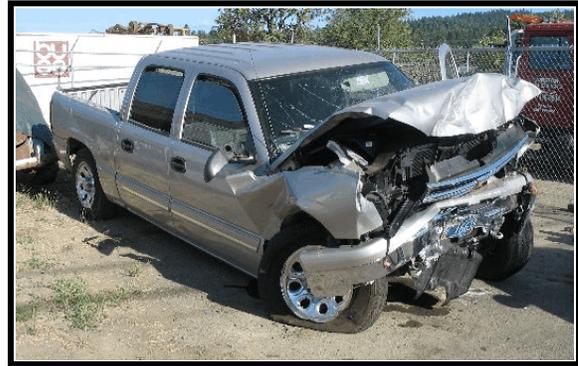
Figure 1. Subject vehicle, 2006 Chevrolet Silverado

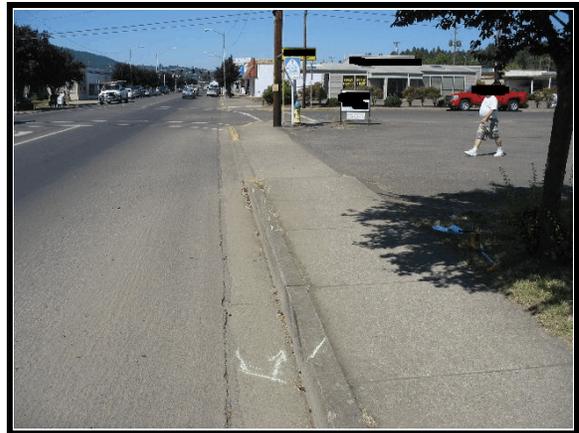
The 2007 Chevrolet Silverado was traveling westbound. It is this investigator's opinion that the driver had sustained a cardiac arrest was not in control of the vehicle. The Silverado departed the roadway on the right side 24.3 m (80 ft) east of the intersection (**Figure 3**), causing damage to the right front tire. After departing the roadway, the Silverado continued westbound, crossed the northern leg of the intersection, and entered a north/south oriented driveway. An on-scene witness reported that during the crash the subject vehicle did not display brake lights or take any evasive actions.

Figure 3. Area of right side roadway departure

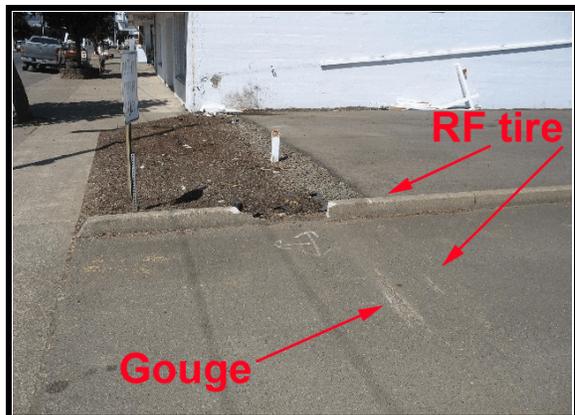
It is this investigator's opinion that the impact with second driveway curb caused the deployment event. The distance from the initial roadway departure and the second driveway curb impact was

Figure 4. Impact with driveway and second curb

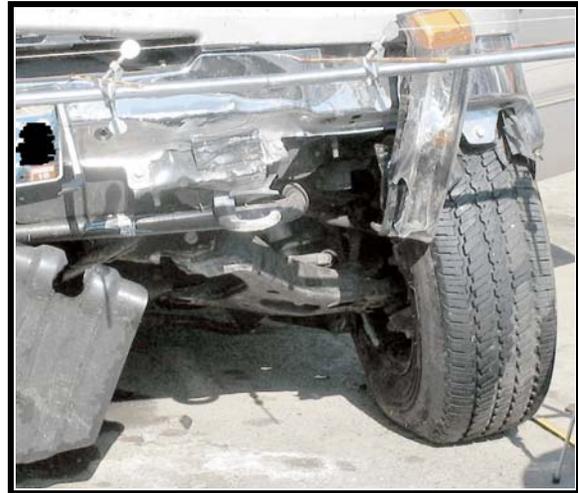
The 2006 Chevrolet Silverado sustained moderate undercarriage damage as a result of the impact with the ground and curb. There was direct contact to the lower A-arm on the left side and to the frame (**Figure 5**).

Figure 5. Front view, undercarriage damage

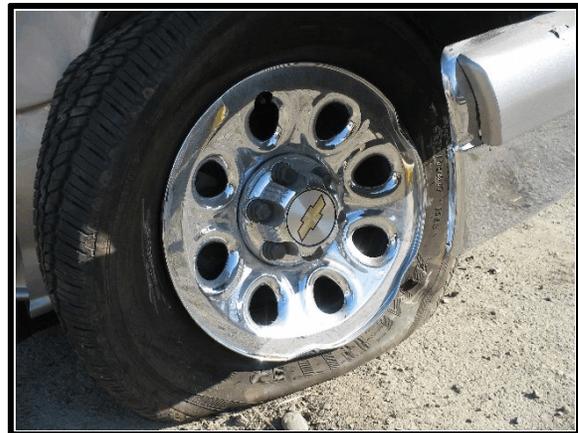
There were three separate areas of contact to the right front rim (**Figure 6**). All of the contacts probably came from curb impacts. The most significant contact measured 9 cm (3.5 in) wide along the rim. There was an associated hole in the sidewall at this location that measured 2 cm (0.8 in) vertically and 1 cm (0.4 in) laterally. This contact most likely occurred during the impact with the first curb. The two other contacts were also located along the rim and measured 8 cm (3.1 in) and 9 cm (3.5 in), respectively.

Figure 6. Contacts to right front tire/rim

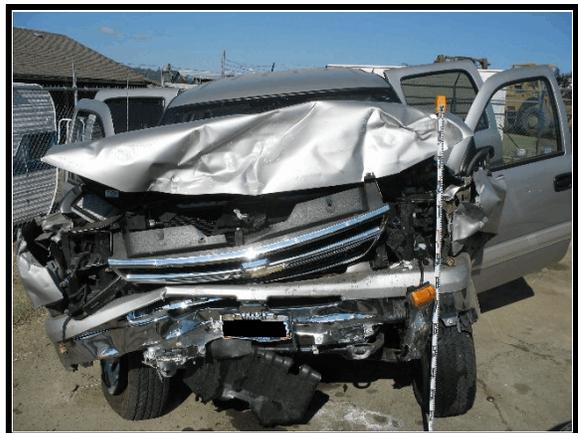
The Silverado sustained major frontal damage as a result of the impact with the building (**Figure 7**). The direct damage began at the right front bumper corner and extended 176 cm (69.3 in) laterally along the front end plane. The maximum crush was located at C4 and measured 63 cm (24.8 in). The entire front end was crushed rearward. The hood was deformed and displaced rearward. The left rear hood edge penetrated the left lower portion of the windshield. The penetration measured 8 cm (3.1 in) in depth, 10 cm (3.9 in) in width, and 8 cm (3.1 in) in height. Both front wheels were restricted. The wheelbase was shortened by 11 cm (4.3 in) on both sides. Six crush measurements were documented at the bumper level as follows: C1 = 54 cm (21.2 in), C2 = 56 cm (22.0 in), C3 = 59 cm (23.2 in), C4 = 63 cm (24.8 in), C5 = 48 cm (18.9 in), C6 = 42 cm (16.5 in). The CDC for the impact with the building was 12FDEW3.

Figure 7. Frontal damage

Damage from the pole impacts and the bushes could not be separated from the damage from the building.

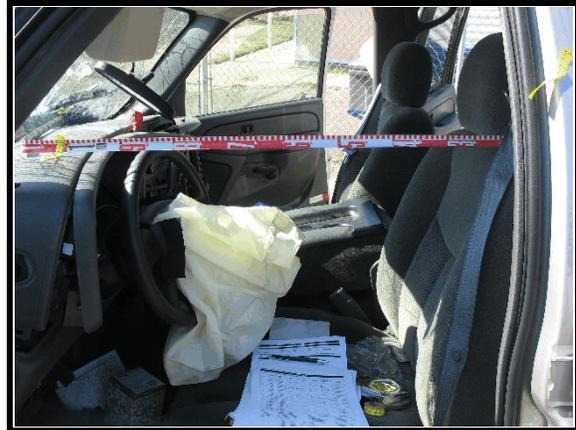
The 2006 Chevrolet Silverado sustained moderate interior damage as a result of passenger compartment intrusion (**Figure 8**). There was longitudinal intrusion of the toe pan and instrument panel. The glovebox was found in an open position during the inspection and would not close. The steering column was compressed 9 cm (3.5 in). The steering wheel rim was shifted 5 cm (1.9 in) to the left (**Figure 9**).

Figure 8. Side view of driver's seated position

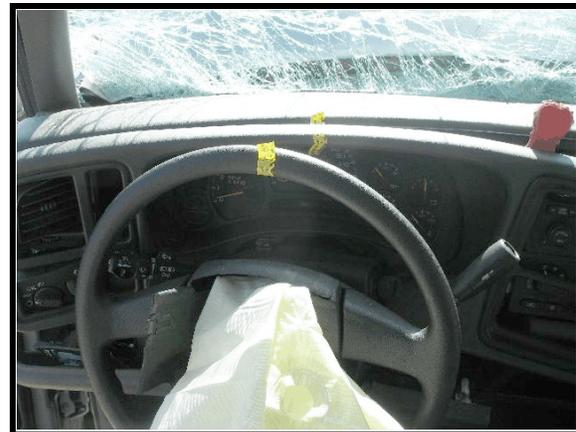
Figure 9. Lateral movement of steering wheel

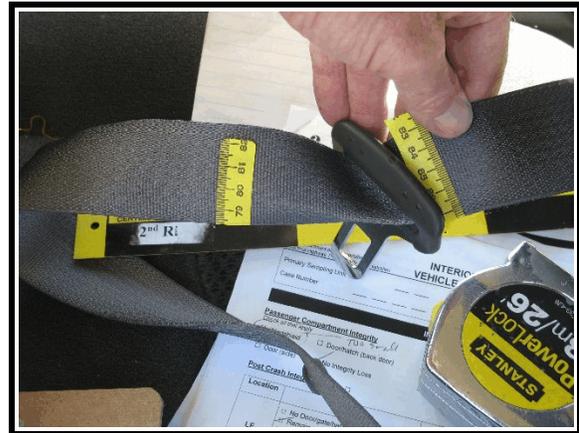
The 2006 Chevrolet Silverado was configured with 3-point lap and shoulder belts for the front outboard seats and the three rear seat positions. The driver's integrated safety belt was configured with a sliding latch plate and an Emergency Locking Retractor (ELR). The driver's safety belt webbing had curling which began 8 cm (3.1 in) from the stop button and measured 26 cm (10.2 in) in length. There was a 10 cm (3.9 in) area of loading to the safety belt webbing 67 cm (26.4 in) from the anchor (**Figure 10**). A 1 cm (0.4 in) x 3 cm (1.2 in) blood spot was located 116 cm (45.7 in) from the anchor.

Figure 10. Loading to seat belt webbing

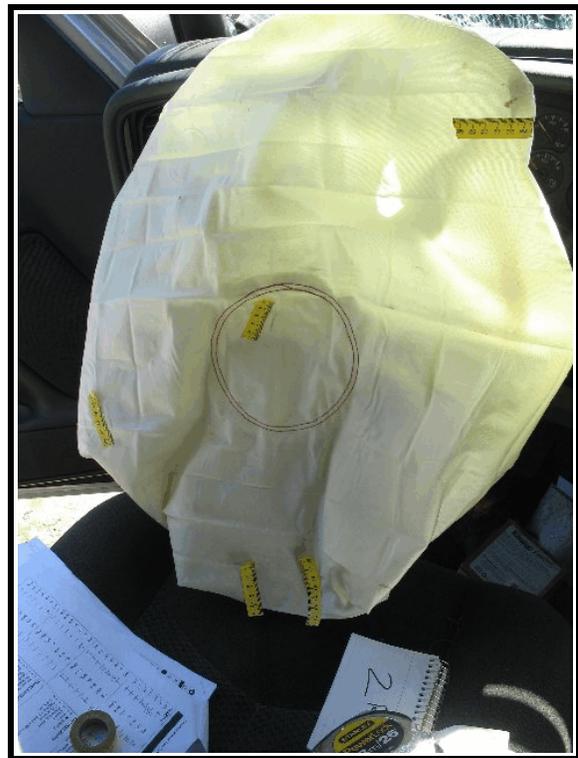
Figure 11. Deployed driver's air bag

The driver's air bag deployed from the center of the steering wheel hub through symmetrical I-configuration module cover flaps (**Figure 11**). Each flap measured 11.5 cm (4.5 in) in height and 6 cm (2.4 in) in width. The deployed driver's air bag measured 64 cm (25.2 in) in height and 53 cm (20.8 in) in width in its deflated state. The air bag was tethered by a single internal flap. The tether was attached to a 15 cm (5.9 in) diameter stitch in the center of the air bag face. Two circular vent ports that measured 3 cm (1.2 in) in diameter were located at the 11 and 1 o'clock aspects on the rear of the air bag. A light body fluid transfer that measured 2 cm (0.8 in) wide was present on the air bag face. The transfer was located 16 cm (6.3 in) to the right of the air bag center line and 2 cm (0.8 in) below the top edge of the air bag. A 3 cm (1.2 in) brown scuff was located in the left lower quadrant. A darker colored scuff that measured 5 cm (1.9 in) by 5 cm (1.9 in) was located at the bottom edge of the air bag face.
