**CALSPAN ON-SITE ROLLOVER CRASH INVESTIGATION**

**SCI CASE NUMBER: CA08033**

**VEHICLE: 2007 FORD EXPLORER EDDIE BAUER**

**CRASH DATE: JULY 2008**

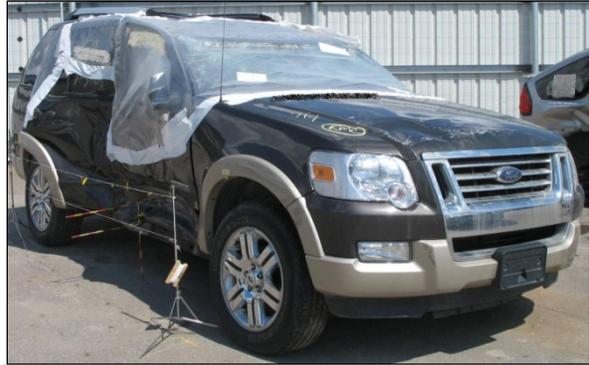
**Figure 1:** Right front oblique view of the Ford Explorer.

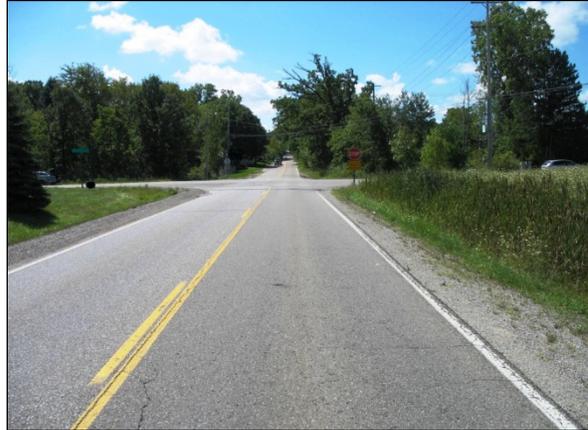
**Figure 2:** Southbound trajectory view of the Ford.

**Figure 2** depicts the southbound trajectory view of the Ford on approach to the intersection.

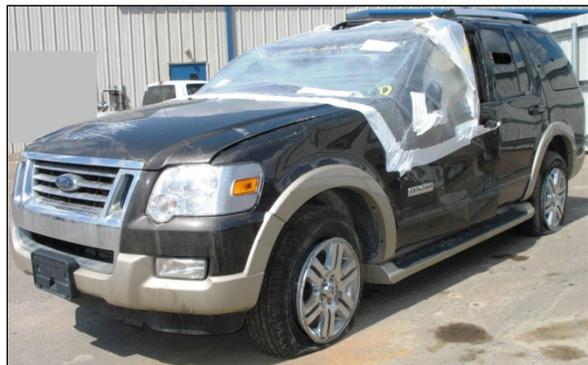
**Figure 3** provides a left front oblique view of the Ford. The electric odometer reading at the time of the SCI inspection could not be obtained due to vehicle damage. The Ford was powered by a 4.0-liter, V-6 gasoline engine linked to a 5-speed automatic transmission with on-demand four-wheel drive. The service brakes consisted of

**Figure 3:** Left front oblique view of the Ford.

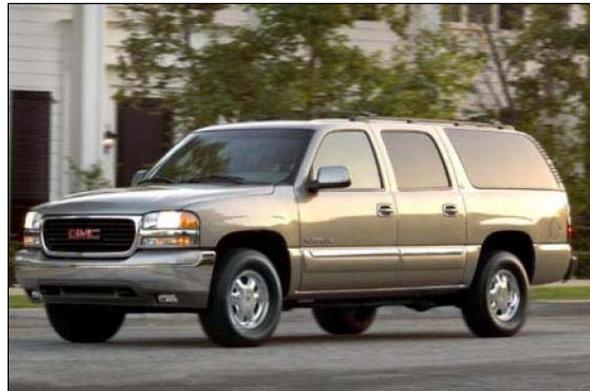
The 2004 GMC Yukon was identified by the VIN: 1GKGK26U14R (production sequence deleted). This four door, full-size sport utility vehicle had on-demand four-wheel drive capabilities, and was powered by a 3.7-liter, V-8 gasoline engine. The GMC had a 330 cm (130 in) wheelbase and was 492 cm (194 in) in overall length, similar to the exemplar depicted in **Figure 4**. The GMC was repaired and returned to its owner prior to the assignment of this case.

**Figure 4:** Exemplar GMC Yukon.

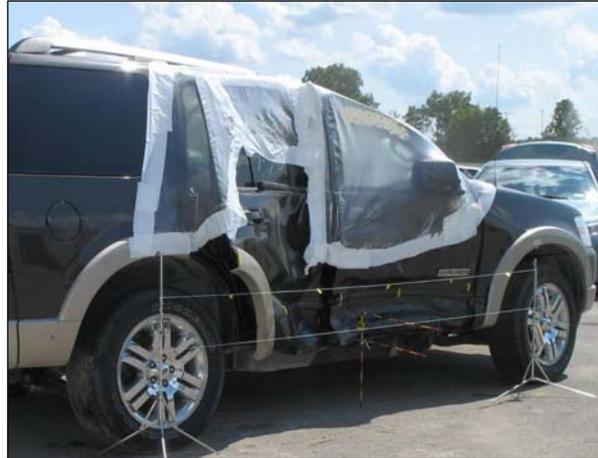
The exterior of the Ford sustained damage to its right, left, and top planes as a result of the side-impact and subsequent rollover sequence. The initial right side damage included the lateral crush and inward buckling of both passenger doors, extruded buckling of the rear aspect of the rear passenger door, lateral crush of the rear aspect of the right front fender aft of the axle, disintegration of the right front glazing, and displacement of the right rear glazing. This damage is depicted in **Figure 5**.

**Figure 5:** Side impact damage to the Ford.

The direct contact damage began 50 cm (19.6 in) aft of the right front axle and extended 156 cm (61 in) rearward. The combined direct and induced damage (Field L) began 15 cm (6 in) aft of the right front axle and extended 250 cm (98.5 in) rearward to the C-pillar. The residual crush measured along the right side at mid-door level was as follows: C1 = 0 cm [-14 cm (-8.5 in)], C2 = 8 cm (3 in), C3 = 17 cm (7 in), C4 = 22 cm (8.5 in), C5 = 13 cm (5 in), and C6 = 0 cm. Maximum crush was 24 cm (9.5 in), located at the edge of the right front door at the B-pillar. The right front door was opened post-crash and would not re-latch due to body distortion. The right rear door latch released during the crash. Due to the post-crash condition of the doors, the door-sill differential was 0 cm. The Collision Deformation Classification (CDC) associated with this damage pattern was 02RYEW3.

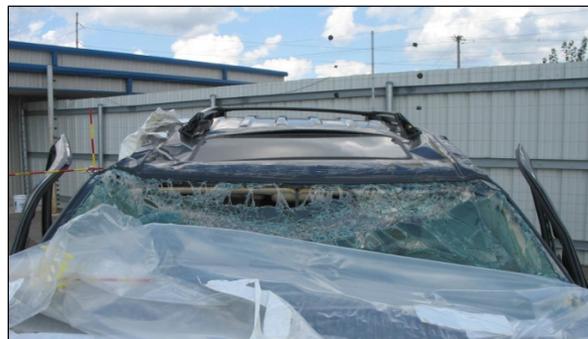
The rollover damage was located across the entire left and top planes of the Ford. The left front door and left front fender were crushed laterally, the left front glazing was disintegrated, and the windshield was shattered. Abrasions and scratches were located across the body surfaces on the left side, with isolated dents to the doors and left front fender. The non-horizontal impact forces sustained during the rollover sequence had crushed the windshield header downward, which displaced both A-pillars rearward at their intersection points with the roof side rail (**Figure 6**). This induced the downward buckling of the

**Figure 6:** Rollover damage to the Ford's roof.

roof at the forward aspect of the passenger greenhouse, however, the roof glazing located in this area was not damaged. There were abrasions and scratches located on the rails of the roof rack. The maximum roof crush was 13 cm (5 in) located at the right roof area between the roof glazing and the right A-pillar/side rail juncture. There was no lateral displacement of the roof structure. The CDC corresponding to the rollover damage was determined to be 00TDDO3.

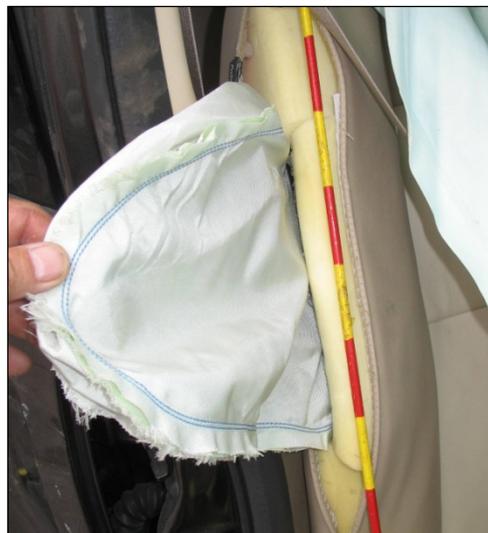
**Figure 7:** Right front seatback-mounted air bag.

The side impact air bag system consisted of front seatback-mounted air bags and the roof rail-mounted IC air bags. The IC air bags were commanded to deploy through side impact crash sensing and rollover sensing. This crash resulted in the deployment of the right seatback-mounted air bag (**Figure 7**) and both IC air bags. This air bag was constructed of Automotive Safety Components International (ASCI) recognized PA 6.6 nylon material and had deployed through 43 cm (17 in) of the outboard seam stitching. The foam padding of the seatback was spilt over a vertical height of 24 cm (9.5 in). The interior cover flap of the side impact air bag module measured 20 cm (8 in) vertically and 6 cm (2.5 in) laterally.

The seatback-mounted air bag, in its deflated state, measured 24 cm (9.5 in) vertically by 22 cm (8.5 in) horizontally. It was vented by a 3 cm (1 in) vent port that was centered 5 cm (2 in) from its leading edge. The side impact air bag was not tethered. Maximum lateral excursion of the air bag measured 8 cm (3 in). There was no evidence of occupant contact on the air bag at the time of SCI inspection.

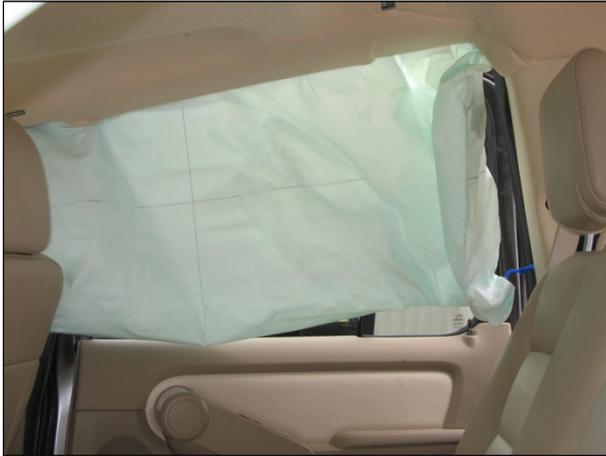
The rear tether of the IC was mounted to a metal guide within a vertically oriented track that was attached to the C-pillar. This guide was designed to slide vertically downward as the bag deployed, maintaining rear coverage of the IC during system deployment. The SCI team noted a discrepancy in the deployment of this system when comparing the left and right. The right side IC deployed full height, while the left IC guide snagged within the track. This had result in partial coverage of the left rear door glazing, as seen in the comparison of **Figure 8** to **Figure 9**.

**Figure 8:** Right inflatable curtain air bag.

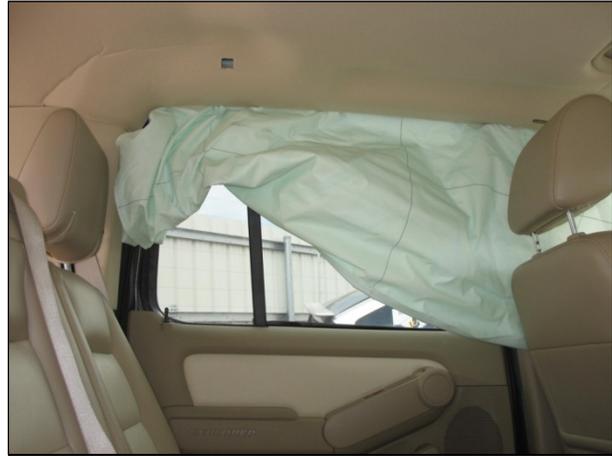
**Figure 9:** Left inflatable curtain air bag.

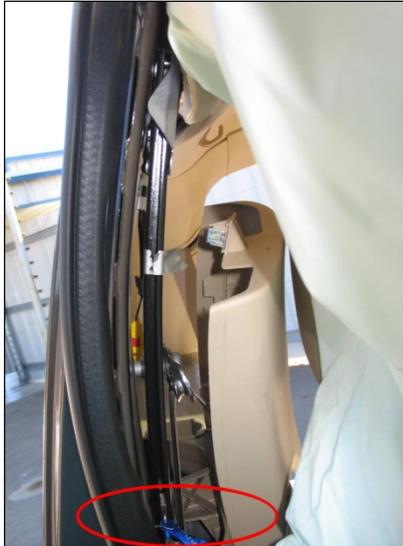
The rear tether of the left IC had snagged on a metal bracket that was affixed to the C-pillar, which had prevented the full deployment of the rear aspect of the IC. This is depicted in **Figures 10** and **11**, which depict the properly deployed right tether and the snagged left tether, respectively (*note the location of the tethers and their corresponding track locations*).

**Figure 10:** Right IC rear tether track.

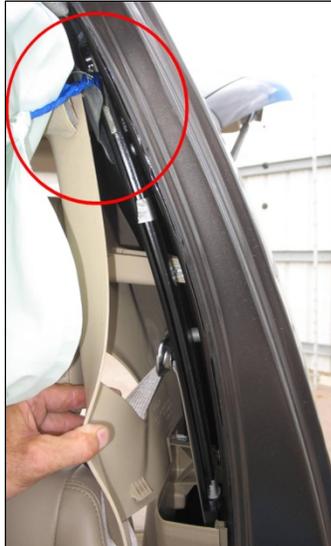
**Figure 11:** Left IC rear tether track.

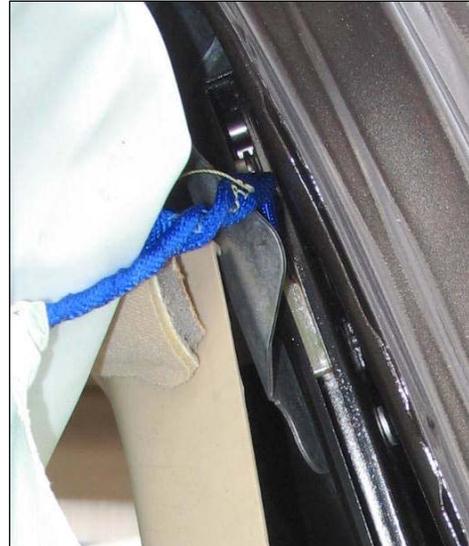
The metal bracket was stamped with the numeric 6690, and was part of the mounting bracket for the upper aspect of the tether track. The SCI team measured a protrusion of 1.4 cm (9/16 in) of the bracket past the centerline of the track, shown in **Figure 12**.

**Figure 12:** Rear tether of left IC snagged on metal bracket.

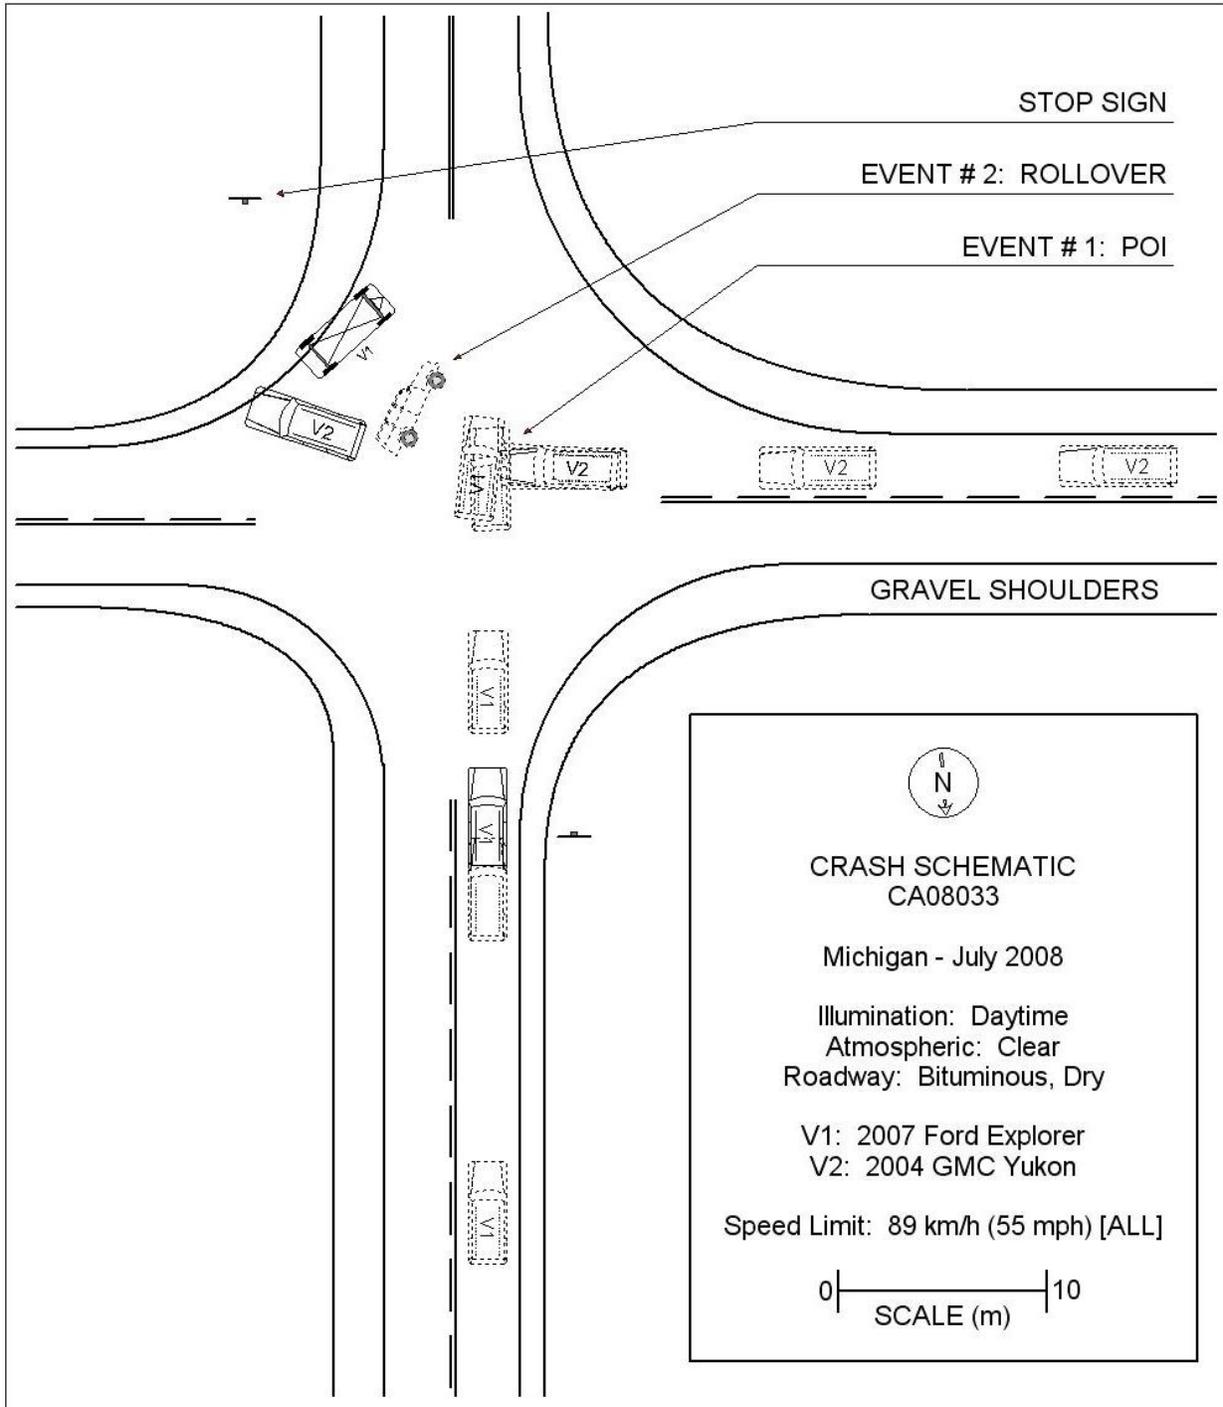
**Figure 13: Crash Schematic**

The GMC was eastbound in the 3.1 m (10 ft) wide travel lane of the 6.2 m (20 ft) wide, two-and-a-half percent downward sloping (-2.5%) bituminous two-lane undivided roadway. Lane delineation consisted of a centerline that permitted passing for eastbound traffic. There was a 2.1 m (7 ft) wide gravel shoulder supporting the eastbound travel lane, separated from the roadway by a solid white fog line. The Crash Schematic is included as **Figure 13** of this report.
