INDIANA UNIVERSITY

ON-SITE CHILD SAFETY SEAT INVESTIGATION

CASE NUMBER - IN08046
LOCATION - OHIO
VEHICLE - 1998 CHEVROLET MALIBU LS
CRASH DATE - November 2008

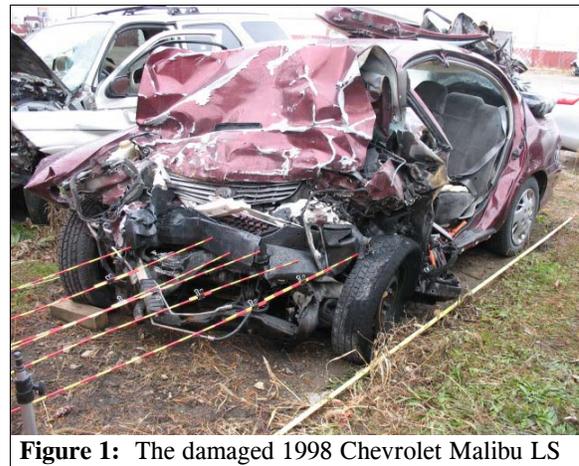
Figure 1: The damaged 1998 Chevrolet Malibu LS

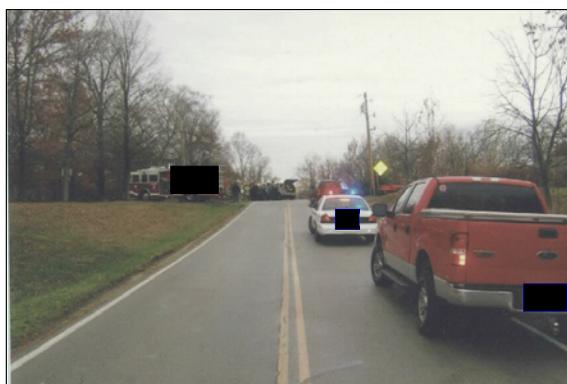
Figure 3: Police on-scene photo showing Ford's approach to impact area and final rest positions of both vehicles

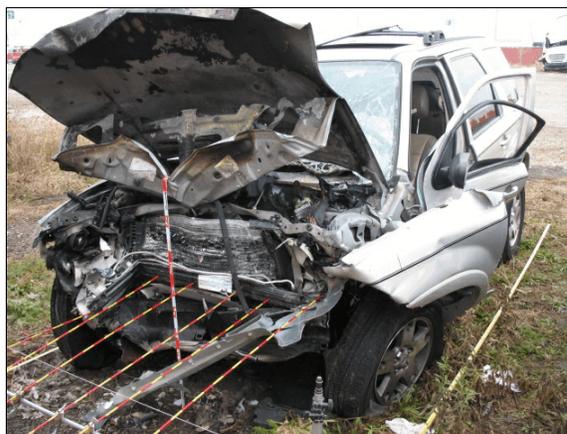
Figure 4: Damage to the front of the Ford from impact with the front of the Chevrolet

Exterior Damage: The Ford's impact with the Chevrolet involved the entire front plane. The direct damage involved the left fender, front bumper, grille, and hood (**Figure 4**). The direct damage began at the front left bumper corner and extended 119 cm (46.9 in) across the front bumper. The maximum residual crush was 78 cm (30.7 in) occurring at C₃. The table below shows the vehicle's front crush profile.

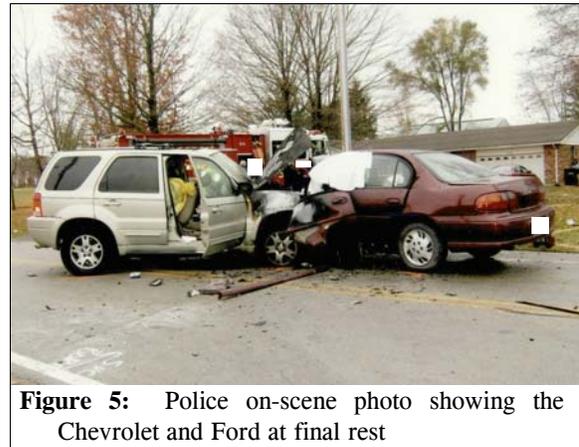
Figure 5: Police on-scene photo showing the Chevrolet and Ford at final rest

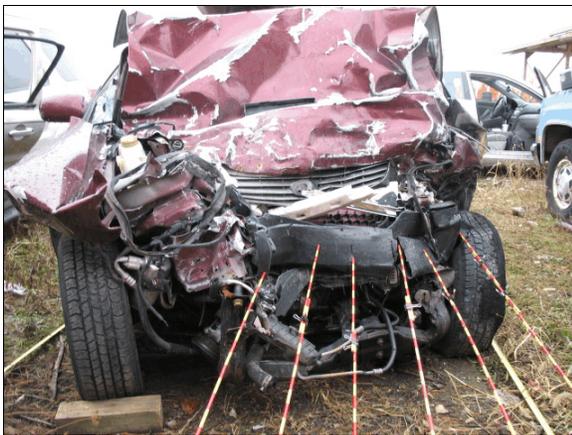
Exterior Damage: The Chevrolet’s impact with the Ford involved the front plane (Figure 6). The bumper, bumper fascia, grille, hood, both turn signal and headlamp assemblies, left fender, left front wheel, left front door, and left A-pillar were all directly damaged. The direct damage began at the front left bumper corner and extended 125 cm (49.2 in) along the bumper. The crush measurements were taken on the front bumper and the maximum residual crush was 146 cm (57.5 in) occurring at C₁ (Figure 7). The table below shows the vehicle’s front crush profile.

Figure 6: Damage to front plane of the Chevrolet from the impact with the front of the Ford

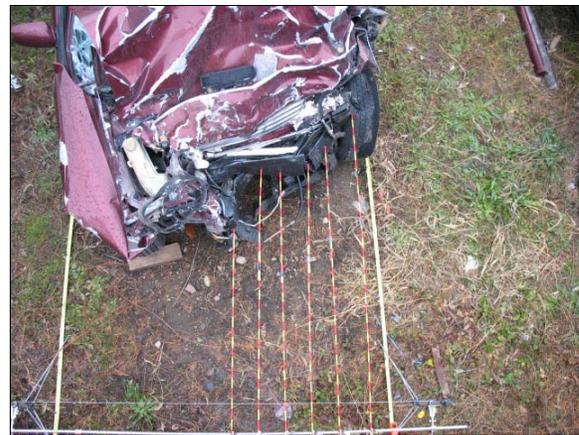
Figure 7: Overhead view of Chevrolet’s front crush profile

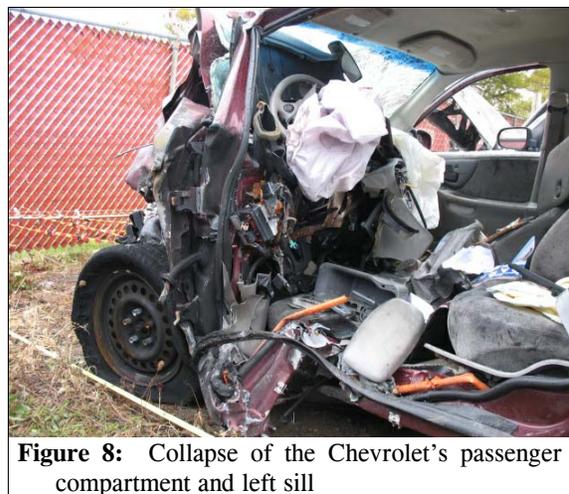
Figure 8: Collapse of the Chevrolet’s passenger compartment and left sill

The Chevrolet sustained significant passenger compartment intrusions into the front row, which all occurred on the longitudinal axis. The most severe intrusions occurred in the driver's space and involved the left A-pillar, toe pan, and instrument panel. The left A-pillar and toe pan intruded 63 cm and 58 cm (24.8 in and 22.8 in), respectively. The left and center instrument panel intruded 48 cm and 52 cm (19 in and 20 in), respectively. The second row seat back was loaded by an object in the trunk. The seat back intruded longitudinally into the left, middle, and right seating positions 12 cm, 20 cm, and 10 cm (4.7 in, 7.9 in, and 3.9 in), respectively.

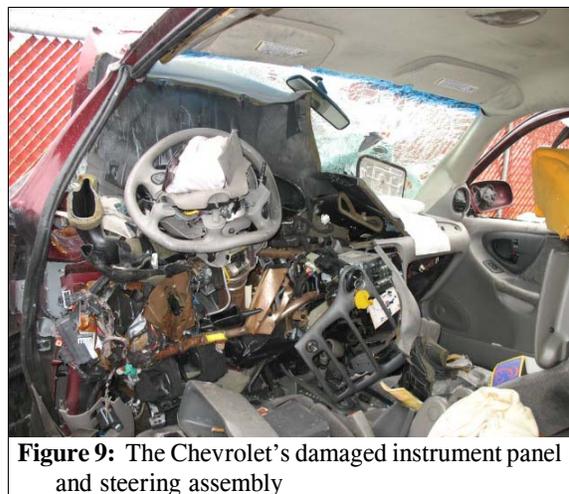
Vehicle Interior: Inspection of the Chevrolet’s interior revealed occupant contacts on the driver’s air bag, steering wheel, and lower instrument panel (**Figure 9**). The steering wheel rim was completely collapsed and the steering column was displaced vertically due to loading by the driver. The instrument panel was significantly deformed on both sides of the steering column due to loading by the driver’s knees. There was no discernable evidence of occupant contact in the second row.

Figure 9: The Chevrolet's damaged instrument panel and steering assembly

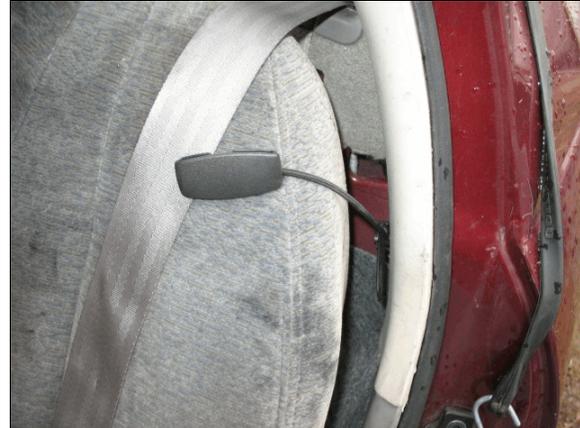
Figure 10: Shoulder belt clip attached to elastic tether cord for second row left seat belt

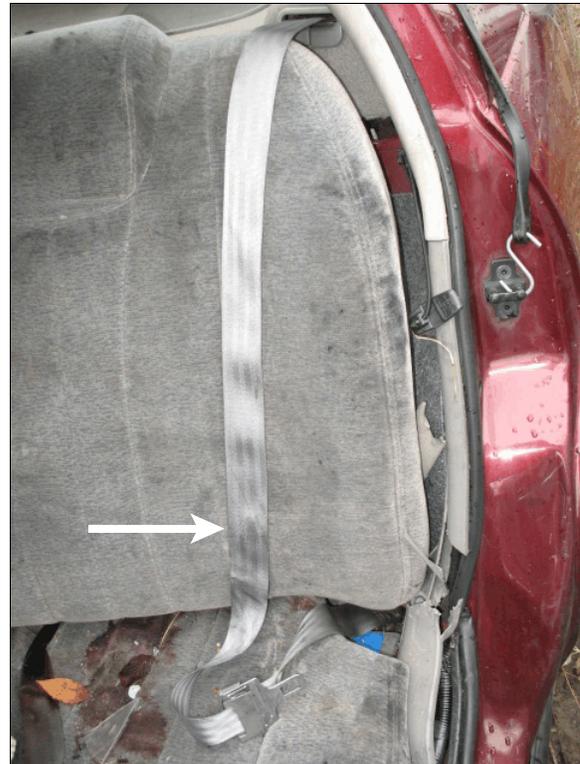
The inspection of the second row left passenger's seat belt assembly revealed historic usage scratches on the latch plate, stretched belt webbing (**Figure 11**), and a jammed retractor. The stretched condition of the webbing and the jammed retractor indicated that the second row left passenger's FSS was secured by the lap-and-shoulder belt at the time of the crash.

Figure 11: Arrow shows stretched belt webbing of second row left seat belt

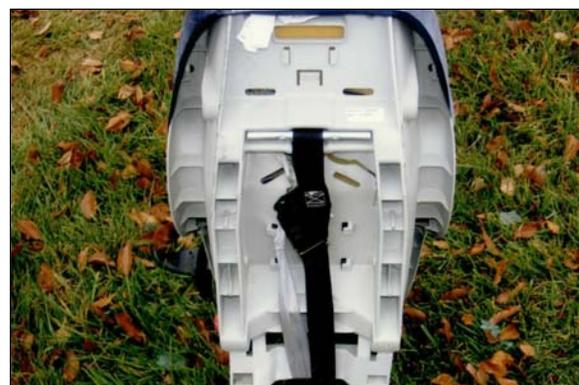
Figure 16: Damage on back of second row right CSS

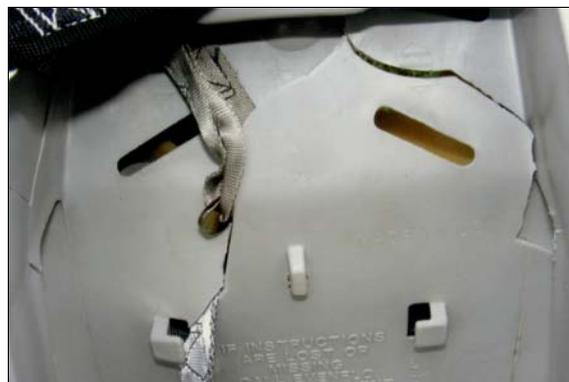
covered foam pad. It was equipped with a 5-point harness, harness retainer clip, and a tether strap. The CSS had three sets of harness slots and the harness straps were threaded through the middle slots. The top harness slots were reinforced for forward facing use, while the middle and lower slots are not reinforced. Since the harness straps were routed through the middle slots, the plastic shell fractured due to the passenger loading the harness straps during the crash (**Figures 16 and 17**) and the splitter plate was stuck within the shell. The damage to the plastic shell was confined to this area (**Figure 17**).

Figure 17: Close view of damage to the shell of the second row right CSS

The Chevrolet's impact with the Ford displaced the second row right passenger forward, opposite the 12 o'clock direction of force. He loaded the CSS harness, which was routed through the unreinforced middle harness slots, and the CSS's plastic shell fractured displacing the harness straps from the harness slots. The passenger sustained lung contusions, fractured right and left clavicles, and compression fractures of T₁₂, L₁, and L₂ due to loading the harness straps. While there was no discernable evidence of occupant contact on the front right seat back, the passenger's left leg probably loaded the seat back, which resulted in fractures of the distal tibia and fibula. He rebounded and his head loaded the CSS's seat back. The passenger sustained a small intraventricular hemorrhage, probably due to this contact. The passenger's medical records indicated that he was taken out of vehicle while still in his CSS.
