ROLLOVER CRASH INVESTIGATION

SCI CASE NO. - CA09001

VEHICLE – 2007 FORD F150 CREW CAB PICKUP TRUCK

CRASH DATE – APRIL 2008

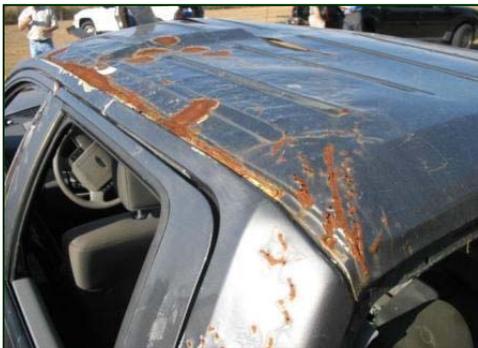
Figure 4. Partially repaired damage of the left roof side rail and C-pillar area.

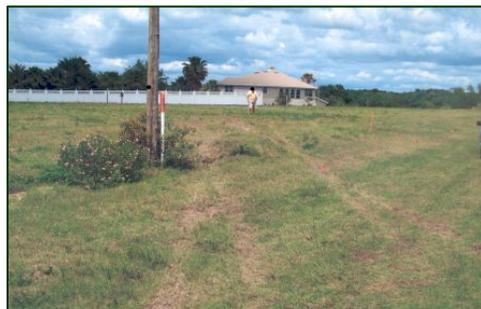
Figure 6. F150 CCW yaw marks across the grass roadside (Image courtesy of the driver).

Based on a review of these CCW yaw marks, the vehicle rotated approximately 90 degrees CCW as it traversed the shallow drainage ditch. The front of the F150 narrowly missed a wooden utility pole and an underground utility marker. The vehicle continued to yaw CCW across the wet grass surface before the right side tires either de-beaded or furrowed into the sandy soil that tripped the F150 into a lateral right side leading rollover event. It was estimated that the F150 rotated approximately 110 degrees CCW prior to the trip point. The length of the CCW yaw marks was not documented during the police investigation. These yaw marks eroded prior to this SCI investigation due to the extended period of time between the crash date and the investigation date.

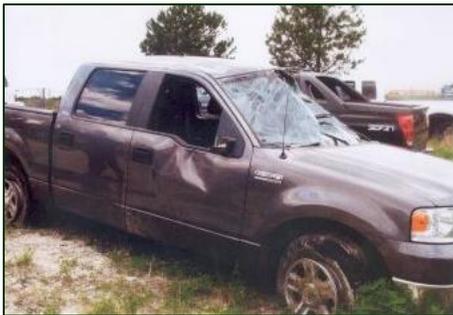
Figure 7. Right side rollover damage to the F150 (Image provided by the driver's attorney).

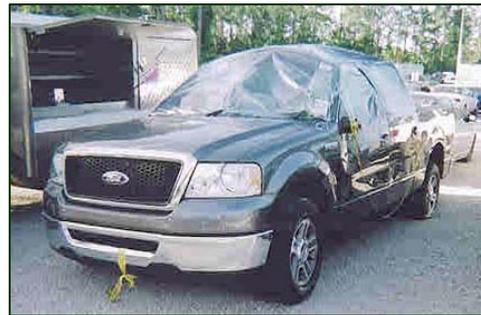
The Ford F150 rolled to its right across the grassy area. The left roof side rail area sustained the greatest extent of roof damage, estimated at several inches of vertical crush with a matching extent of lateral crush at the left B-pillar area. The vehicle overturned an estimated five-quarter turns before coming to rest on its right side an unknown distance from the trip point. In addition to the sheet metal crush, the windshield was cracked and holed at the left header area. The left side door glazing and the right front door glazing disintegrated during the rollover. The right rear door glazing remained closed and intact. The fixed backlight glazing was not damaged.

Figure 8. Left side rollover damage prior to the noted repairs (Image provided by the driver's attorney).

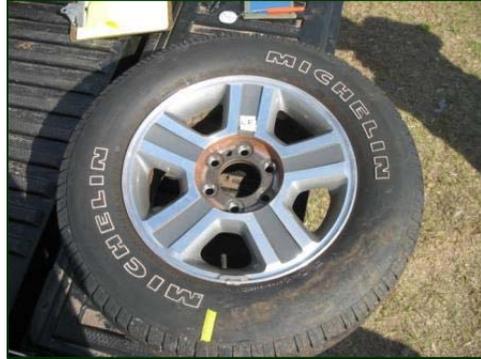
Figure 11. Left front tire and wheel.

Tire - The left front tire was found inflated and the bead was fully engaged against the aluminum wheel. This tire was the only tire on the vehicle that remained inflated during and after the rollover crash. The Tire Identification Number (TIN) for this tire was DOT M3LT H7WX 5306. The tire pressure was measured at 10 kPa (1.5 PSI) using an Accutire digital tire pressure gauge. The tread depth averaged 8 mm (10/32”) with a minimum depth of 7 mm (9/32”) located in the outboard groove in the vicinity of the tire valve stem and a maximum depth of 9 mm (11/32”) measured at the third groove from the outboard side 180 degrees from the referenced stem. There was no damage to the sidewalls or to the tread area of the tire (**Figure 11**).

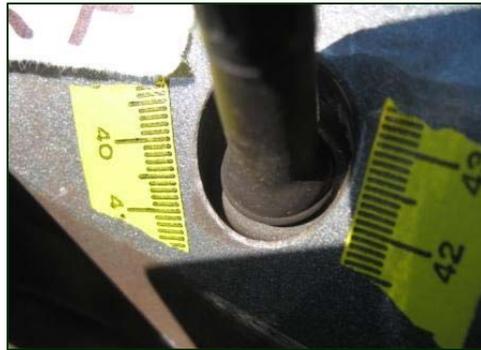
Figure 12. Left front tire valve stem.

Valve Stem - The left front rubber snap-in tire valve stem was intact with no visible damage or cracking (**Figure 12**). The manufacturer identification on the bottom of the stem is unknown as the tire remained inflated and the bead was fully seated, thus preventing a visual inspection of the stem.

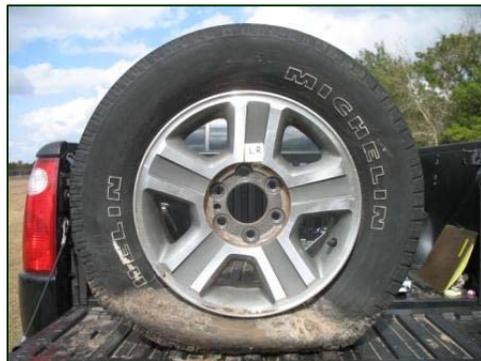
Figure 13. Left rear tire and wheel.

Tire - The left rear tire (**Figure 13**) was flat and de-beaded from the aluminum wheel rim at the time of the SCI inspection. Images of the vehicle on the day or days following the crash were provided to the SCI investigator and depicted the left rear tire in the same flat and de-beaded condition. The TIN for this tire was DOT M3LT H7WX 0507. The measured tread depth was 6 mm (7/32”) uniformly across all four grooves at various regions of the tread. The outer

sidewall of the tire had superficial gouges and abrasions that possibly resulted from the rollover event, or from previous contact with an unknown object. These gouges and abrasions were superficial to the sidewall.

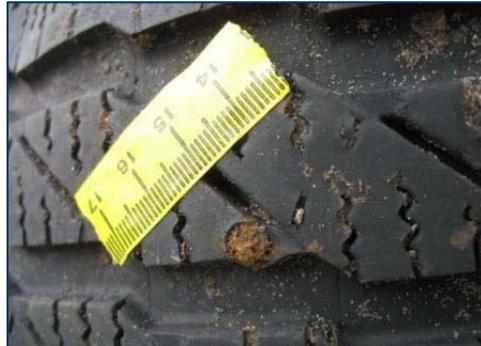
A rusty metal object resembling a nail was present in the tread and was located in the second row tread rib from the outboard aspect of the tire (**Figure 14**). Viewing the outboard aspect of the tire, this object was located approximately 140 degrees clockwise from the valve stem. It is unknown if this metal object resulted in air loss.

Figure 14. Steel object in the tread of the left rear tire.

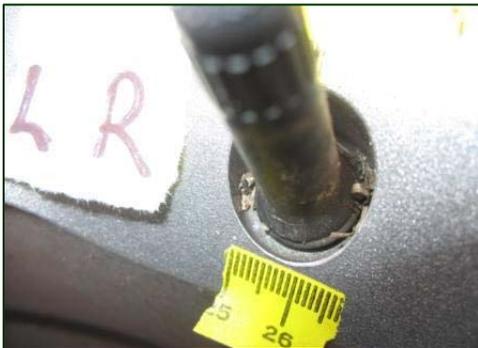
Valve Stem – The rubber snap-in valve stem was in place in the wheel rim and exhibited a laterally oriented crack at the base of the stem, immediately above the wheel on the inboard aspect of the stem (with respect to the wheel). A second laterally oriented crack of approximately 4 mm in length was located on the flare of the stem above the previously mentioned crack (**Figure 15**). A mirror was positioned on the inside aspect of the wheel rim to obtain the identification numbers from the stem. The identification appeared to be 08TR4 with the remainder of the characters abraded from probable interaction of the tire bead (**Figure 16**).

Figure 15. Lateral cracking of the left rear valve stem.

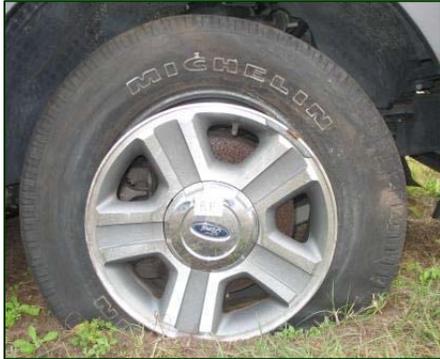
Tire – The right front tire (**Figure 17**) was flat and de-beaded from the OEM wheel rim. The TIN was DOT M3LT H7WK 0507. The tire tread depth was 6 mm (7/32”) and was uniform across the tread. There were no defects or visible punctures of the tire tread. The outboard sidewall of the Michelin tire was gouged at both midpoints

of the raised white letters MICHELIN. These gouges did not penetrate the sidewall of the tire.

Figure 17. Right front tire and wheel rim prior to removal from vehicle.

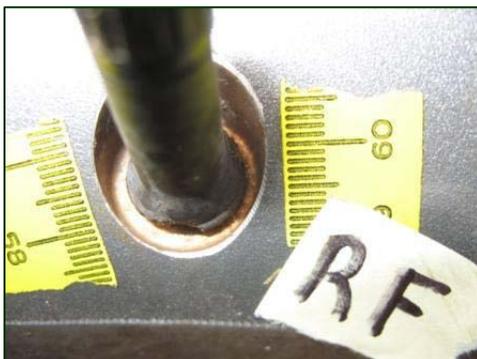
Valve Stem – The right front valve stem was intact within the aluminum wheel rim. The outboard base of the stem at the bell-shape was cracked with minimal loss of rubber material (**Figure 19**). The stem appeared to be gouged; however, there was no damage to the surrounding aluminum wheel rim to support contact with a hard surface. Without flexing the rubber stem, no linear cracks to the stem were visible.

Figure 19. Crack/gouge to the base of the right front valve stem.

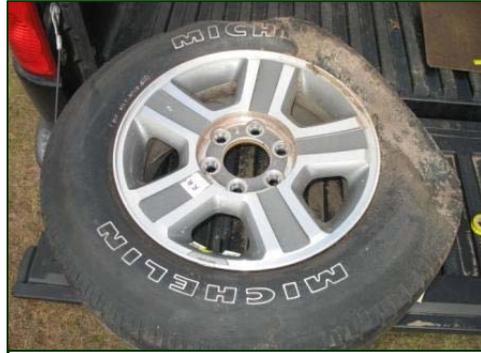
Figure 21. Right rear tire and wheel.

Tire – The right rear tire was flat with the inner and outer beads engaged against the wheel rim. The tire was identified by the following TIN: DOT M3LT H7WX 0407. The tire tread depth averaged 6 mm (7/32”) with the third rib yielding a depth of 6 mm (8/32”). There was no visible damage to the tread or sidewall surfaces of the tire (**Figure 21**).

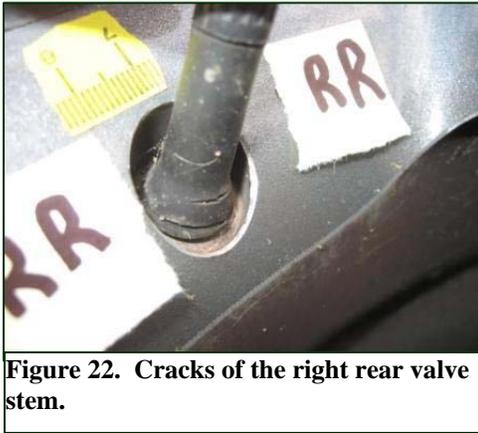
Valve Stem – The rubber valve stem was intact and fully engaged in the bore of the aluminum wheel rim. The shaft of the stem was cracked at the flare. The top of the stem was moved approximately 6-13 mm (0.25-0.5”) by the SCI investigator to open the linear crack for photographic purposes. The stem was also cracked at the base on the outboard aspect of the wheel rim. **Figures 22 and 23** are of the cracks to the right rear valve stem. Due to the engagement of the tire bead against the alloy wheel, the identification numbers of the stem could not be obtained.

Figure 22. Cracks of the right rear valve stem.

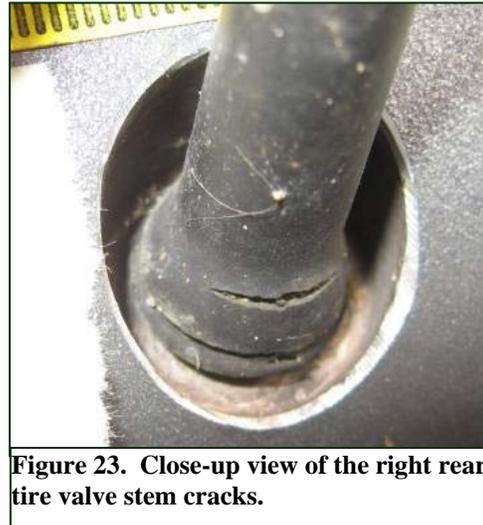
Figure 23. Close-up view of the right rear tire valve stem cracks.
