**CALSPAN ON-SITE SIDE IMPACT INFLATABLE OCCUPANT
PROTECTION SYSTEM CRASH INVESTIGATION
SCI CASE NO: CA09003**

VEHICLE: 2008 CHEVROLET IMPALA

LOCATION: NEW YORK

CRASH DATE: JANUARY 2009

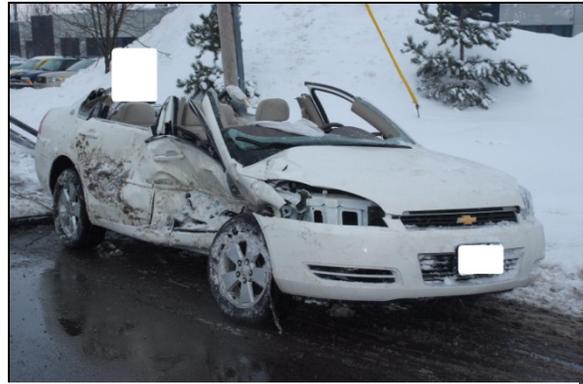
Figure 1: Right front oblique view of the 2008 Chevrolet Impala. Image supplied by the police investigator.

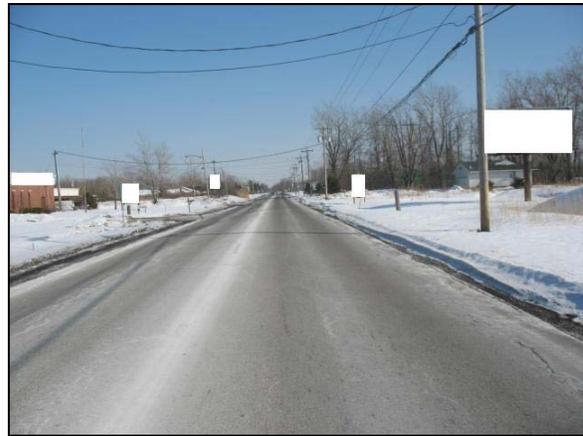
Figure 2: Eastbound view of the Chevrolet's pre-crash path of travel.

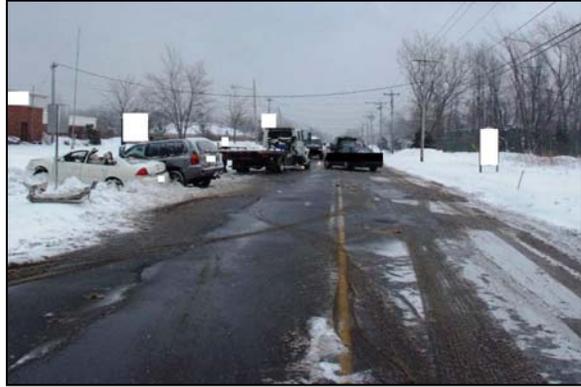
Figure 3: On-scene final rest positions of the Chevrolet and GMC. Image supplied by the police investigator.

The force of the impact, forward of the Chevrolet's center of gravity, caused this vehicle to rotate counterclockwise approximately 55 degrees before coming to final rest (**Figure 3**). The GMC's forward momentum was altered laterally from impact forces which produced a clockwise rotation of approximately 55 degrees before arriving at final rest. The Chevrolet came to final rest on the north side of the roadway approximately 8 m (26.2 ft) west of the west side of the driveway. The GMC came to final rest adjacent to and immediately east of the Chevrolet.

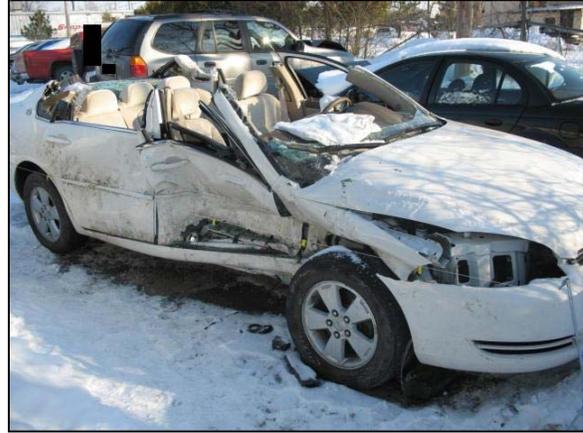
The exterior of the Chevrolet sustained right side-plane damage as a result of the crash sequence. The direct contact damage measured 149 cm (58.7 in). This direct damage extended from the right/front fender to the B-pillar area and included the right/front wheel. The vertical aspect of the direct damage ranged from the sill to the beltline area. The impact forces resulted in lateral and longitudinal deformation of the left/front door and front fender components but did not produce any vehicle shifting. The right wheelbase was measured to be 5 cm (2 in) shorter and the left wheelbase was measured to be 2 cm (0.8 in) longer than the manufacturer's original specification. The damage profile (**Figure 4**) measured 290 cm (114.2 in) between deflection points. The residual crush profile was measured at the mid-door level and its results are as follows: C1 = 2 cm (0.8 in), C2 = 16 cm (6.3 in), C3 = 46 cm (18.1 in), C4 = 55 cm (21.7 in), C5 = 24 cm (9.4 in), C6 = 7 cm (2.8 in). The maximum crush was located at C4. The Door Sill Differential (DSD) measured 25 cm (10 in) on the mid-aspect of the right front door. Refer to **Figure 5**. The left/front door remained closed and operational, however, all other doors were found to be jammed shut at the time of the SCI inspection. The roof support pillars were cut and the roof was removed during the extrication of the occupants. The Collision Deformation Classification assigned to this damage pattern was 02RYEW3.

Figure 4: The right side crush profile of the Chevrolet.

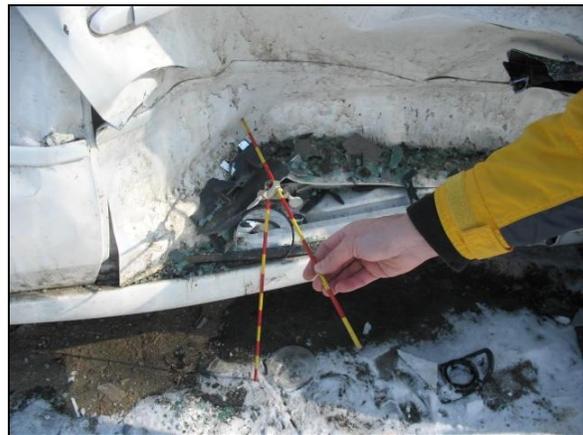
Figure 5: The right side crush profile of the Chevrolet.

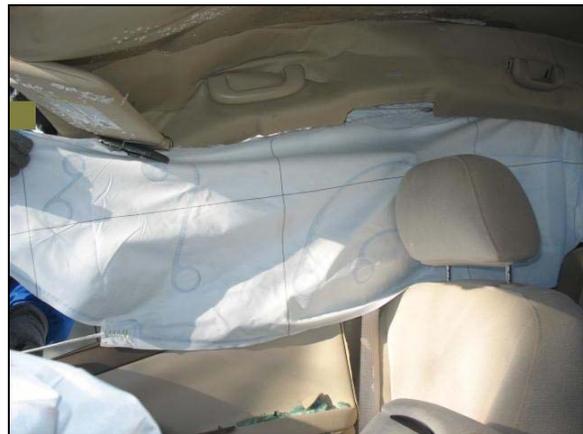
The Chevrolet was equipped with side impact IC air bags mounted to the roof side rails. Both ICs deployed as a result of the impact. The IC air bags (**Figure 6**) measured 175 cm x 41 cm (68.9 in x 16.1 in) length x height in overall dimensions and provided coverage from the upper aspect of the A- to C-pillar area. A 26 cm (10.2 in) long tether extended from the A-pillar and was sewn to the forward aspect of the bag. The vertical coverage of the curtain extended 12 cm (4.7 in) below the beltline in both the front and second rows.

Figure 6: Left side IC airbag in Chevrolet.

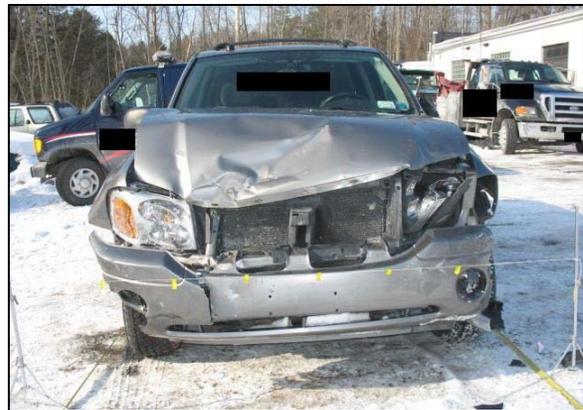
The exterior of the GMC sustained distributed front end-plane damage as a result of the crash sequence. The direct contact damage measured 164 cm (64.6 in) and included the bumper fascia, radiator/grill, both head-light assemblies and frontal aspects of both the hood and front fenders. The impact forces resulted in longitudinal deformation to the front bumper reinforcement, radiator, engine compartment and hood. The left wheelbase was reduced 3 cm (1.2 in). The combined crush profile (**Figure 7**) was measured along the bumper reinforcement bar and its results are as follows: C1 = 6 cm (2.4 in), C2 = 3 cm (1.2 in), C3 = 10 cm (4 in), C4 = 11 cm (4.3 in), C5 = 6 cm (2.4 in), C6 = 2 cm (0.8 in). The maximum crush was located at C4. The Collision Deformation Classification assigned to this damage pattern was 12FDEW1. All glazing within the GMC was intact and all doors were closed and operational at the time of the SCI inspection.

Figure 7: The front crush profile of the GMC.

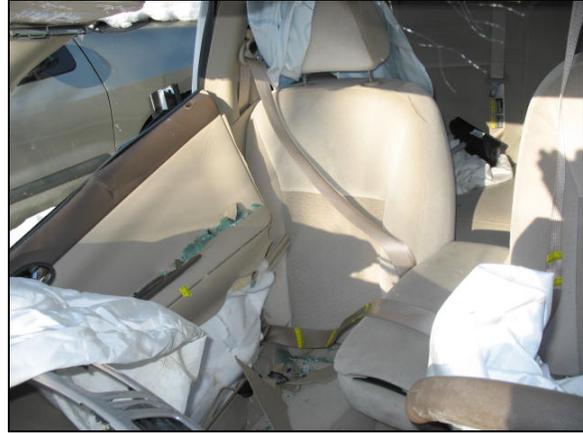
abrasions to the underside of the webbing. The passenger contacted the lower rear quadrant of the right/front door panel (**Figure 8**) with the right aspect of her hip area as evidenced by the identified fracture of this component. The passenger also contacted the right/front door armrest with her lower right arm area as evidenced by the identified deformation of this component. A deformation of the right/front seat cushion was also identified as a possible contact point. The forward aspect of her trajectory resulted in chest contact to the deployed front right passenger air bag. The lateral aspect of her trajectory resulted in head contact to the deployed IC passenger air bag. The passenger rode down the force of the crash through her contact with the deployed air bags and then rebounded back into her seat where she came to final rest. No discernable contact evidence was documented to the deployed air bags as a result of this occupant's kinematics.

Figure 8: Contact point evidence on the Chevrolet's right/front door panel
