**NOT-IN-TRAFFIC SURVEILLANCE  
CALSPAN REMOTE FALLING VEHICLE INCIDENT INVESTIGATION**

**SCI CASE NO.: CA09009**

**VEHICLE: 1992 FORD TAURUS**

**INCIDENT DATE: NOVEMBER 2008**

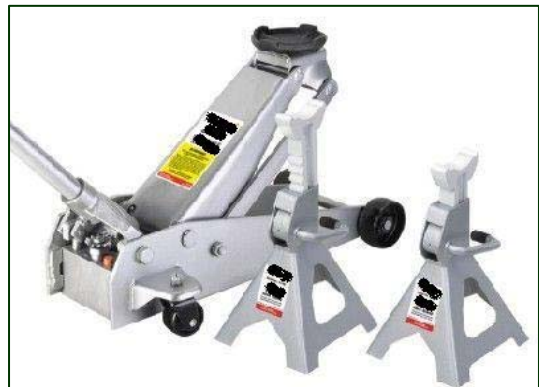
The investigating officer stated the non-motorist used a hydraulic floor jack to raise the front of the vehicle on the grass surface. Jack stand manufacturers typically recommend that the jack stands are to be used only on hard, level surfaces capable of sustaining rated capacity loads. The non-motorist jacked the vehicle to an unknown height and placed two jack stands under the front lower control arms. These jack stands were placed directly on the grass surface. The jack stands utilized a ratchet-type locking system for height adjustment. The officer further noted that the non-motorist failed to set the vehicle's parking brake or chock the rear tires to prevent the vehicle from rolling. **Figure 1** is a view of an exemplar style floor jack and jack stands that were used in this incident.

**Figure 1. Exemplar style floor jack and jack stands.**

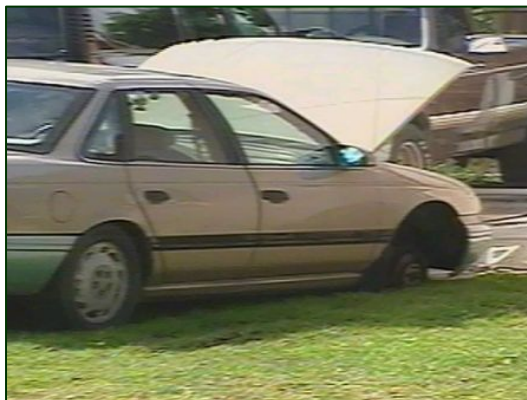
on the grass surface under the Ford, the non-motorist crawled head-first under the front of the vehicle. His lower extremities extended forward of the front bumper. **Figure 2** is a view of the Ford at rest on the grass surface with the front right tire removed. The Incident Schematic is attached to this report as **Figure 3**.

As the non-motorist was under the Ford in a face-up position, the vehicle rolled rearward and the jack stands fell rearward with respect to the vehicle. The front of the Ford subsequently fell onto the non-motorist with the engine cradle area resting on his chest. At rest, the non-motorist was lying between the jack stands with the stands positioned on their sides parallel to the Ford.

**Figure 2. Location and post-incident condition of the 1992 Ford Taurus. (Imaged obtained from an Internet-based news site.)**

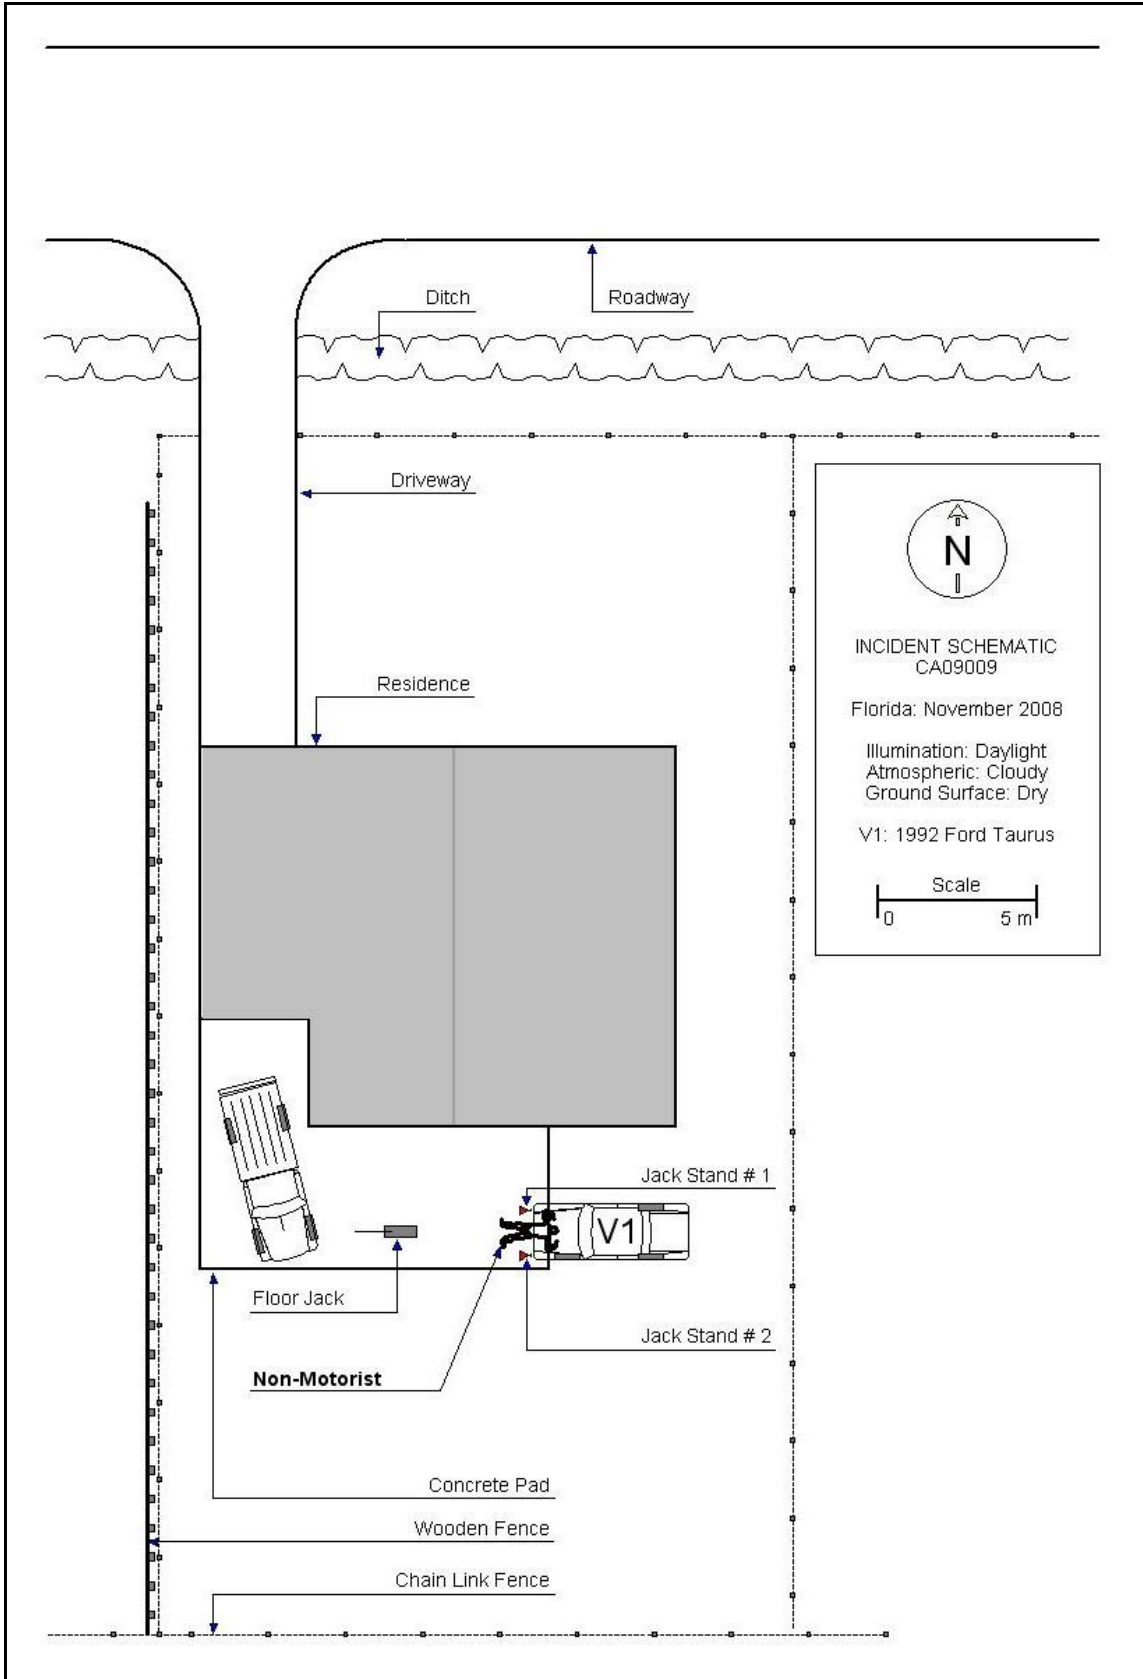
Figure 3: Incident Schematic

1. The Ford was not running and the automatic transmission was placed in the PARK position.
2. The non-motorist raised the front the front-wheel-drive sedan and failed to chock the rear wheels or set the parking brake.
3. The Ford was parked completely on the grass with the front of the vehicle facing the concrete slab.
4. The jack stands appeared to be in proper working condition with no damage noted to the stands.
5. Although the time of the incident was not known, the frozen food item that was placed in the sink was partially thawed indicating that it was removed from the freezer on the morning of the incident.
