On-Site Ambulance Investigation  
Dynamic Science, Inc. (DSI), Case Number DS09019  
1999 Ford E350 Econoline  
Arizona  
February 2009

1. Report No. DS09019	2. Government Accession No.		3. Recipient Catalog No.	
4. Title and Subtitle On-Site Ambulance Investigation			5. Report Date February 9, 2010

14. Sponsoring Agency Code	
15. Supplemental Notes				
16. Abstract <p>This on-site investigation focused on the crash dynamics and injuries sustained in a crash involving a 1999 Ford E350 Econoline van that was configured as an ambulance. The crash occurred within an intersection. The Ford was being driven by a 24-year-old male. The front right seat was occupied by a 71-year-old male who was the uncle of the patient that was being transported. There was a male Emergency Medical Technician in the rear of the ambulance who was attending to a 31-year-old female. The female was on an ambulance cot prior to the crash. The first other vehicle was a 2006 Dodge Charger that was being driven by a 20-year-old male. The second other vehicle was a 2000 GMC Sierra pickup. The Ford was traveling westbound approaching the intersection on a green light without emergency lights and sirens. The Dodge

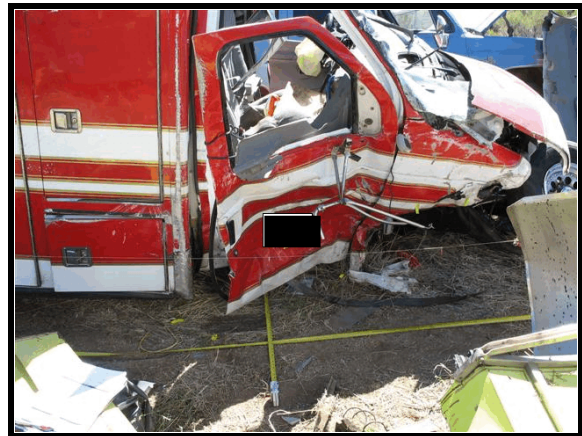
**Figure 6.** Right side damage (subject vehicle)

The damage from the impact with the Dodge began 241 cm (94.9 in) forward of the rear axle and extended 191 cm (75.2 in) forward along the right side of the vehicle (**Figure 6**). The damaged area included the right front bumper. Both front wheels were displaced and fractured from the vehicle, and the drive shaft was separated from the transmission (**Figure 7**). The right front tire was embedded with a 13 x 7 cm (5.1 x 2.8 in) section of plastic fascia from the Dodge. A 16 x 3 cm (6.3 x 1.2 in) section of the rim was missing. Six crush measurements were documented at the sill level as follows:  $C_1 = 14$  cm (5.5 in),  $C_2 = 33$  cm (12.9 in),  $C_3 = 43$  cm (16.9 in),  $C_4 = 27$  cm (10.6 in),  $C_5 = 36$  cm (14.2 in),  $C_6 = 64$  cm (25.1 in). The Collision Deformation Classification for the impact with the Dodge was 01RYEW4.

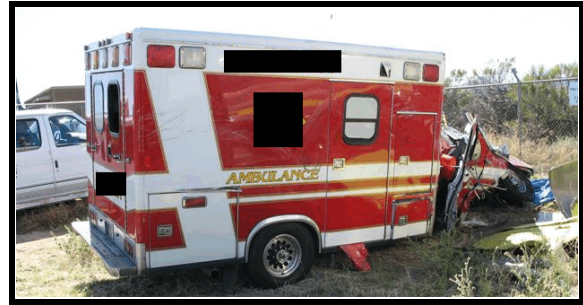
**Figure 8.** Right side rollover and sideslap damage (subject vehicle)

There was direct contact damage to the ambulance body that extended from the right rear corner forward 351 cm (138.2 in) to the end of the body

(**Figure 8**). The damage also included contact to the right B-pillar. The damage included vehicle-to-vehicle sideslap damage and damage from the right side rollover. The damage extended from the bottom of the body 216 cm (85 in) vertically to the top of the body. The CDCs for the rollover and sideslap were 00RDAO2 and 03RBEW1, respectively. The front bumper was displaced during the crash and contacted the top of the Dodge.

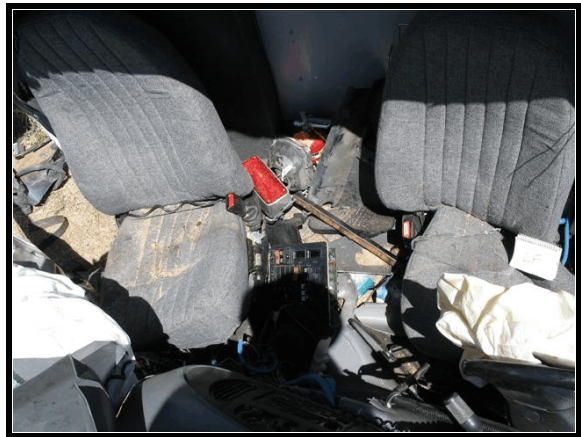
**Figure 9.** Overview of front seating area (subject vehicle)

The Ford ambulance sustained moderate damage from intrusion and occupant contacts (**Figure 9**). The Ford sustained lateral intrusions of the right door, right sill, right window frame, right lower kick panel, the engine cowling, and the toe pan. The right side window disintegrated during the impact and the windshield was cracked. The status of the left side window was not known. The right front door was jammed shut and was forced open by rescue personnel.

There were occupant contacts located within the cab area of the ambulance. The left and right knee bolsters were deformed, the right door panel was fractured and deformed, the foot controls were deformed, the engine cowling was shifted, and there was a blood deposit to the right upper window frame. There was also a cloth transfer located on the front panel of the driver's air bag. Several possible contacts were located within the ambulance body. Slight deformation to the panel adjacent to the rear-facing seat that was located 17 cm (6.7 in) rear of the forward aspect and 74 cm (29.1 in) above the floor was identified. There was a dent to the right interior door that, based on its location and shape, may have been caused by the emergency cot. The dent was located 71 cm (27.9 in) from the bottom of the door, 40 cm (15.7 in) above the floor, and 14 cm (5.5 in) rear of the forward aspect of the door. Above the right interior door, there was an area of scuffing that measured 17 x 16 cm (6.7 x 6.3 in). Just aft of the door, damage to a plastic panel and an oxygen connector was identified.

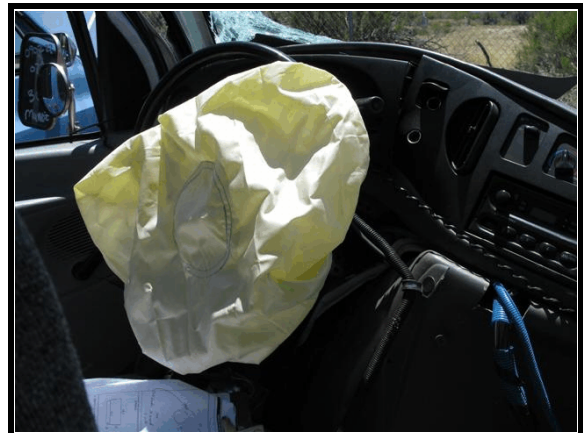
**Figure 12.** Driver's air bag (subject vehicle)

The driver's air bag deployed from the center of the steering wheel hub through H-configuration module cover flaps (**Figure 12**). The top flap measured 15 cm (5.9 in) high by 20 cm (7.9 in) wide. The bottom flap measured 3 cm (1.2 in) high by 20 cm (7.9 in) wide. The air bag measured 50 cm (19.7 in) in diameter in its deflated state. The air bag was configured with circular 4 cm (1.6 in) vent ports at the 11 and 1 o'clock positions and a single tether strap. On the back panel of the air bag there was a 5 x 2 cm (1.9 x 0.8 in) area of melted plastic (**Figure 13**). The base of the tether strap was also melted; the strap was frangible and separated from the air bag when moved (**Figure 14**). The damage at both locations was as a result of heat generated by the inflator during the air bag deployment.

On the front panel of the air bag there was a 16 x 6 cm (6.3 x 2.4 in) cloth transfer pattern. The transfer began 8 cm (3.1 in) lateral to the center of the bag and 7 cm (2.8 in) above the center; the transfer ended 20 cm (7.9 in) lateral to the center and 13 cm (5.1 in) above the center.

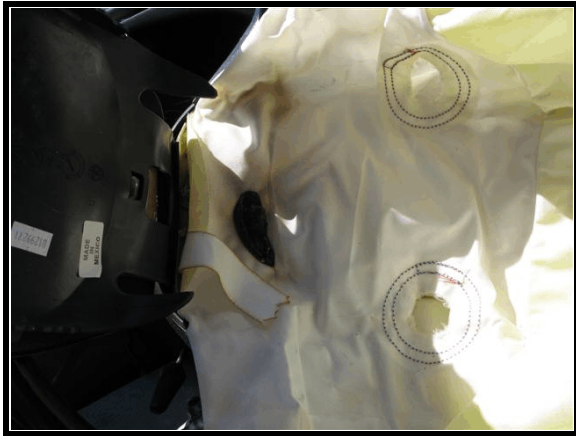
**Figure 13.** Melted plastic on air bag (subject vehicle)

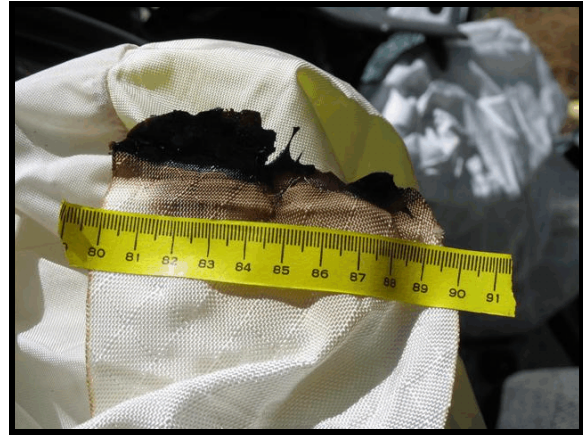
**Figure 14.** Melted tether strap (subject vehicle)

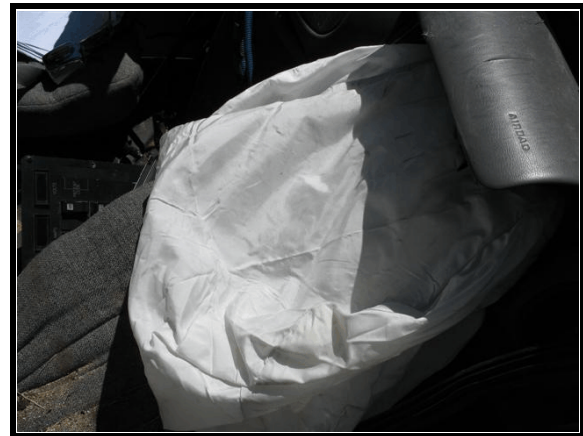
**Figure 15.** Passenger air bag (subject vehicle)

The front right passenger's air bag deployed from a single rectangular module flap that was hinged at its forward aspect (**Figure 15**). The flap measured 22 cm (8.7 in) high by 38 cm (14.9 in) wide. The air bag measured 53 cm (20.9 in) wide seam to seam and was 63 cm (24.8 in) high. The maximum excursion measured 65 cm (25.5 in). There was a 4 x 5 cm (1.6 x 1.9 in) tear along the bottom edge of the module cover that was located 13 cm (5.1 in) from the left corner of the cover. There was a blood deposit located on the front panel that was located 14 cm (5.5 in) lateral from the left edge of the air bag and 20 cm (7.9 in) from the top.

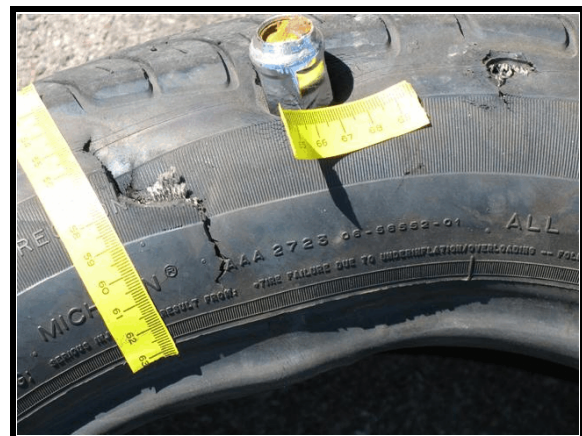
**Figure 16.** Left front tire damage, 2006 Dodge Charger

The left front tire sustained an 8 cm (3.1 in) cut that began at the bead and extended into the sidewall. A jagged 7 cm (2.8 in) cut in the outboard sidewall, and an 8 cm (3.1 in) "J" shaped cut in the inboard sidewall were present. A 3 cm (1.2 in) lug nut from the right front tire of the Dodge was embedded in the outboard sidewall (Figure 16).

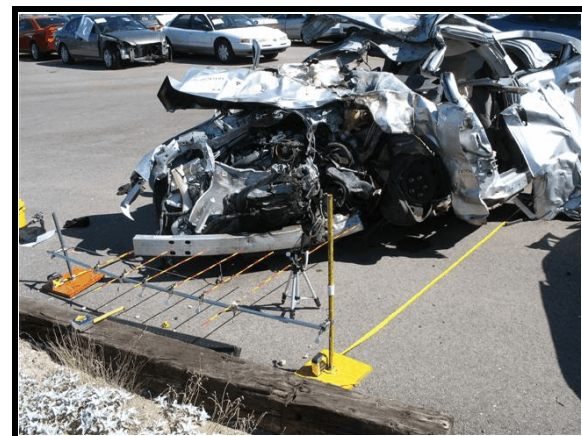
**Figure 17.** Frontal damage, 2006 Dodge Charger

The Dodge sustained severe damage from the initial impact with the Ford and moderate damage from secondary impacts (Figure 17). The Dodge also sustained minor damage from an engine fire.

The direct damage from the initial impact with the Ford began at the left front bumper corner and extended 80 cm (31.4 in) laterally to the right. Six crush measurements were documented along the bumper backing bar as follows:  $C_1 = 101$  cm (39.7 in),  $C_2 = 82$  cm (32.2 in),  $C_3 = 62$  cm (24.4 in),  $C_4 = 43$  cm (16.9 in),  $C_5 = 26$  cm (10.2 in),  $C_6 = 4$  cm (1.6 in). The CDC for the initial impact with the Ford was 11FYEW5.

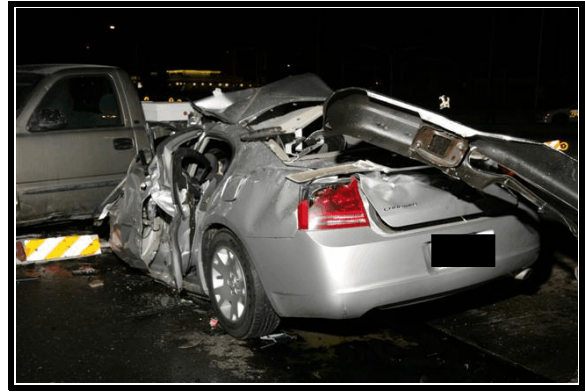
**Figure 18.** Left and rear damage to Dodge Charger (police photo)

There were patterns of direct contact along the entire left side of the Dodge from the secondary impact with the Ford which partially overturned onto the Dodge. Contact to left A-pillar that extended 31 cm (12.2 in) laterally along the windshield frame was located. This was likely caused by the forward edge of the ambulance body. Direct contact to the left front door was located that measured 43 cm (16.9 in) in height by 90 cm (35.4 in) in width.

There was 143 cm (56.2 in) of direct red paint contact to the trunk lid and the rear spoiler. The spoiler was deformed downward. This damage was caused by the front bumper of the Ford which had become partially separated from the vehicle (**Figure 18**). The CDC for this event was 00TBDW1.

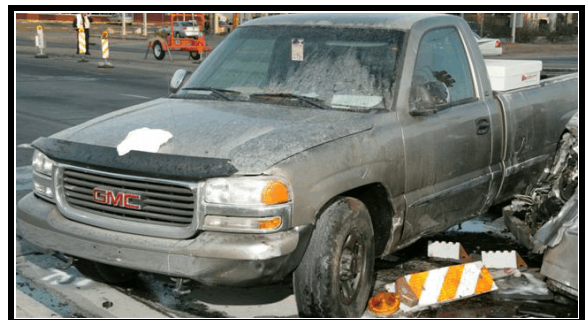
**Figure 19.** 2000 GMC Sierra pickup (police photo)

The 2000 GMC Sierra 1500 pickup was identified by the VIN: 1GTEC14V9YZxxxxxx. The GMC was a 2-door pickup that was equipped with a 4.8-liter, 8-cylinder engine, automatic transmission, 4-wheel anti-lock brakes, 4-wheel disc brakes, and rear-wheel drive. The vehicle manufacturer recommended P235/75R16 tires. The vehicle sustained minor left side damage from the impact with the Dodge (**Figure 19**). The direct damage began at the front left bumper corner and extended rearward an estimated 382 cm (150.3 in) to the left rear tire. The CDC for this impact was 10LDAW2.

The right front tire contacted the curb, but there did not appear any residual damage. The vehicle was towed from the scene despite there being little visible damage.

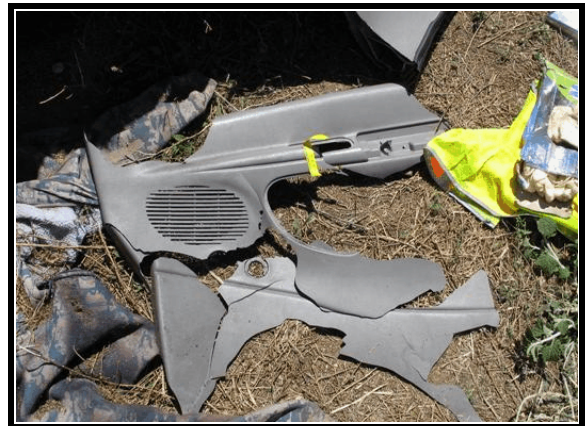
**Figure 20.** Plastic fascia from front right door
