CRASH DATA RESEARCH CENTER

**CALSPAN ON-SITE HEAVY TRUCK REAR IMPACT GUARD CRASH INVESTIGATION
SCI CASE NO.: CA09060**

**VEHICLE: FREIGHTLINER TRACTOR W/ 2005 STOUGHTON TRAILER
LOCATION: NORTH CAROLINA**

CRASH DATE: SEPTEMBER, 2009

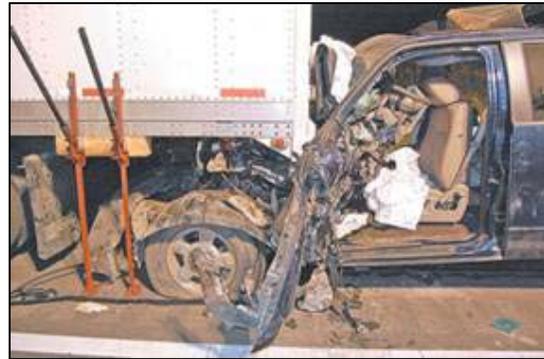
Figure 1: Left side view of the Ford at rest under the back of the struck trailer (Image courtesy of Internet news article).

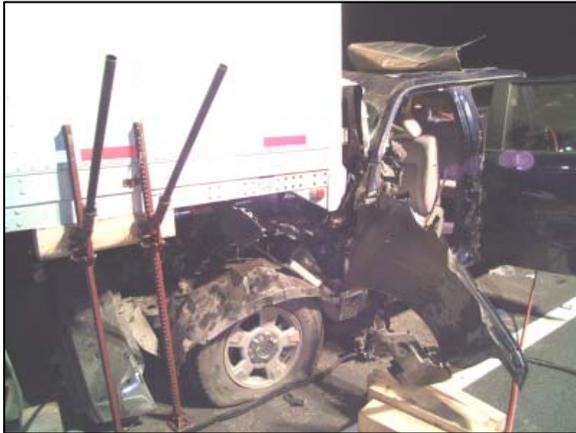
Figure 6: Left view of the Ford at final rest. Image supplied by the police investigator.

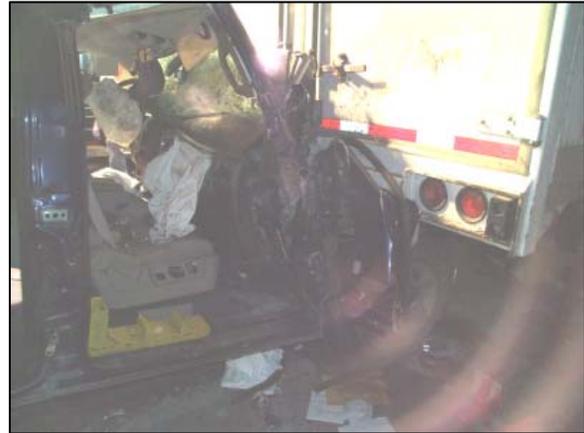
Figure 7: Right rear oblique view of the Ford at final rest. Image supplied by the police investigator.

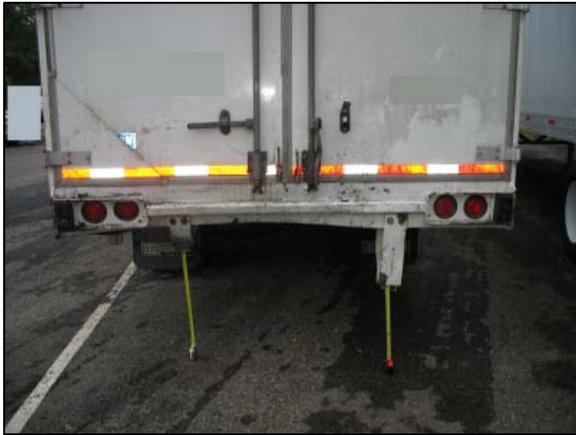
The rear impact guard and the back of the trailer sustained moderate damage as a result of the impact (**Figure 8**). The direct contact damage, measured along the lower edge of the back plane, began 60 cm (23.5 in) right of center and extended 189 cm (74.5 in) to the left rear corner. The left vertical support of the rear impact guard was located within the region of the direct contact and had deformed forward and upward. The webbing of the I-beam was buckled. **Figure 9** is a right side view of the deformed support. The height of the left support measured 71 cm (28 in) above the ground. The height of the right vertical support measured 55 cm (21.5 in).

Figure 8: Back view of the trailer and deformed rear impact guard.

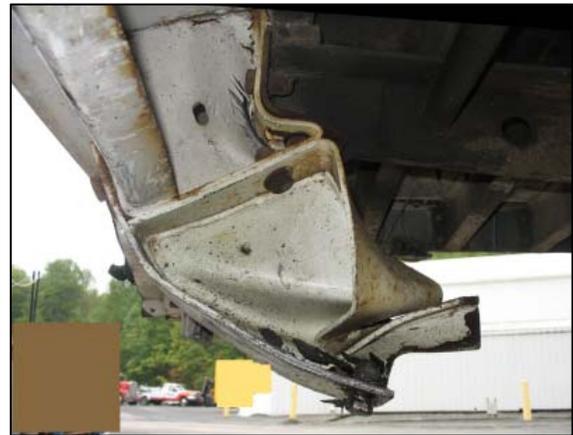
Figure 9: Right side view of the deformed rear impact guard vertical support.

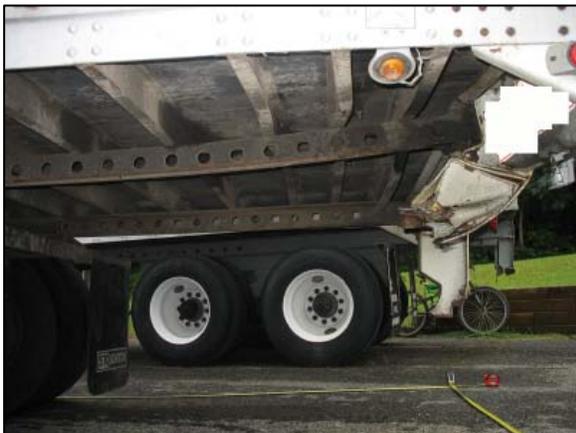
Figure 10 is a view depicting the deformation of the left rear corner of the trailer and slider frame. The end of the left slider frame rail was deformed vertically 6 cm (2.5 in) as a result of the underride. The left rear corner of the trailer's interior floor was vertically buckled over an area that measured 198 cm x 116 cm (78 in x 45.5 in), width by depth. The left rear door of the trailer was jammed closed. **Figure 11** is a view looking rearward toward the deformed back plane.

Figure 10: Left view depicting the deformed left slider frame rail and trailer.

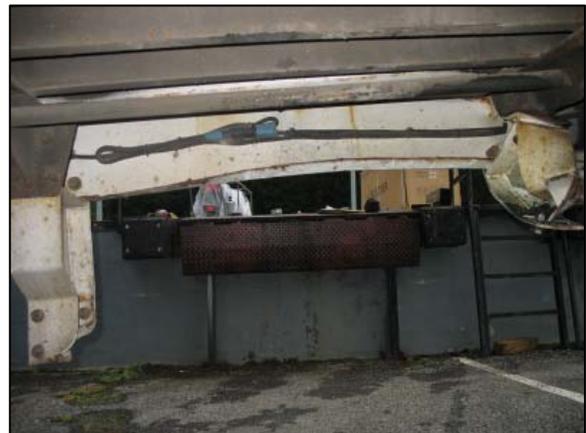
Figure 11: View looking rearward of the deformed back plane and rear impact guard supports.

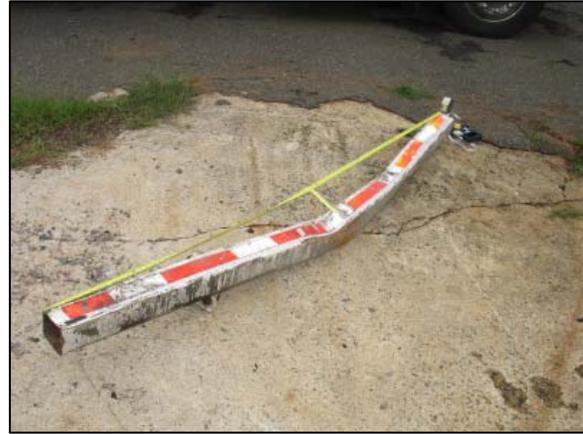
The rear impact guard beam (**Figure 12**) had separated from the vertical supports during the underride of the Ford and was located in the bed of the pickup. The guard beam was deformed in a shallow V pattern. The deflection at the midpoint of the beam measured 13 cm (5 in). In its pre-crash condition, the beam was fastened to the vertical supports by three 16 mm (5/8 in) Grade 5 bolts through an intermediate plate that was welded to the beam. **Figure 13** is a view of the left side of the guard beam and the intermediate connection plate. The left side of the beam separated through one of the bolted connections and by shearing of the flange of the vertical I-beam support. **Figure 14** is a view of the right side of the guard beam. The right side of the beam separated from the vertical support by a tearing of the metal that surrounded the welded intermediate connection plate. The connection plate remained bolted to the right vertical support.

Figure 12: View of the separated rear impact guard beam.

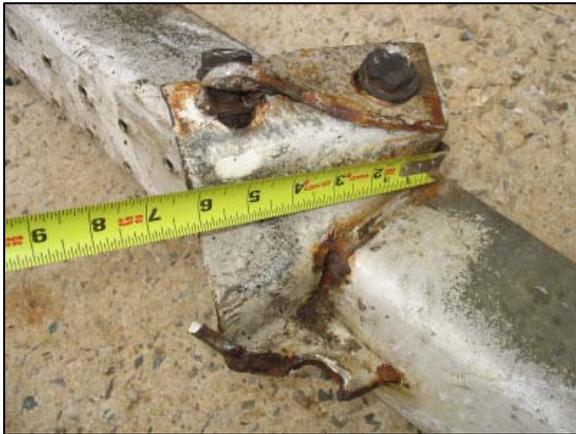
Figure 13: View of the left end of the guard beam and the welded intermediate connection plate.

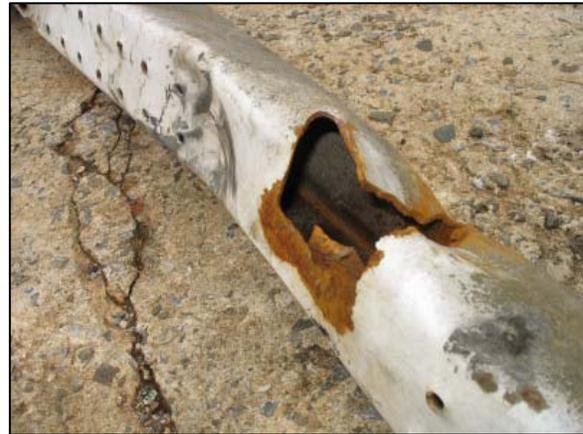
Figure 14: View of the right side of the guard beam and the torn metal surrounding the welded connection of the intermediate plate.

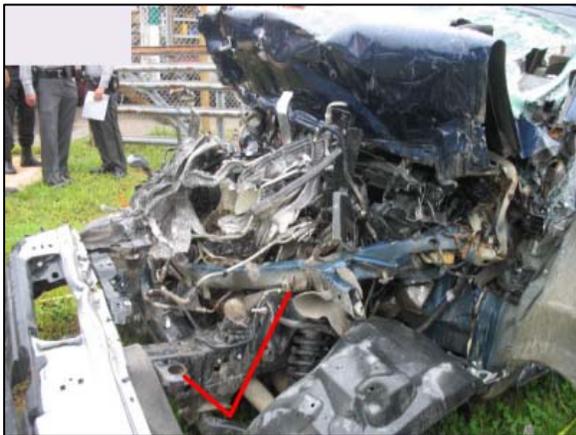
The 2009 Ford F-150 sustained severe impact damage due to the underride of the trailer's rear overhang. The vehicle structure above the level of the frame compressed rearward through the engine compartment and into the cowl resulting in extensive occupant compartment intrusion. **Figures 15 and 16** are left and right views of the engine compartment deformation.

The vertical face of the front bumper had rotated about its connection to the forward ends of the frame rails and was in a horizontal orientation at inspection. The front of the Ford struck the back plane of the trailer and crushed rearward. The body mounts located at the lower edge of the radiator support separated from the frame rails and deformed rearward. The longitudinal displacement of the left and right body mounts measured 41 cm (16 in) and 34 cm (13.5 in),

respectively. The hood folded into an inverted V-pattern and crushed into the A-pillars and lower aspect of the windshield. Crush profiles were documented at the bumper level and at the level of the hood face. The maximum crush at the bumper level was located 49 cm (19.3 in) right of center and measured 17 cm (6.7 in). The maximum crush at the level of the hood face was located on the vehicle's centerline and measured 157 cm (61.8 in). The crush profiles at the bumper level and at the level of the hood were averaged and utilized as an input to the WinSMASH program to estimate the crash delta-V. The average crush profile was as follows: C1 = 67 cm (23.4 in), C2 = 75 cm (29.5 in), C3 = 85 cm (33.5 in), C4 = 87 cm (34.3 in), C5 = 83 cm (32.7 in), C6 = 84 cm (33.1 in). There was no change in the wheelbase dimensions. The front doors of the Ford were jammed shut by the force of the impact and removed during the extrication of the occupants. Inspection of the vehicle revealed cab-to-bed contact on both side planes. The Collision Deformation Classification of the Ford was 12-FDAW6.

Figure 15: Left view of the frontal deformation. The left body mount is highlighted in the image.

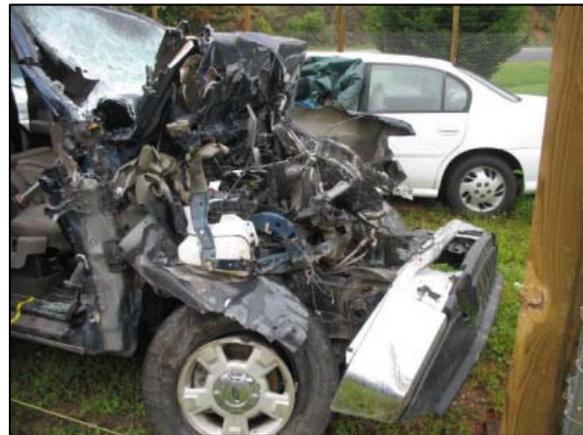
Figure 16: Right view of the frontal deformation.

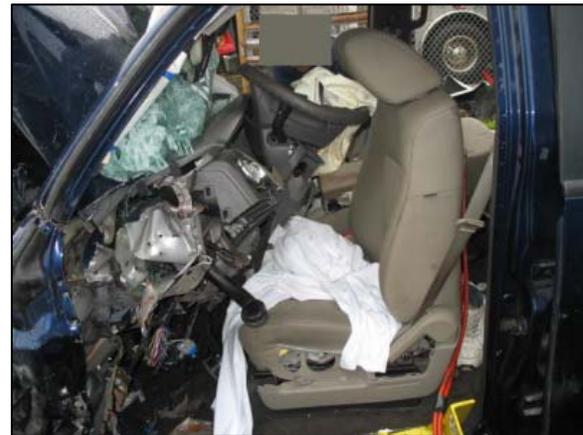
The forward occupant compartment in the Ford sustained severe instrument panel intrusion as a result of the underride. **Figure 17** is a view of the driver's position. The driver seat was adjusted to a full-rear track position. The driver seat back angle measured 5 degrees aft of vertical and the adjustable head restraint was in the full-down position. The steering column was displaced rearward in close proximity to the driver seat and had rotated to a near vertical position. The left shear capsule displacement was 3 cm (1 in); the right shear capsule was displaced 1 cm (0.5 in). The deployed air bag module in the center of the steering wheel was used as a reference in order to document the displacement of the steering wheel/column. Comparison measurements to an exemplar Ford F-

Figure 17: Left lateral view at the driver's position.

150 indicated the center of the steering wheel was displaced 15 cm (6 in) vertically and 22 cm (8.5 in) rearward. The horizontal distance from the seat back to the center of the steering wheel rim measured 25 cm (10 in). The steering wheel was rotated approximately 90 degrees counterclockwise. The rim was deformed 8 cm (3 in) in the 5 to 9 o'clock sectors. The longitudinal intrusion at the left corner of the instrument panel measured 29 cm (11.5 in).

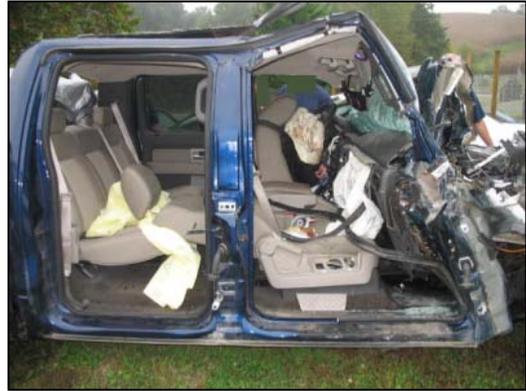
Figure 18 is a right lateral view across the front row. The front right seat was in the full-rear track position. The seat back had been reclined by the first responders during the extrication of the front passenger. The head restraint was adjusted 8 cm (3 in) above full-down. The instrument panel intruded to the leading edge of the seat cushion. The intrusion at right corner of the instrument panel measured 20 cm (8 in). The center instrument panel intrusion also measured 20 cm (8 in).

Figure 18: Right lateral view of the occupant compartment.
