CALSPAN ON-SITE AMBULANCE CRASH INVESTIGATION

SCI CASE NO: CA09076

VEHICLE: 1998 FORD E350 TYPE III AMBULANCE

CRASH DATE: OCTOBER, 2009

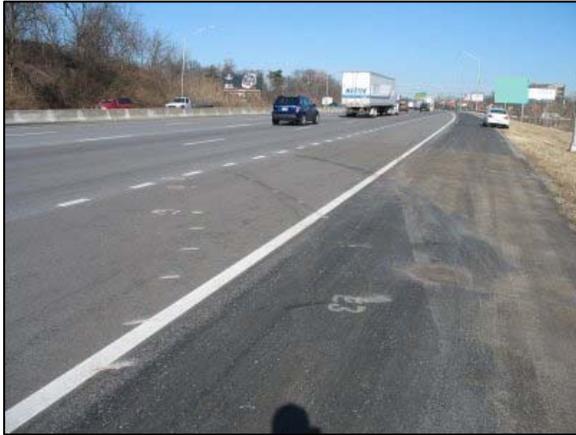
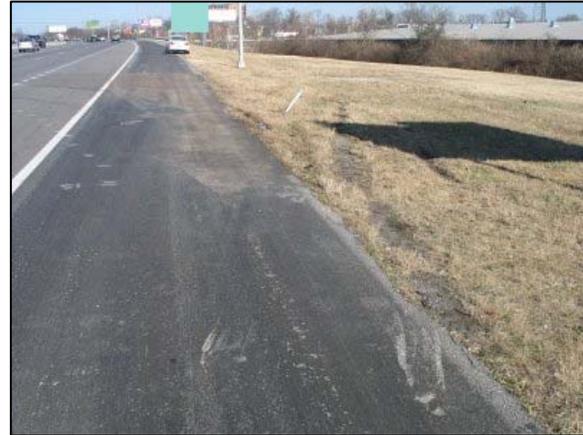
170 degrees CCW across the shoulder. The vehicle came to rest in the outboard northbound lane, 17 m (56 ft) north of the point of impact. Its post-impact movement was evidenced by three arcing tire marks, **Figure 3**. The driver then moved the GMC to its post-crash location on the right shoulder of the roadway. The ambulance continued along its northeast trajectory and came to rest on the east roadside 18 m (59 ft) from the impact. Its post-crash trajectory was evidenced by two parallel gouge marks in the roadside terrain, **Figure 4**.

Figure 3: View of the post-crash tire marks defining the trajectory of the GMC.

Figure 4: View of the point of impact and post-crash trajectory of the ambulance.

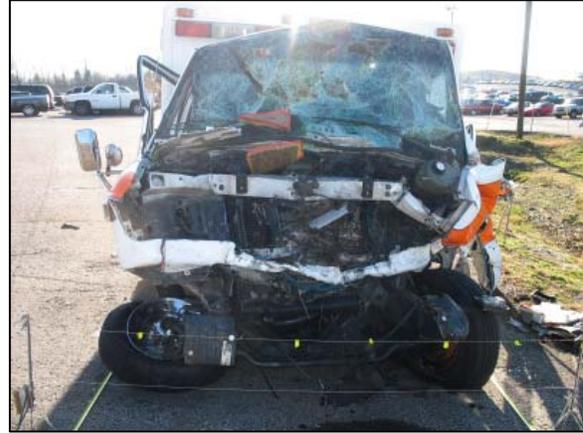
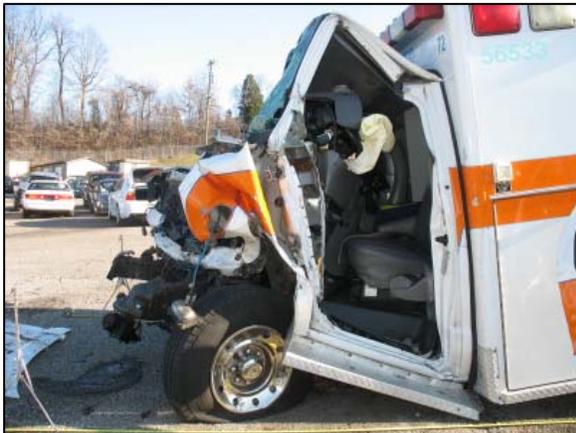
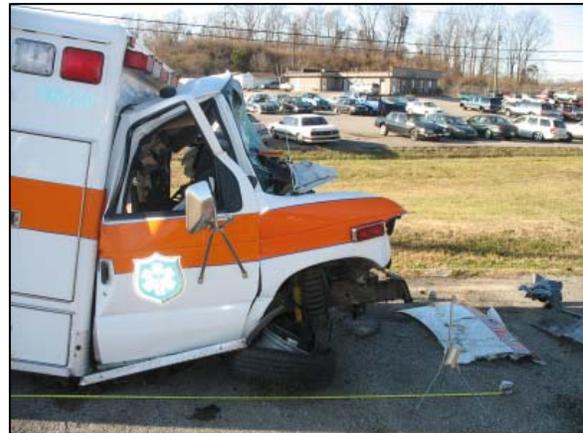
The forward aspect of the ambulance sustained severe impact damage as a result of the impact with the back plane of the GMC. **Figures 5 through 7** are the front, left and right views of the ambulance cab. The depth of the crush extended nearly to the left A-pillar area. The cab was compressed into the forward wall of the patient compartment and the ambulance frame buckled. The front bumper separated from the frame rails during the impact. The width of the direct contact damage measured 155 cm (61.0 in), beginning 69 cm (27.2 in) right of center and extended to the left front corner. The forward aspect of the left frame rail crushed 35 cm (13.8 in) and buckled. The right frame rail underrode the back plane of the GMC and was undamaged. A crush profile was measured along the vertical face of the ambulance originally located immediately above the bumper. The residual crush profile was as follows: C1 = 89 cm (35.0 in), C2 = 79 cm (31.1 in), C3 = 69 cm (27.2 in), C4 = 47 cm (18.5 in), C5 = 37 cm (14.7 in), C6 = 15 cm (5.9 in). The left fender was completely crushed. The left A-pillar was in a near vertical orientation. The roof buckled vertically 23 cm (9.0 in) at the left door opening. The width of the left door crushed 13 cm (5.0 in) and it buckled outboard. The door was removed by the first responders to access the driver. The right front door was jammed closed. The left wheelbase was reduced 20 cm (8.0 in). The right front suspension fractured during the impact and the wheel/tire separated. The Collision Deformation Classification (CDC) was 12-FDAW6.

Figure 5: Front view of the ambulance

Figure 6: Left view depicting the extent of crush.

Figure 7: Right view of the ambulance.

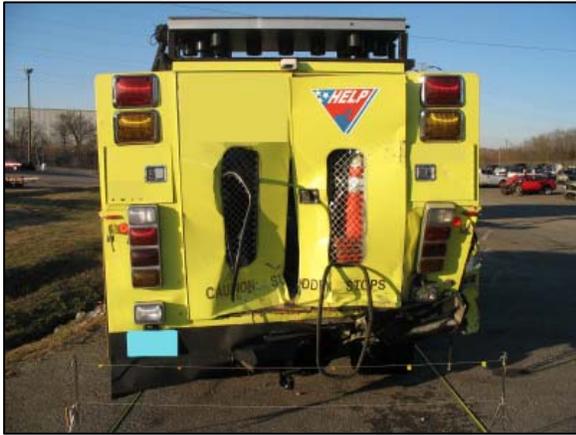
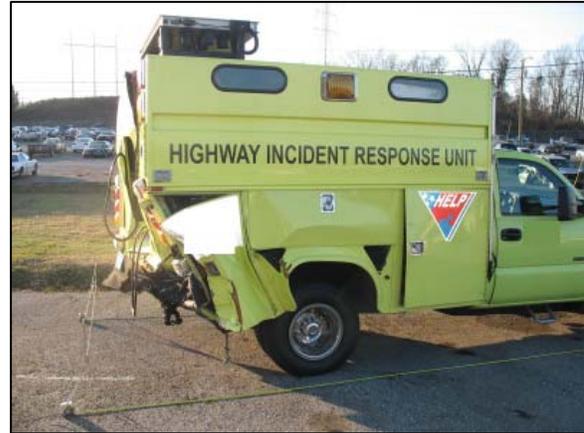
The GMC K3500 Work Truck sustained moderate severity damage as a result of the impact (**Figure 8 and 9**). The damage was biased to the right due to the offset impact configuration.

The direct contact damage began 34 cm (13.5 in) left of center and extended 144 cm (56.5 in) to the right corner of the bumper. Within the damaged region, the height of the direct contact on the back plane of the truck measured 191 cm (75 in) above the ground. The residual crush profile along the rear bumper of the truck was as follows: C1 = 0, C2 = 0, C3 = 11 cm (4.3 in), C4 = 27 cm (10.6 in), C5 = 34 cm (13.4 in), C6 = 50 cm (19.7 in). The right wheelbase was reduced 6 cm (2.5 in). The left wheelbase was unchanged. There was contact between the forward right corner of the utility box and the right aspect of the cab. The cab's right door frame overlapped the right B-pillar structure 3 cm (1.0 in). The backlight of the cab was disintegrated. The CDC was 06-BDEW3.

Figure 8: View of the GMC's back plane.

Figure 9: Right view depicting the extent of crush.

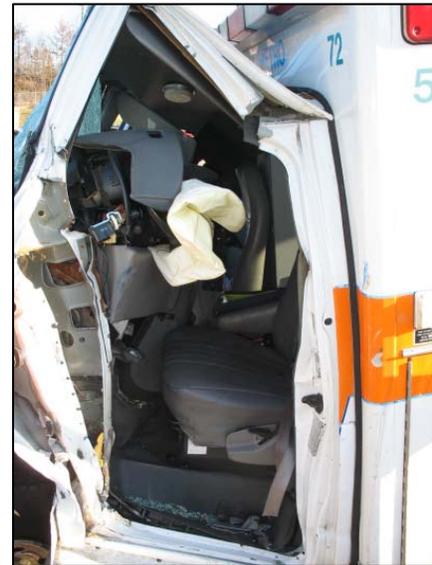
The interior of ambulance cab sustained severe intrusion as a result of the frontal crash. **Figure 10** is a left lateral view of the ambulance cab. The box-mounted driver seat was adjusted to the full-rear track position and was jammed in place. The seat track travel of an exemplar vehicle measured 19 cm (7.5 in). The seat back angle measured 10 degrees aft of vertical. The horizontal distance from the seat back to the driver air bag module in the center of the steering wheel measured 46 cm (18.1 in). The adjustment of the two-spoke, tilt steering wheel was unknown. In its undamaged condition the driver air module is located approximately 1 cm (0.5 in) forward of the plane of the steering wheel rim. At inspection, the driver air bag module/inflator hub protruded 8 cm (3 in) aft of the plane of the steering wheel. As the driver loaded the deployed air bag and steering wheel rim during the crash, the steering column was displaced rearward (through the plane of the rim) due to the extent of the crush. There was no separation of the steering column's shear capsules from the intruded instrument panel.

Figure 10: Left lateral view of the ambulance cab.

The instrument panel, steering wheel/column, knee bolster and associated components deformed rearward into the driver's occupant space. The magnitudes of the longitudinal intrusion are identified in the table below:

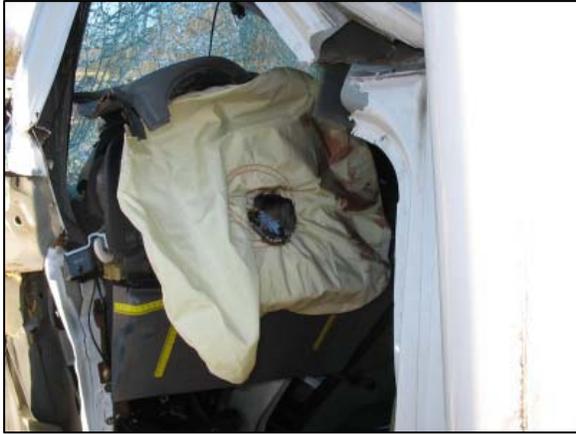
The 1998 Ford E-350 was equipped with a redesigned frontal air bag system for the driver and front right positions. As a result of the frontal impact, the air bag system deployed. The driver's air bag was conventionally located in the center of the steering wheel hub and was concealed by two cover flaps. The top cover flap measured 19 cm (7.5 in) in height and 13 cm (5 in) in width. The lower cover flaps measured 6 cm (2.5 in) in height and 13 cm (5 in) width. **Figure 11** is an overall view of the driver air bag. The air bag measured 61 cm (24 in) in diameter in its deflated deployed state. The air bag contained two tethers at the 12 and 6 o'clock positions and was vented by two vent ports at the 11 and 1 o'clock positions. The air bag contained a heavy concentration of body fluids in the 2 to 5 o'clock sectors. The 6 o'clock sector of the air bag was captured between the steering wheel rim and the intruded knee bolster.

Figure 11: View of the deployed driver air bag.

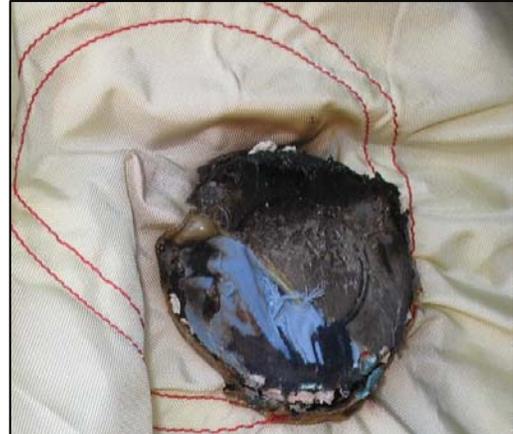
Most significant in the inspection of the driver air bag was that the inflator had melted through the center aspect of the face of the air bag. **Figure 12** is a close-up view of the inflator. Blue fabric from the driver's shirt adhered to the inflator's top surface. During the impact, as the driver loaded the deployed air bag and compressed the steering wheel, the steering column intruded rearward and compressed against the driver. At final rest, the driver was slumped forward against the steering wheel and deflated air bag. The hot air bag inflator contacted and melted the face of the air bag. The driver's shirt was burned and melted. The autopsy record identified a burn injury to his left upper chest.

Figure 12: Close-up view of the driver air bag inflator visible through the face of the melted air bag.

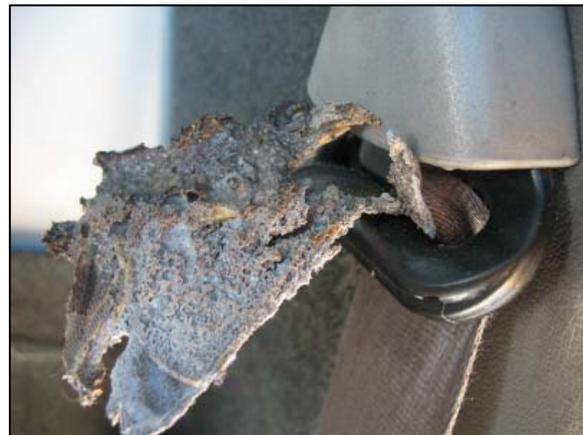
The 1998 Ford E350 was equipped with manual 3-point lap and shoulder safety belts for the two seating positions. The driver's safety belt was configured with continuous loop webbing, a sliding latch plate, a height adjustable D-ring, an Emergency Locking Retractor (ELR), and a buckle-mounted pretensioner. The D-ring was adjusted to the full-down position at the time of the SCI inspection. The buckle pretensioner had actuated during the impact evidenced by buckle stalk compression. The latch plate was still buckled into the receiver and a 124 cm (49 in) length of webbing was threaded through the latch plate. The first responders had cut the webbing in order to remove the driver from the vehicle. The webbing was cut immediately above the sleeve at the outboard anchor and at a position 56 cm (22 in) above the latch plate. This webbing section was creased at the latch plate. At the D-ring, a 10 cm (4 in) section of the webbing was observed to be heat-stressed and brittle. Melted fabric from the air bag was fused to the webbing. **Figure 13** is a view of the shoulder belt webbing and melted air bag fabric. This section of the belt contacted the driver air bag and the hot inflator when the driver was slumped forward at final rest. The hot inflator melted the air bag fabric and belt webbing. When the webbing was cut by the first responders, the melted section was captured in the D-ring

Figure 13: View of the driver's safety belt webbing at the D-ring.

as the retractor spooled in the slack belt. The SCI observations of the belt system during the inspection determined the driver was restrained at the time of the crash.

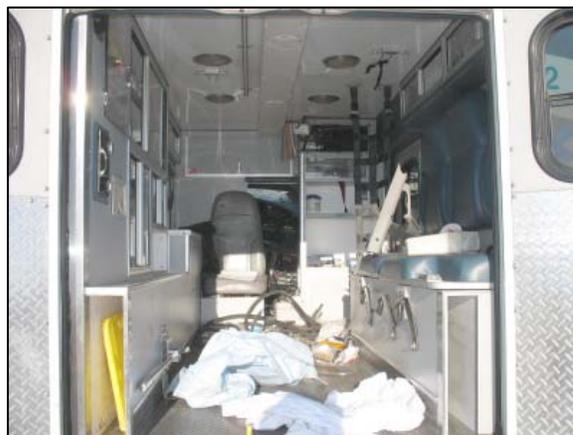
Figure 14 is a view into the patient compartment through the rear doors. There was no interior damage to the left, rear or right side walls and cabinetry. The interior was constructed of plywood overlaid with composite panels and aluminum trim. The cabinets had fore/aft sliding plexiglass doors with friction closures. The box-mounted rear-facing jump seat was located at the forward wall, behind the driver's position. The cushion of the seat appeared to have been loaded by the patient and/or loose objects during the crash. The floor-mounted antler bracket and rail clamp that secured the cot in its transport position were not damaged.

Figure 14: Rear view into the patient compartment.

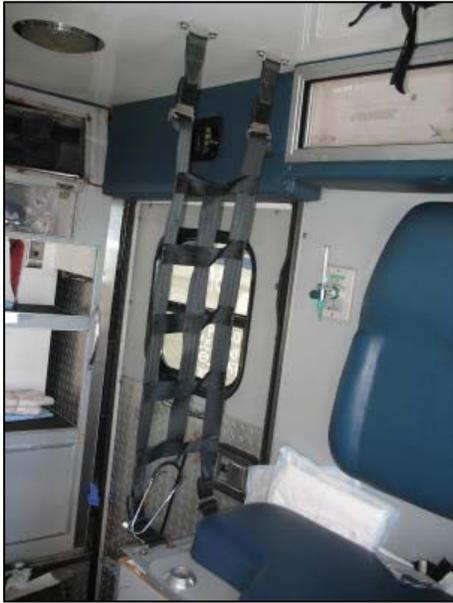
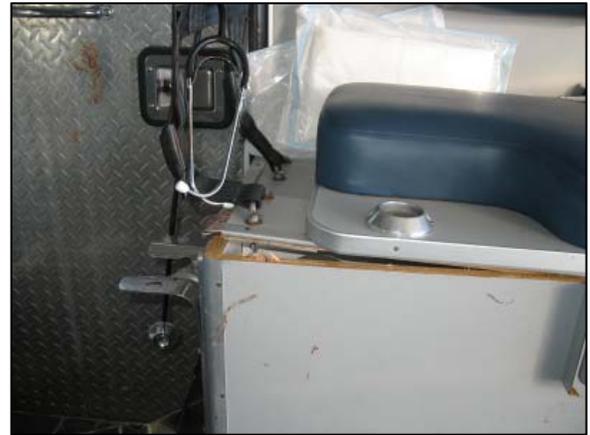
The paramedic was seated on the center position of side facing bench. An on-scene police image depicted that a cardiac monitor was located at the forward aspect of the bench. A vertical-oriented net restraint was located at the forward end of the bench. The net restraint measured 30 x 122 cm (12 x 48 in) and was comprised of five horizontal straps woven to three vertical straps. Each strap was 5 cm (2 in) wide. The ends of the vertical straps were sewn into loops. A metal pull-handle was placed through each loop and the pull-handle was attached to the ceiling and the base cabinet of the bench seat by wood screws. During the impact, the paramedic was displaced forward by the impact force and into the netting. His loading force into the net was distributed to the roof and cabinet through the fastener connections. It was observed that the wood screws in the ceiling had partially pulled out and that the inboard cabinet joint, adjacent to the net, had fractured from his loading. Refer to **Figures 15 and 16**.

Figure 15: View of the net restraint.

Figure 16: View of the fractured base cabinet as a result of the net restraint loading.

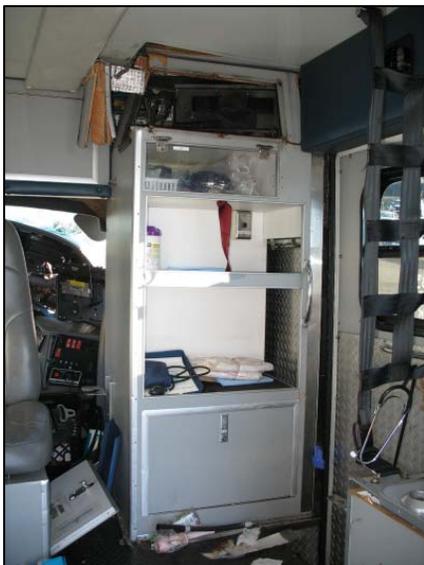
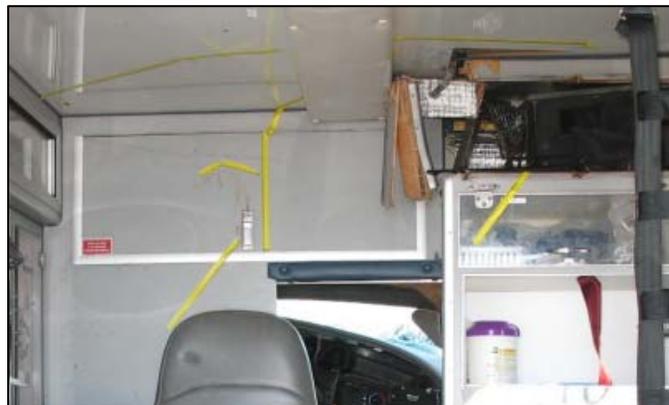
A 170 x 71 cm (67 x 28 in) three-shelf cabinet was located at the forward right aspect of the patient compartment. The upper inboard corner of this cabinet was fractured by contact from the displaced patient and paramedic (**Figure 17**). The entire cabinet was also displaced forward 5 cm (2 in), measured at its inboard corner. The aluminum trim surrounding the shelves and corners was abraded. The paramedic's hat was found within the fractured top shelf area. A 22 x 25 in area of body fluid spatter was located on the forward wall, left of the fractured cabinet, **Figure 18**.

Figure 17: Forward cabinet fractured by occupant contact.

Figure 18: View of the fractured cabinet and fluid evidence.
