**CALSPAN ON-SITE CHILD RESTRAINT SYSTEM CRASH INVESTIGATION  
SCI CASE NO.: CA10004**

**VEHICLE: 2000 JEEP GRAND CHEROKEE LAREDO 4X4**

**LOCATION: NORTH CAROLINA**

**CRASH DATE: DECEMBER 2009**

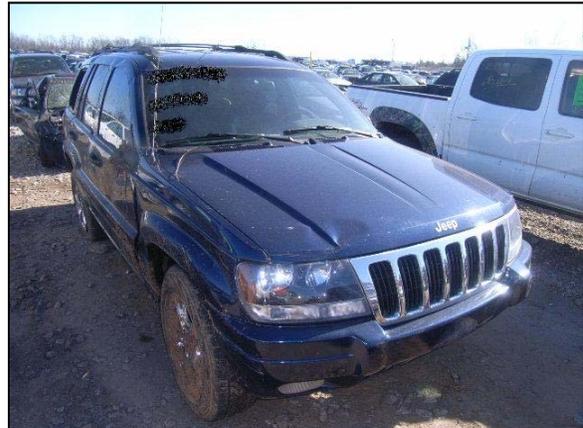
**Figure 1: Right front oblique view of the 2000 Jeep Grand Cherokee.**

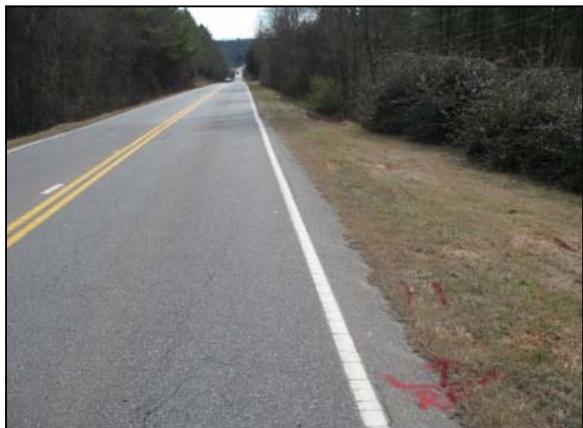
**Figure 2: Southbound trajectory view of the Jeep at the right roadside departure.**

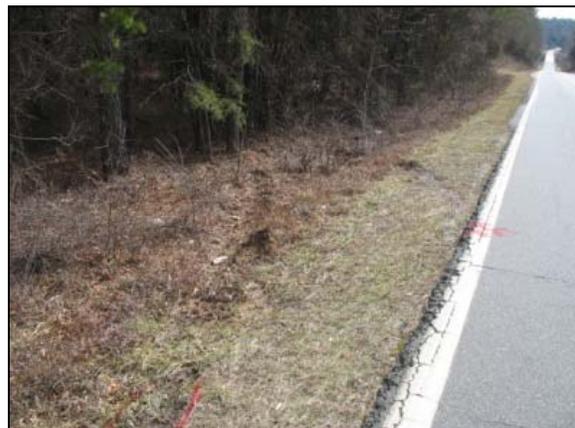
**Figure 3: Southbound trajectory view of the Jeep at the left roadside departure.**

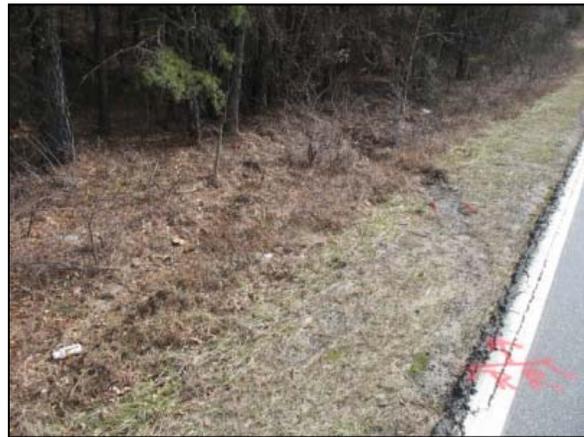
The furrowing right tires tripped the Jeep into a right side leading rollover (Event 1). The Jeep rolled one-quarter turn to the right. The top plane of the vehicle then impacted a 20 cm (7.8 in) diameter tree (Event 2). The severity of this impact was minor. The tree was located within the tree line 7.1 m (27.1 ft) east of the roadway. The Jeep came to rest on its right side facing north against the tree. The interrupted rollover distance was 5 m (16.4 ft). **Figure 4** is a view of the tree line, the area of the rollover and the Jeep's final rest location.

**Figure 4: Southeast trajectory view of the area of the rollover and the Jeep's final rest.**

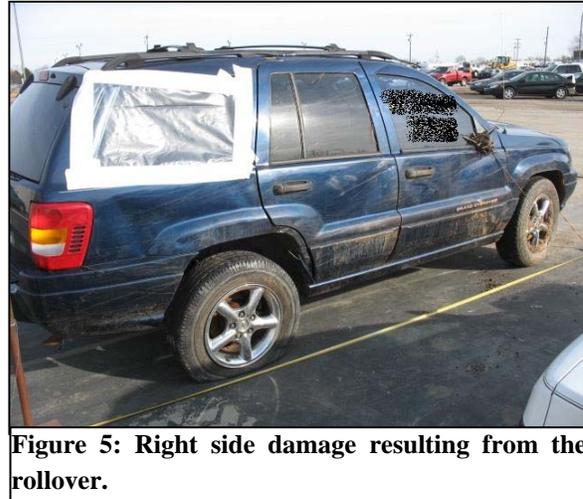
The exterior of the Jeep sustained minor severity damage to the top plane and moderate severity damage to the right side plane as a result of this multiple impact crash. The damage from the rollover (Event 1) was limited to the right side and extended 140 cm (55.1 in) vertically from the door sill to the roof side rail and longitudinally 426 cm (167.7 in) from the right rear bumper corner to the right front bumper corner (**Figure 5**). The maximum vertical and lateral crush was both located directly above the rear door seam at the junction of the right roof side rail and right C-pillar. The maximum lateral crush measured 3 cm (1.2 in) and the maximum vertical crush was 2 cm (0.8 in). The rear right glazing adjacent to the cargo area was disintegrated by the impact forces. All other side glazing and the windshield and backlight were not damaged in this crash. All of the vehicle doors remained closed during the crash and were operational post-crash. The CDC assigned for the rollover was 00RDAO2.

**Figure 5: Right side damage resulting from the rollover.**

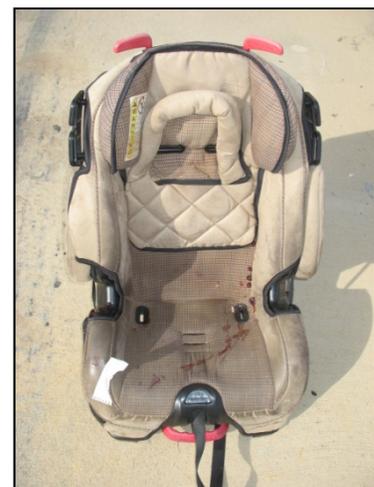
The CRS utilized in the second row right seating position was a Cosco/Dorel, Eddie Bauer Deluxe 3-in-1 that could be configured as a rear-facing infant CRS, a forward facing CRS, or a high-back booster CRS (**Figure 6**). The 5-point harness had been removed and the CRS was used as a high-back booster seat at the time of the crash. The infant head stabilizing pillow was still attached to the CRS. The seat was manufactured on December 21, 2004 and was purchased new by the driver. The Model and Serial numbers were 22-755-MAC and AE2B000344, respectively. A stamp on the rear aspect of the shell showed that this seat should not be used after December 2012. The seat was designed with LATCH; however, the LATCH system was not used during this crash. The booster seat application of the CRS

**Figure 6: View of the Eddie Bauer Deluxe 3-in-1 CRS.**

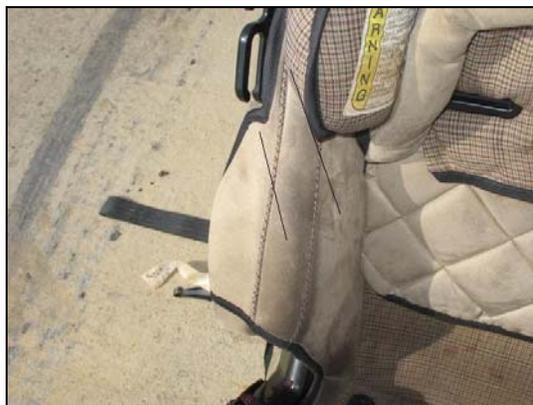
The vehicle’s manual safety belt was used to secure the child and CRS during this crash. The lap portion of the belt was routed across the belt positioning channels located on both sides of the CRS shell. On the upper outboard aspects of the CRS were two shoulder belt height adjustment guides. The shoulder belt was routed through the lower right shoulder belt height adjustment guide. Inspection of the CRS identified a black transfer and wear of the CRS fabric covering that led to the lower height adjustment guide consistent with the safety belt being used in this seating position and using the lower height adjustment guide (**Figure 7**). The CRS included two adjustable armrests. These armrests were adjusted in the up or stowed position at the time of this crash. The remainder of the CRS shell was inspected and no damage was found.

**Figure 7: CRS lining wear indicating lower right height adjustment use.**
