**CALSPAN ON-SITE POTENTIAL UNINTENDED ACCELERATION
CRASH INVESTIGATION**

SCI CASE NO.: CA10009

VEHICLE: 2007 TOYOTA RAV4

CRASH DATE: FEBRUARY 2010

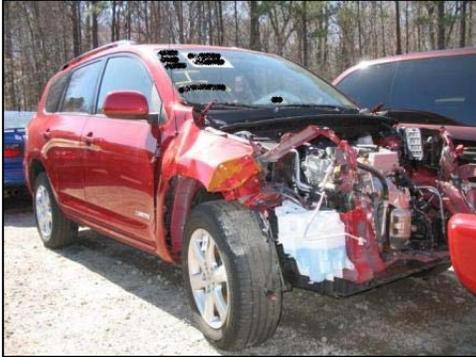
The Toyota sustained moderate severity frontal damage from its impact events with the back plane of the Ford. The exterior damage was dismantled from the structure of the Toyota during the insurance appraisal process. The Toyota was deemed a total loss and was transferred to the regional vehicle salvage facility. None of the damaged parts were with the vehicle at the salvage facility. The dismantled parts included the front bumper system, radiator support, air conditioning condenser and the radiator, hood, left front fender, battery and battery tray, air intake box, and the electric cooling fans. The right front fender, although damaged remained in place. **Figure 5 and 6** are frontal views of the dismantled damage to the Toyota.

Based on the remaining structure, the damage was distributed across the full frontal width of the Toyota. It appeared that the damaged was biased to the right. The post-crash front overhang measurements indicated the right frame rail was displaced rearward 10 cm (3.75 in). There was no displacement of the wheelbases.

Figure 5. Front right view of the 2007 Toyota RAV4.

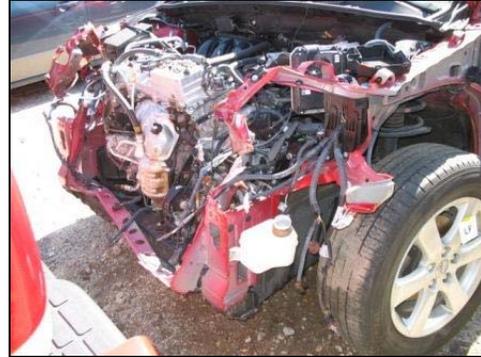
Figure 6. Close-up view of the dismantled damage at the front left area of the Toyota RAV4.

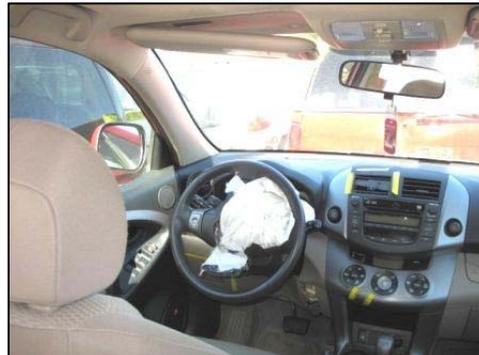
The interior of the Toyota sustained minor severity damage that was associated with air bag deployment and driver contact (**Figure 7**). There was no intrusion of the passenger compartment. The driver's CAC frontal air bag deployed from the tri-flap module within the center hub of the steering wheel. The cover flap opened at the designated tear points.

Figure 7. Overall view of the interior of the Toyota.

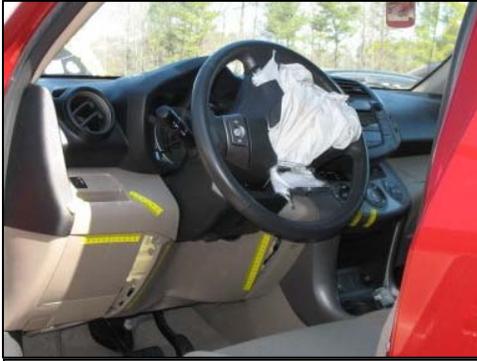
The unrestrained driver initiated forward trajectories in response to the frontal impacts. Her initial trajectory resulted in damage to the mid instrument panel, the knee bolster, and the energy absorbing steering column. The driver's left knee contacted the left mid instrument panel. The contact that compressed the plastic panel was located 53 - 66 cm (21 - 26 in) left of the vehicle's centerline and 23 - 29 cm (9 - 11.4 in) below the top of the instrument panel. Her right knee engaged the knee bolster directly under the steering column. The contact deformed the bolster to a depth of 9 cm (3.5 in) over the full height of the panel. The bolster deformation was located 25 - 51 cm (10 - 20 in) left of the vehicle's centerline and 36 - 55 cm (14 - 21.7 in) below the top brow of the instrument panel. **Figure 8** depicts the knee contact points.

Figure 8. Knee contacts to the mid instrument panel and the knee bolster.

The driver's left knee engaged the left mid instrument panel directly above the level of the knee bolster. This loading minimally compressed the rigid plastic panel and produced stress loading to the panel (whitened). As a result of this contact, the driver sustained a laceration over the knee area.

The driver's right knee engaged the knee bolster under the steering column. The loading deformed the bolster panel 8.9 cm (3.5 in) forward over the height of the panel. She sustained a contusion of the right knee from this contact.

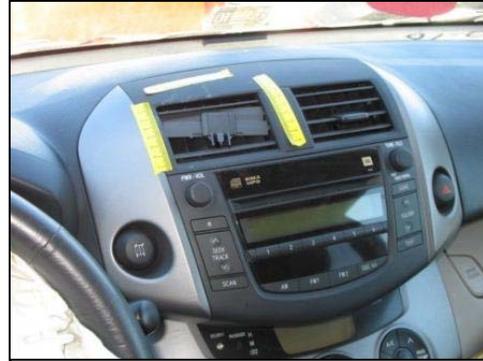
Figure 9. Forehead contact to the upper mid instrument panel.

The secondary frontal impact displaced the driver forward and right of the steering wheel and the deflating frontal air bag. Her face impacted the upper mid instrument panel and the vent louver for the HVAC system (**Figure 9**). The instrument panel was scuffed at the top surface of the vent louver and two of the four vent louvers were displaced. The scuff mark was located 5 - 10 cm (2.0 - 4.0 in) left of center and 0 - 3cm (0 - 1.2 in) below the top surface of the instrument panel. Nasal mucus was also present at the contact area on the lower mid instrument panel below the HVAC controls.

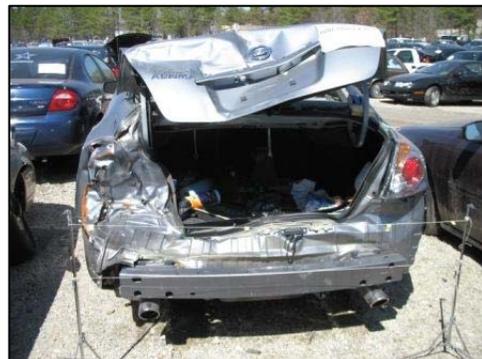
The Nissan sustained moderate severity damage to the back plane (**Figure 10**) from its impact event with the Ford. The damage and resultant crush was located above the level of the bumper. Maximum crush was 42 cm, (16.5 in) and was located at the inboard edge of the tail lamp sheet metal adjacent to the trunk lid opening, 30 cm (12 in) above the rear bumper beam. The bumper fascia was separated from the Nissan at the time of the inspection. The fascia was abraded full width from contact with the road surface. There was no discernable contact evidence from the impact event. The direct contact damage at the level of the trunk began 10 cm (4.0 in) right of the centerline and extended 85 cm (33.5 in) to the back left corner of the quarter

Figure 10. Back plane damage to the Nissan Altima.

panel. The left tail lamp assembly was disintegrated by the impact. The impact deformed the full width of the back sheet metal resulting in a combined induced and direct contact damage length of 145 cm (57 in). A crush profile was documented at the rear bumper beam level. After free space was subtracted, the crush profile results were zero for all six “C” locations. A second crush profile was documented at the level of the sheet metal 19 cm (7.5 in) above the bumper beam. This crush profile was as follows: C1 = 32 cm (12.6 in), C2 = 31 cm (12.2 in), C3 = 12 cm (4.7 in), C4 = 3 cm (1.2 in), C5 = 0 cm, C6 = 0 cm. These two crush profiles resulted in the following average: C1 = 16 cm (6.3 in), C2 = 16 cm (6.3 in), C3 = 0 cm, C4 = 0 cm, C5 = 0 cm, C6 = 0 cm.

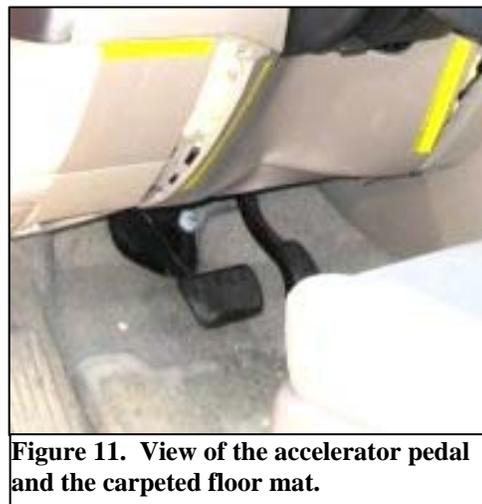
The 2007 Toyota RAV4 was equipped with a Denso accelerator pedal. The pedal moved freely at the time of the SCI inspection without binding and did not engage the OEM carpet when fully depressed.

The OEM carpeted floor mats were installed in the Toyota throughout the driver’s ownership of the vehicle. The front left floor mat was secured in position by two rear-facing hooks located at the aft edge of the mat. The forward edge of the mat was factory cut rearward of the accelerator and brake pedals. The floor mat did not interfere with pedals. **Figure 11** is a view of the foot pedals and the position of the floor mat.

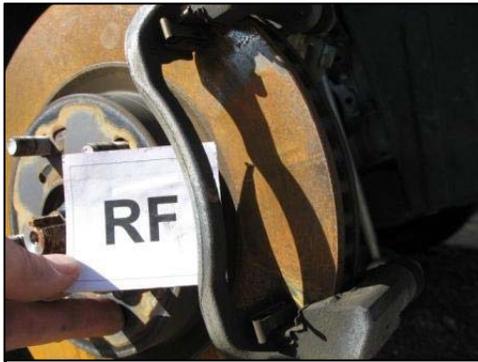
The Toyota was equipped with power-assisted 4-wheel disc brakes. The owner of the vehicle stated that the brakes were OEM and that there were no reported problems with the braking system. During the SCI inspection, the right side tires of the Toyota were raised off the ground with a floor jack and the wheels were removed to inspect the brakes. Both right side rotors were covered with light surface rust.

The right side rotors did not display evidence of heat associated with excessive braking. The calipers were removed via the 14 mm hex head bolts. The pistons were slightly compressed to allow easy removal of the caliper and the brake pads from the rotors. The calipers were removed and the slides moved freely. The brake pads were removed from the calipers and exhibited no evidence of excessive wear or heat. The outer metallic brake pads were covered with light surface rust from exposure to the elements. There was no damage or evidence of prolonged braking to the right side brakes. **Figure 12 and 13** are views of the right front brake rotor and pads.

Figure 12. Right front brake rotor.

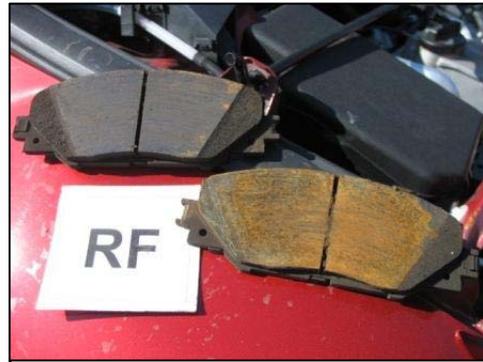
Figure 13. Right front brake pads.
