**CALSPAN ON-SITE POTENTIAL UNINTENDED ACCELERATION  
CRASH INVESTIGATION**

**SCI CASE NO.: CA10010**

**VEHICLE: 2010 TOYOTA RAV4**

**CRASH DATE: MARCH, 2010**

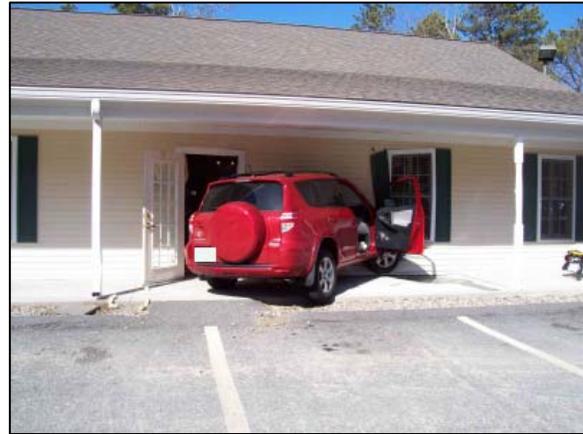
**Figure 1:** View of the 2010 Toyota RAV4 at final rest. Image supplied by the police investigator.

Toyota overrode the sidewalk and impacted the wall of the wood-frame structure. **Figure 1** is an on-scene police image of the crash site. The

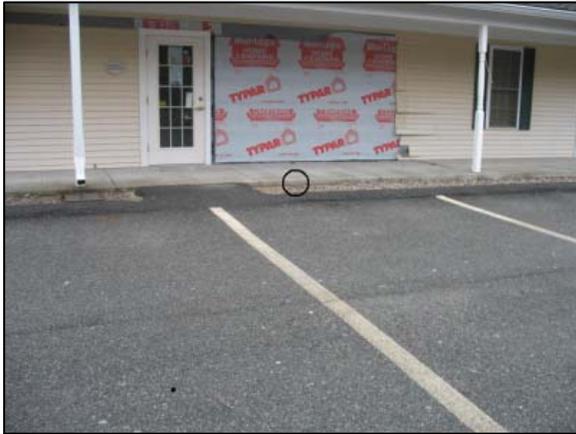
undergoing repair. **Figure 2** is a trajectory view of the Toyota looking northward at the building and the general area of impact. The image was taken at the time of the SCI inspection.

**Figure 2:** Trajectory view of the Toyota approaching the building and the general area of impact.

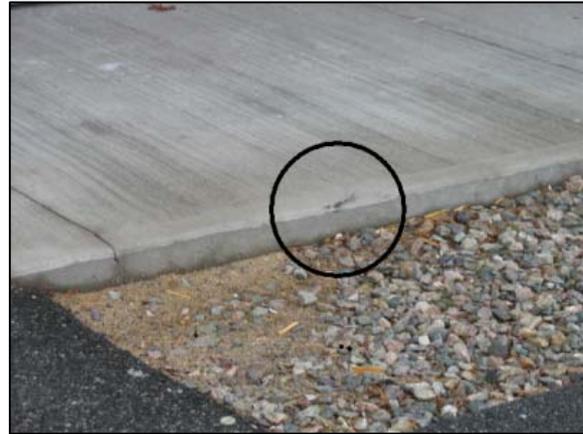
The parking stalls were oriented perpendicular to the face of the building and terminated at a 28 cm (11 inch) wide, tapered asphalt curb. The height of the triangular-shaped asphalt curb measured 8 cm (3.0 in). Immediately beyond the asphalt was an 89 cm (35 in) wide gravel landscaped area which bordered a 191 cm (75 in) wide sidewalk. The sidewalk was located along the perimeter of the building. The top surface of the sidewalk measured 8 cm (3.2 in) above the gravel surface. A 9 cm (3.5 in) long tire scuff mark was observed on the outboard edge of the sidewalk. The tire mark measured 17 cm (6.5 in) in width and wrapped onto the vertical face of the sidewalk. The tire mark was caused by the Toyota's right rear tire at final rest (**Figure 3**).

**Figure 3:** Right rear tire scuff identified at the crash site during the SCI investigation.

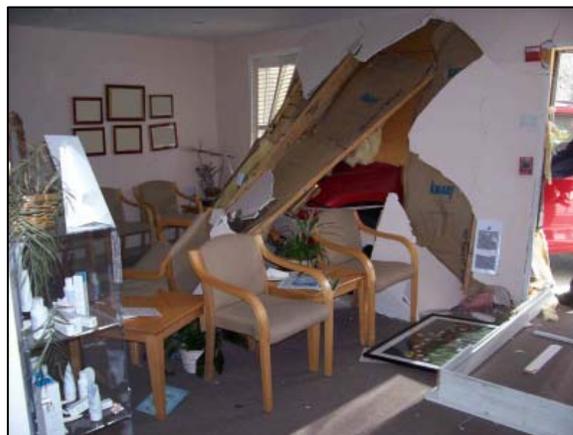
The front left and center aspects of the vehicle's front plane impacted the south wall of the building. As the vehicle penetrated the structure, the entire width of the frontal plane contacted the wall. The bottom plate of the wood structure separated from its attachment to the concrete floor and cantilevered inboard at the ceiling. The vehicle came to rest approximately 1.2 m (4 ft) inside the building, **Figure 4**. A scuff mark attributed to the left front tire was observed on the office carpet. The mark was arc-shaped and measured 38 cm (15 in) long. The maximum width of the mark was 25 cm (10 in).

**Figure 4:** On-scene police image of the vehicle at final rest.

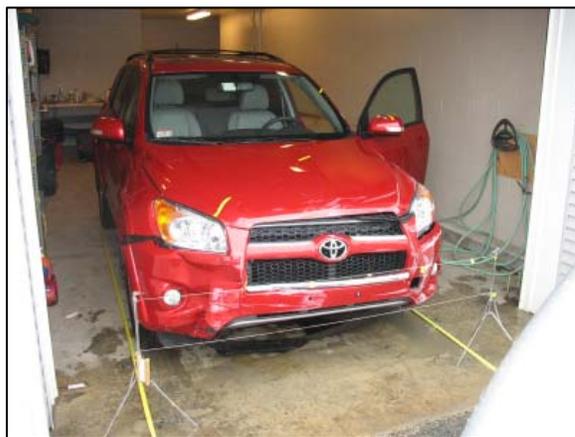
The Toyota RAV4 sustained minor severity damage to the front plane, hood, and the forward aspect of the left side plane due to the yielding impact with the building wall. **Figure 5** is a front view of the Toyota. The damage primarily consisted of surface abrasions to the body panels and deformation of the bumper fascia. Examination of the bumper reinforcement beam revealed 3 cm (1.2 in) of crush to the right end of the beam. The center and left aspects of the reinforcement beam were undamaged. Surface abrasions were noted across the hood, along the left A-pillar, on the body of the left mirror and on the leading edge of the left door panel. There was no change in the wheelbase dimensions. There was no damage to the windshield or side glazing. All the doors remained closed during the impact and were operational post-crash. The residual crush profile at the front bumper elevation was as follows: C1 = 2 cm (0.8), C2 = 1 cm (0.4), C3 = 1 cm (0.4), C4 = 0, C5 = 1 cm (0.4), C6 = 5 cm (2.0 in). An analysis of the crash severity (delta-V) was beyond the scope of the WinSMASH program due to the yielding impact. The Barrier Equivalent Speed based on the damage profile was 14 km/h (8.7 mph). The Collision Deformation Classification was (CDC) 12FDEW1.

**Figure 5:** Front right oblique view of the Toyota RAV4.

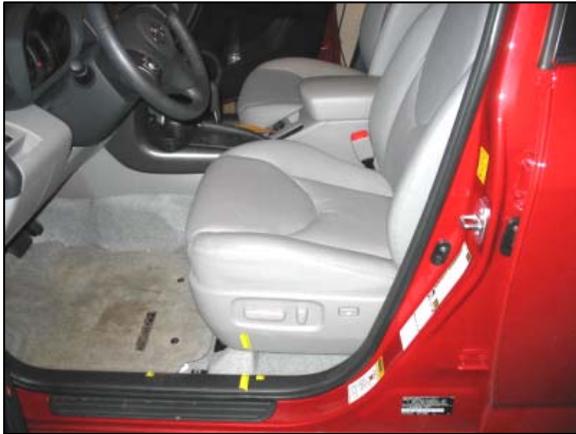
the care taken by the police investigator to preserve and store the vehicle, this was probably the at-crash adjustment of the seat. The front interior was equipped with the OEM carpeted floor mats. The driver mat was secured by the hooks to the floor. **Figure 6** is an interior view of the driver floor mat and the foot controls.

**Figure 6:** View of the driver interior and floor mats.

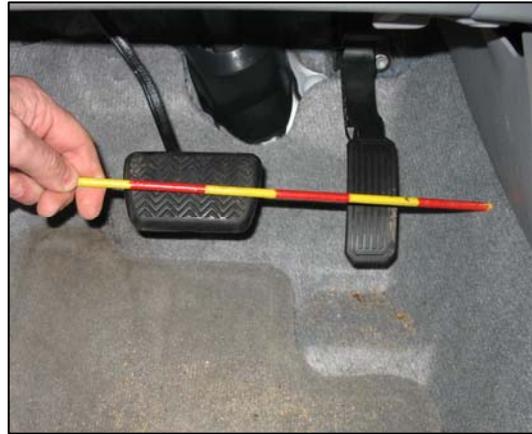
The Toyota was equipped with the CTS accelerator pedal and was subject to the Sticky Pedal Recall. The Toyota was serviced for the recall on February 16, 2010. The service record indicated that a 2.0 mm shim was inserted into the pedal assembly. **Figure 7** is a view of the accelerator and brake pedals taken during the SCI inspection. The accelerator pedal was identified by the following:

**Figure 7:** View of the foot controls.

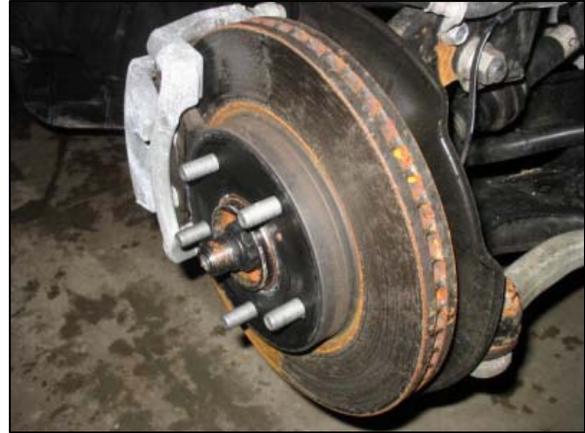
During the SCI inspection, the left front wheel/tire was removed in order to assess the condition of the brakes. The surface of the rotor was lightly rusted from exposure to the environment. There was no sign of prolonged heating to the rotor or pads. The brake pads had adequate thickness. The brake fluid reservoir (at the master cylinder) was full of brake fluid and there were no apparent leaks in the brake system. **Figure 8** is a view of the left front rotor and brake assembly.

**Figure 8:** Left front rotor and brake assembly of the Toyota.

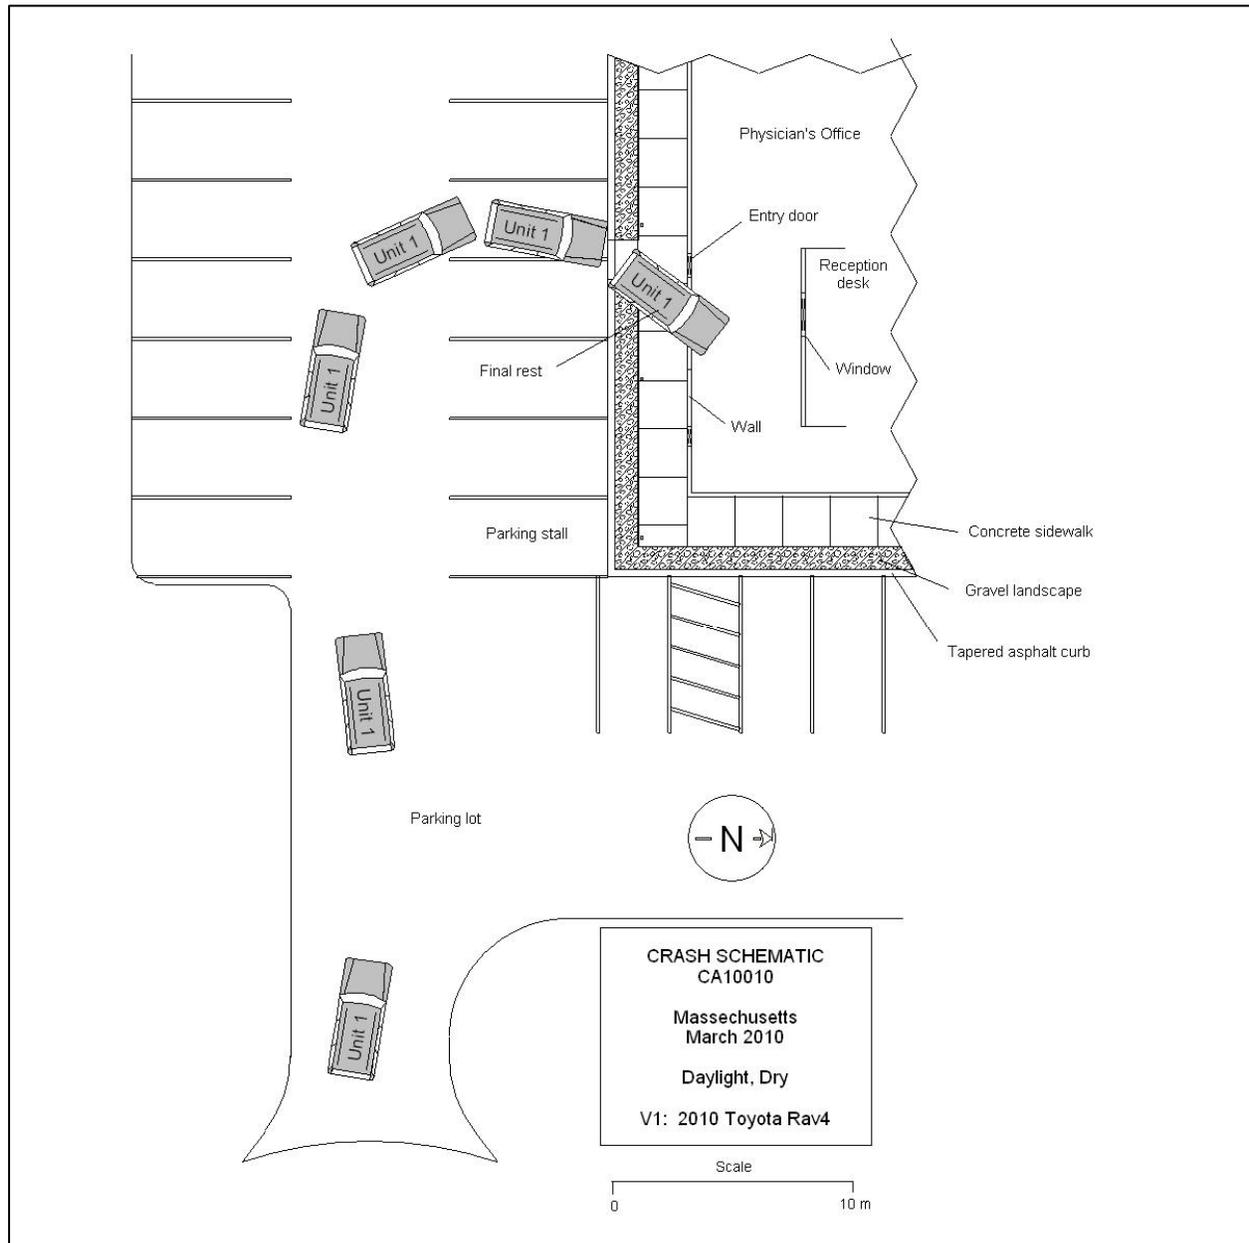
Figure 9: Crash schematic.

A schematic of the crash sequence is attached to the end of this report as **Figure 9**. The Toyota completed a left turn from the adjacent roadway and entered the parking lot adjacent to the office building. The Toyota was travelling on a westward trajectory, south of the building, at an EDR reported speed of 10.0 km/h (6.2 mph) 5 seconds prior to the crash. The driver steered clockwise to enter a parking stall and park the vehicle outside of the physician's office. The crash reconstruction indicated that driver over-shot the entry turn into the stall and had to turn beyond 90 degrees in order to remain within the stall. The vehicle approached the curb and sidewalk at approximately 75 degrees (relative to the curb). The Toyota then overrode the curb and sidewalk.
