**OFFICE OF DEFECTS INVESTIGATION  
CALSPAN ON-SITE POTENTIAL UNINTENDED ACCELERATION  
CRASH INVESTIGATION**

**SCI CASE NO.: CA10014**

**VEHICLE: 2007 TOYOTA CAMRY**

**CRASH DATE: MARCH, 2010**

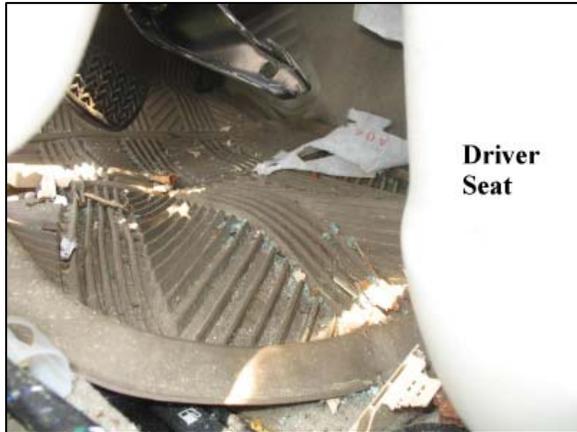
The four outboard positions of the Toyota were equipped with unsecured aftermarket all-weather floor mats positioned on top of the OEM carpeted floor mats. The OEM carpeted mat in the driver's position was secured to the vehicle by the two floor hooks that were located immediately forward of the driver seat. **Figure 2 and 3** are views of the driver's floor area and the position of the aftermarket mat. The driver's OEM floor mat was not removed from the vehicle's interior during the SCI inspection. Refer to the *Interior Damage* section of this report for further information regarding the foot controls and the intrusion into the driver's floor area.

**Figure 2: Driver floor area and the aftermarket floor mat.**

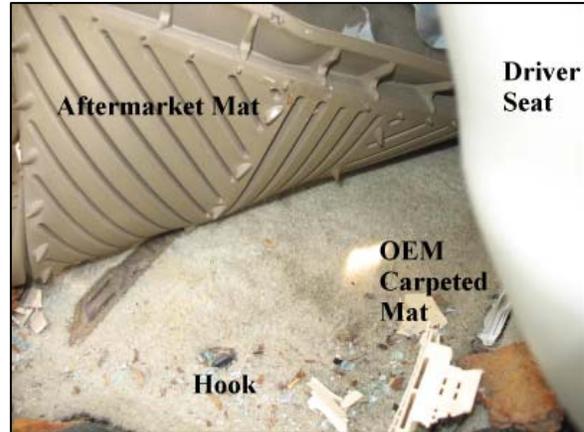
**Figure 3: Aftermarket mat on top of OEM mat.**

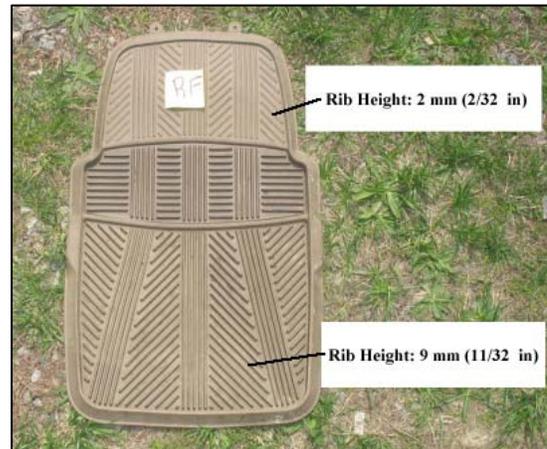
**Figure 4** is a view of the right front aftermarket floor mat. It was found outside the vehicle. This floor mat appeared to be similar to the driver's floor mat. The overall dimensions of the mat measured 74 cm x 46 cm (29 in x 18 in), length by width. The forward aspect of the mat tapered to a 37 cm (14.5 in) width. The underside of the mat was embossed with the following manufacturer's label: V450 7055-Uf-C. Clock stamps embossed into the mat indicated that the mat was manufactured during the 4<sup>th</sup> month of 2008. The top surface of the mat consisted of a symmetrical raised-rib pattern. The height of the ribs at the forward-most aspect of the mat measured 2 mm (2/32 in). The rib height in the aft section of the mat measured 9 mm (11/32 in).

**Figure 4: View of the right front aftermarket floor mat.**

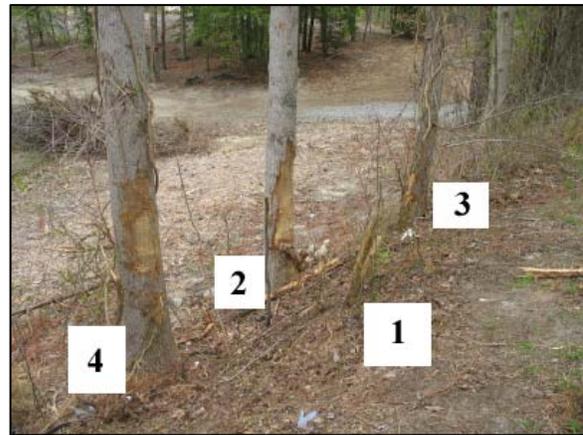
was the point of impact. Four trees exhibited contact damage as a result of the crash. **Figure 6** is a trajectory view immediately prior to the impacts.

**Figure 6: Close-up northward view of the impacted trees.**

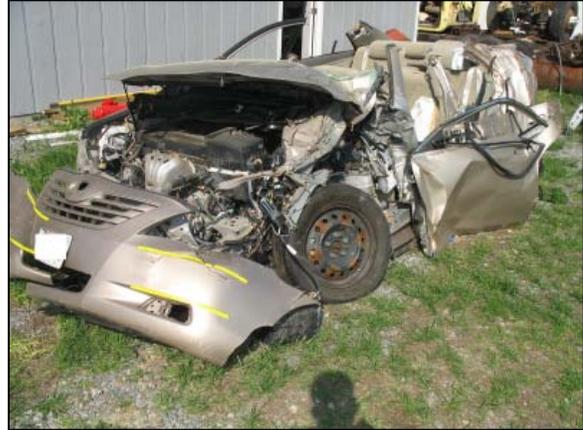
The Toyota Camry sustained severe impact damage to the left plane as a result of the multiple tree impacts. **Figure 7** is a left front oblique view of the vehicle. The front bumper fascia exhibited three regions of surface abrasions that were related to the three tree impacts. The first region of abrasions began 12 cm (4.7 in) right of center and extended 29 cm (11.4 in) to the right. This damage was related to Event 1. The left aspect of the fascia was abraded over a 30 cm (11.8 in) width. This abraded region began 58 cm (22.8 in) left of center, extended to the left and around left front corner. This damage resulted from Event 2. The right aspect of the fascia was abraded over a 30 cm (11.8 in) region that began 46 cm (18.1 in) right of center and extended to the right corner. This abraded region resulted from Event 3.

**Figure 7: Left front oblique view of the Toyota Camry.**

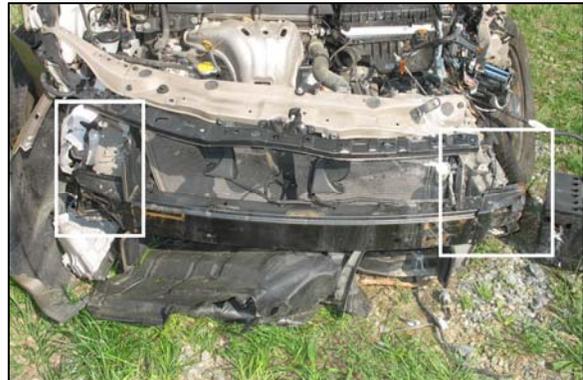
The front bumper fascia had separated during the impacts and exposed the bumper reinforcement beam. The reinforcement measured 120 cm (47.2 in) in width and was relatively undamaged. There was no measurable residual crush along the width of the beam. Only the extreme outboard ends of the beam exhibited damage from the tree impacts (**Figure 8**). The left end of the beam was deformed over an 8 cm (3.1 in) width beginning 52 cm left of center. The residual deformation was less than 5 cm (2 in). There was no compression of the Toyota's left uni-body frame rail. The right end of the reinforcement beam was deformed over a 10 cm (3.9 in) width. The deformation began 50 cm (19.7 in) right of center. The deformation within the region measured approximately 5 cm (2.1 in). There was no compression of the right uni-body frame rail. Based on the physical evidence, the front corners of the Toyota engaged the respective trees. Then as the vehicle continued forward, the trees became engaged with the vehicle's structures outboard of the frame rails.

**Figure 8: Close-up view of the reinforcement beam.**

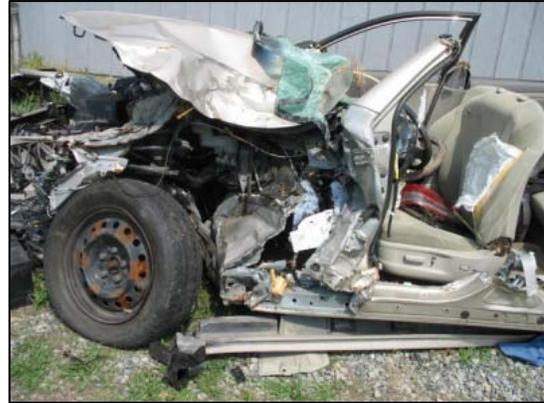
The left side of the Toyota (**Figure 9**) sustained impact damage that extended from the front corner to the A-pillar area, as a result of the tree contact of Event 2. The direction of the impact

force was in the 11 o'clock sector. The left fender and components of the left inner fender separated during the impact. The left aspect of the hood exhibited direct contact damage that measured 23 cm (9.0 in) laterally by 91 cm (36.0 in) longitudinally. The tree engaged the aft aspect of the wheelhouse and pocketed into the left aspect of the cowl and A-pillar. The spot welds at the base of the A-pillar separated from the sill due to overload. The longitudinal crush at the mid-Aspect of the A-pillar measured 51 cm (20.1 in). There was no change in the left wheelbase dimension.

**Figure 9: View of the forward left side damage to the Toyota.**

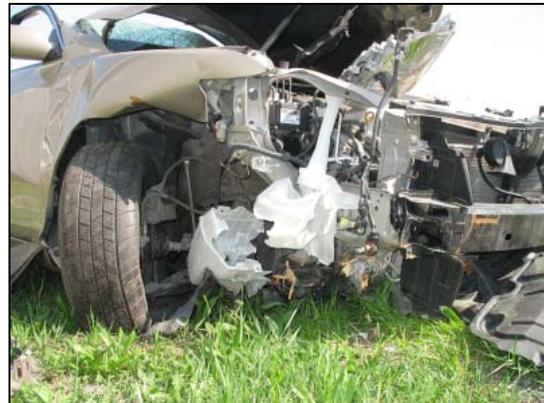
The forward aspect of the right plane exhibited damage extending from the front corner consistent with the tree impact of Event 3 (**Figure 10**). The lower aspect of the right fender was deformed and the right wheel assembly was deformed rearward. The right wheelbase was reduced 7 cm (2.8 in). Tree bark was observed to have adhered to the damaged components.

**Figure 10: View of the damage to the forward right side of the Toyota.**

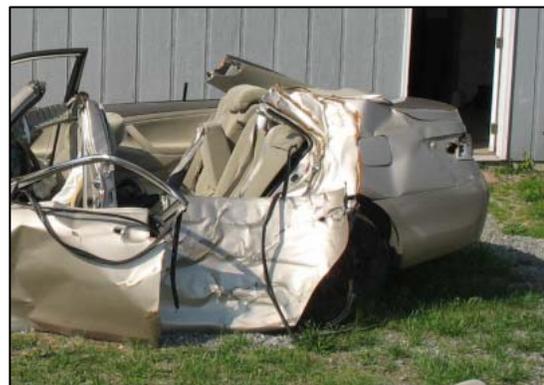
The direct contact damage from Event 4 began at the forward edge of the left rear door and ended 9 cm (3.5 in) aft of the left rear axle. Refer to **Figure 11**. The damage within this region extended vertically onto the left roof side rail. The left aspect of the roof was buckled. The tree pocketed in the area of the left C-pillar. The measured depth of the pocketing was 20 cm (8.0 in). The direction of force was in the 11 o'clock sector.

**Figure 11: View of the damage at the rear aspect of the left side.**

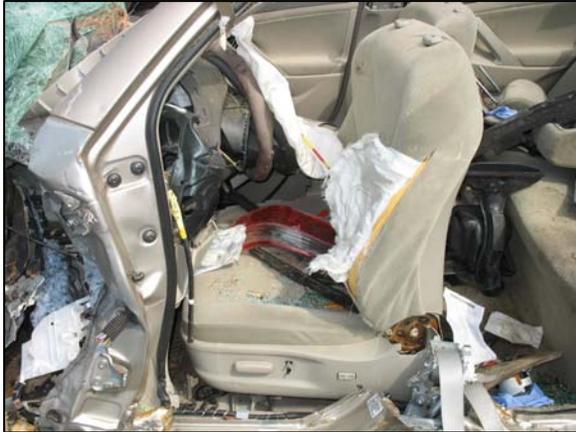
The interior of the Toyota sustained moderate damage as a result of the crash. **Figure 12** is a left lateral view across the front row depicting the intrusion into the driver's interior. **Figure 13** is an overhead view of the interior. The instrument panel, toe pan and associated components intruded into the driver's position. The roof and left C-pillar intruded into occupant space of the second row left passenger. The measured intrusions are listed in the table below:

**Figure 12: Left lateral view across the front row.**

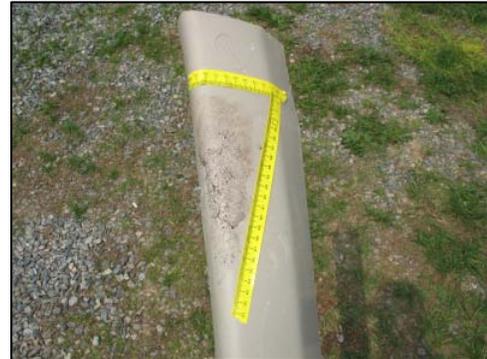
The driver seat was located in a rear-track position that measured 4 cm (1.5 in) forward of full-rear. The total seat track travel of an exemplar vehicle measured 27 cm (10.5 in). The post-crash seat back angle measured 5 degrees aft of vertical. The intruded A-pillar trim panel exhibited an 18 cm x 5 cm (7 in x 2 in) area of contact (**Figure 14**). The center of the contact area was located 18 cm (7.0 in) below the top of trim. This contact was attributed to the driver's head. A left lower extremity contact was identified to the left aspect of the knee bolster (behind the knee air bag). The contact measured 8 cm x 5 cm (3.0 in x 2.0 in) and was located 11 cm (4.5 in) right of the outboard edge of the bolster panel.

**Figure 14: View depicting the head contact to the left A-pillar.**

*Discussion:* The Medical Examiner (ME) only conducted an external autopsy of the driver and listed the cause of death as blunt force trauma to head, chest and abdomen. An internal examination was not conducted. It should be noted that both the hospital records and ME's report reference an obvious head injury. Specifically, the Discharge Summary identified "significant damage to the left side of her cranium" and the external examination stated "an obvious head injury". It is believed that the driver sustained a significant (unknown) head injury that contributed to her death. Unfortunately, due to the identification of the scalp (head) laceration in the records, current AIS injury coding conventions do not allow the above statements to be used as an injury identifier. The source of the (probable) head trauma would have been attributed to the left A-pillar as evidenced by the identified occupant contact. Refer to **Figure 14** above. Per protocol, the NASS coded cause of death was unknown.

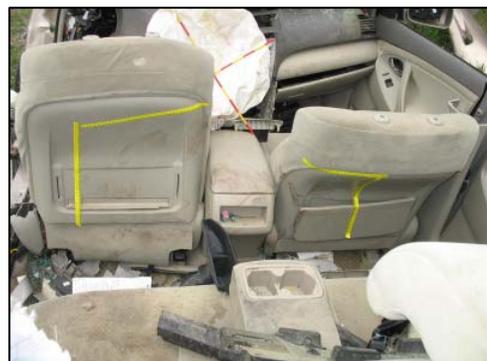
The backs of the driver seat and front right seat were loaded from behind by the unrestrained occupants in the second row. The contact area to the driver seat back measured 38 cm x 36 cm (15.0 in x 14.0 in), width by height. The inboard upper aspect of the driver seat was deformed slightly forward. The contact to the front right seat back measured 18 cm x 39 cm (7.0 in x 15.5 in), width by height. Post-crash body fluid evidence was noted on both seat backs and on the center console, **Figure 15**.

**Figure 15: View of the contacts to the front row seat backs**

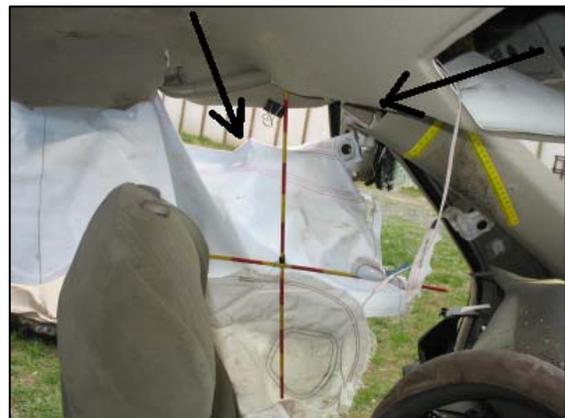
During the crash, the left A-pillar deformed rearward. This in-turn deformed the left roof side rail and caused a rearward displacement of the most forward attachment point of the IC. The A-pillar and attachment point displacement allowed a pocket to form at the left front window and reduced the tension across the length of the IC. The reduced tension allowed a partial ejection through the left rear window opening. During the crash, the left forearm of the unrestrained second row left passenger was partially ejected and injured. **Figure 18 and 16** (above) depict the pocketing and reduced tension in the IC.

**Figure 18: Right lateral view of the deployed left IC and seat-mounted air bag.**

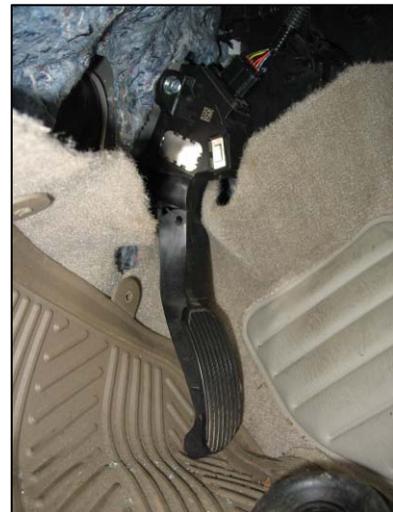
The Toyota was equipped with the CTS accelerator pedal and was subject to the Sticky Pedal Recall. It could not be determined if the pedal had been serviced prior to the crash. The shape of the pedal did not appear to have been modified as required by the recall. **Figure 19** is a view of the accelerator pedal taken during the SCI inspection. The pedal was identified by the following:

**Figure 19: Post-crash position of the Toyota's accelerator pedal.**

It was noted that the accelerator pedal was in contact with the floor mat. However, the pedal was in the closed position. It was not jammed or captured by the after-market floor mat. The deformation of the toe pan caused the pedal assembly (as a whole) to rotate downward (clockwise) and contact the floor. The pedal assembly was in a near-vertical position. The intrusion prevented fore/aft movement of the pedal. There was minor lateral pedal movement. **Figure 20** is a close-up view of the accelerator at its contact with floor. **Figure 21** is a view of the arrangement of the foot controls in an exemplar 2007 Toyota Camry. The accelerator pedal measured 8 cm (3 in) above the floor in its undamaged condition. The toe pan intrusion and subsequent rotation of the pedal in the case vehicle reduced its clearance above the floor.

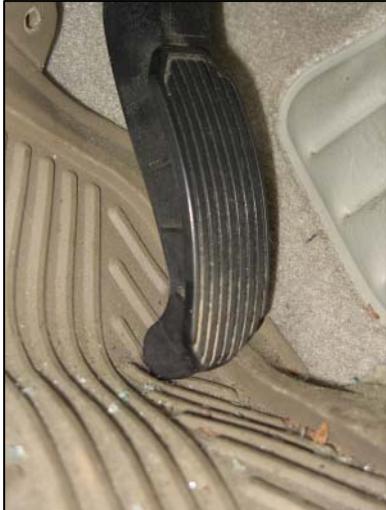
**Figure 20: View of the accelerator pedal in contact with the floor mat.**

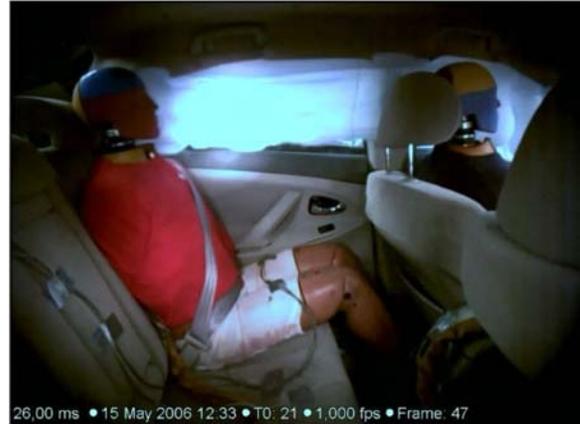
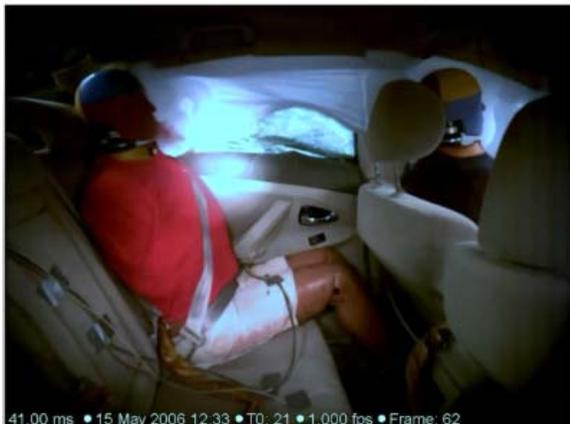
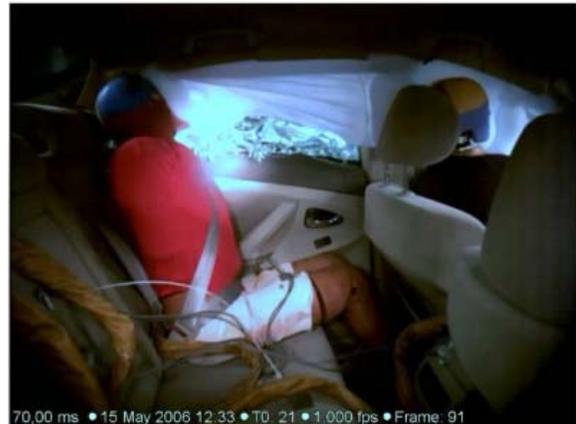
Additional research into the deployment pattern of the Toyota's IC air bag was conducted by the SCI team. The side impact test films indicated that there existed an opening during the deployment sequence of the IC. An intermittent gap between the window sill and the deploying IC air bag develops and closes as the chambers inflate and tension develops across the IC. **Figures 22 – 24** are frame captures from the test crash video depicting the gap opening. It should be noted that in the lateral crash test, there was no A-pillar displacement and the IC should have been under maximum tension. However, the opening was still present. The displacement of the A-pillar during the subject crash would have greatly reduced the tension across the IC, thereby allowing the left arm of the second row left occupant to become partially ejected.

**Figure 22: Right interior view of the deploying IC in NHTSA test #5674 at 26 milliseconds post-impact.**

**Figure 23: Right interior view of the deploying IC in NHTSA test #5674 at 41 milliseconds post-impact.**

**Figure 24: Right interior view of the deploying IC in NHTSA test #5674 at 70 milliseconds post-impact.**
