TRANSPORTATION RESEARCH CENTER

ON-SITE AMBULANCE CRASH INVESTIGATION

CASE NUMBER - IN10018
LOCATION - MINNESOTA
VEHICLE - 1999 FORD E350 TYPE II AMBULANCE
CRASH DATE - May 2010

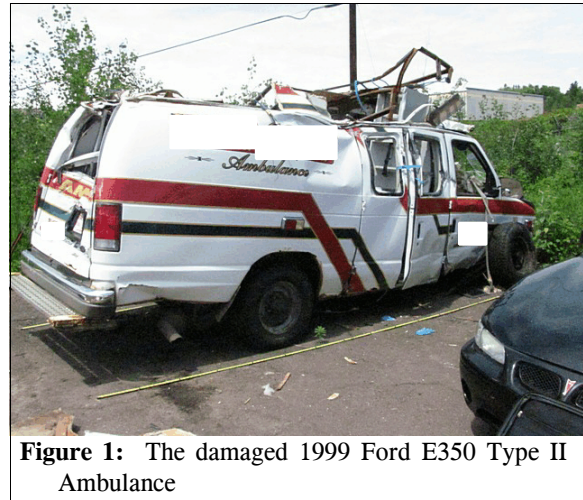
Figure 1: The damaged 1999 Ford E350 Type II Ambulance

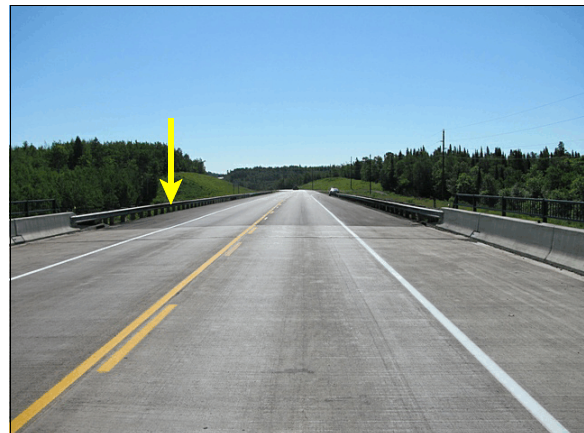
Pre-Crash: The ambulance was traveling east (Figure 2) with the emergency lights and siren activated and was crossing a slush covered bridge. The Jeep was traveling west and the 30-year-old male driver had stopped on the north shoulder in response to the approaching ambulance. The ambulance lost traction on the bridge and began to rotate counterclockwise and travel toward the north shoulder (Figure 3). The SCI inspection of the ambulance revealed that the tread depth of the right and left rear tires was 0 mm and 1 mm (0.039 in), respectively. The tread depth of each front tire was 10 mm (0.39 in) and they were significantly overinflated. The tire information table is on page 6 of this report.

Figure 2: Approach of the ambulance eastbound on the bridge; arrow shows the area of the crash

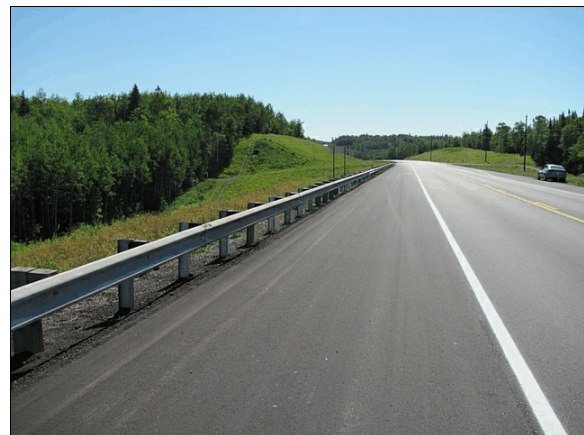
Figure 3: View northeast to the area of impact with the Jeep, which was stopped on the shoulder

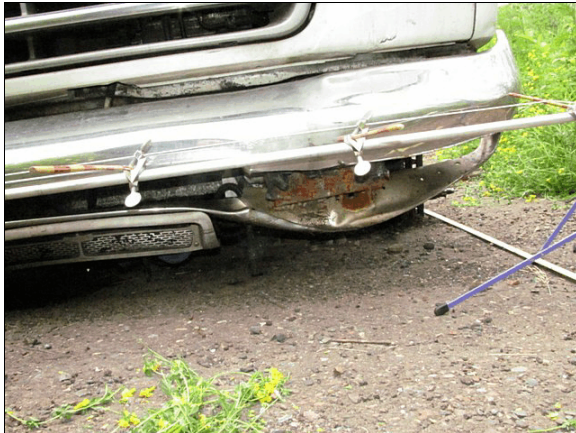
Figure 4: Damage on the front bumper of the ambulance from the impact with the guardrail

Exterior Damage Event 2: The ambulance sustained damage on the front bumper during the impact with the guardrail. The direct damage began at the front left bumper corner and extended 62 cm (24.4 in) across the bumper. Crush measurements were taken on the bumper and the

maximum residual crush was 8 cm (3.1 in) occurring at C₆. The left front wheel engaged the guardrail during this impact, which severed the wheel from the hub. The right front wheel was also displaced rearward 31 cm (12.2 in). The table below presents the front plane crush profile.

Damage Classification Event 2: The CDC for the front bumper impact was 12FYLW1. The WinSMASH program could not be used to determine a Delta V since impacts with yielding objects are out of scope for the program. The severity of the damage was minor based on the damage on the bumper.

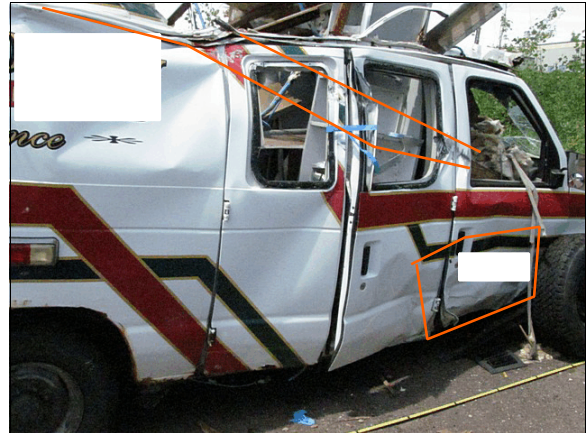
Figure 5: The outlined areas show the damage on the vehicle from rolling over onto the guardrail

The direct damage on the right side plane began on the roof side rail above the right rear axle and extended 70 cm (27.6 in) forward along the roof side rail. The damage then extended diagonally downward to the B-pillar ending 117 cm (46 in) above the ground. The total length of this damaged area along the right side plane was 240 cm (94.5 in). The maximum crush was 12 cm (4.7 in) and occurred on the roof side rail immediately rear of the patient compartment entry doors. There was also direct damage on the lower portion of the right front door and patient compartment entry door that began 185 cm (72.8 in) forward of the right rear axle and extended 115 cm (45.3 in) forward.

Damage Classification Events 3 and 4: The CDC for the rollover onto the guardrail was 00TZDO4. The CDC for the right side plane damage that occurred during the rollover was 00RPHW3. The WinSMASH program could not be used since a rollover and a non-horizontal impact are out of scope for the program. The severity of the damage for the rollover was severe based on the extent of the crush on the top plane. The severity of the damage on the right side plane was moderate based on the crush on the right roof side rail.

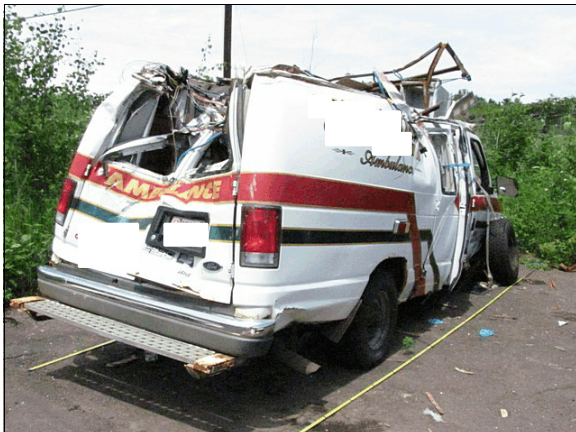
Figure 6: The top of the patient compartment was destroyed and the patient loading doors were damaged during the rollover

Exterior Damage Events 3 and 4: During the rollover, the ambulance sustained damage on the right side plane and top plane from impacts with the guardrail. The direct damage on the top plane extended 410 cm (161.4 in) forward from the backlight header to the windshield header and involved the full width of the top, 146 cm (57.4 in). The top of the patient compartment was constructed of fiberglass and plywood and was supported by a metal frame. This structure was torn off the vehicle with the exception of the front metal frame members. The top of the patient loading doors was crushed forward 89 cm (35 in). The maximum vertical crush of the top structure was 88 cm (34.6 in) and occurred at the backlight header of the left patient loading door. It included the crush and displacement of the fiberglass and plywood top and its metal frame. The maximum lateral crush of the top structure was 20 cm (7.9 in) and occurred at the left C-pillar.

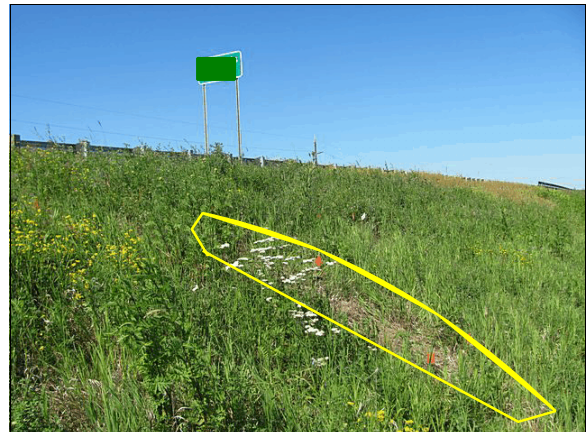
Figure 7: View back to the roadway; highlighted area shows divot on ground at the final rest location of the ambulance

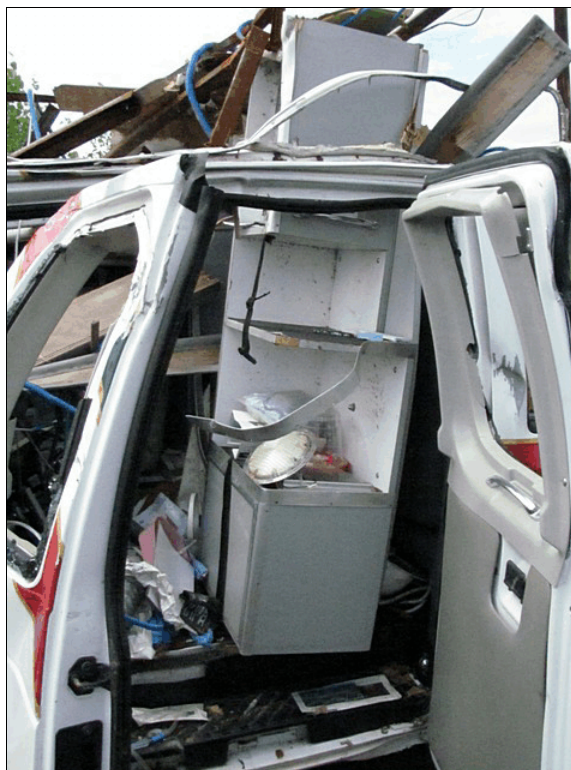
Figure 8: Damage and displacement of the front storage cabinet

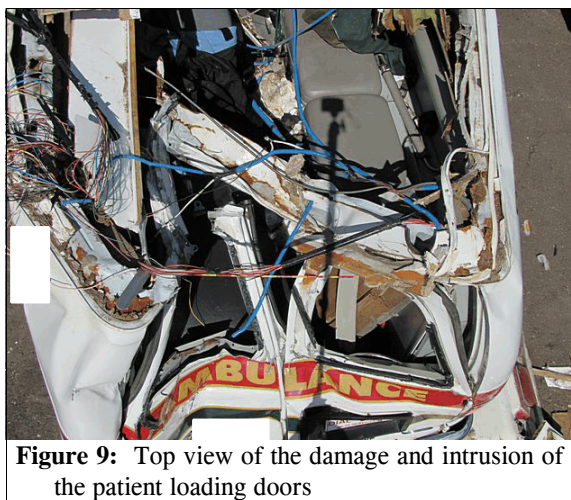
Figure 9: Top view of the damage and intrusion of the patient loading doors

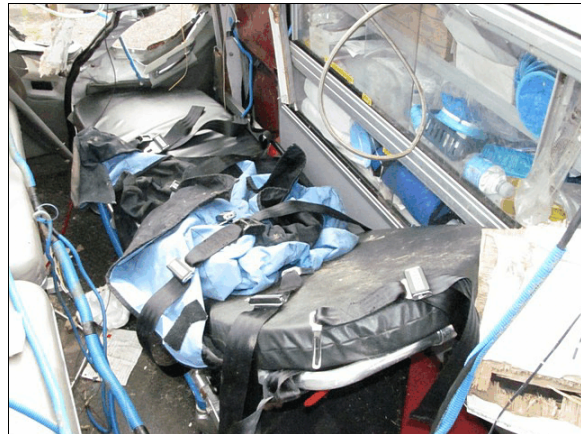
The cot that was used to transport the patient was a Ferno PowerFlex+ (**Figure 10**), which was designed for bariatric transport. The model number and serial number could not be determined since moving the cot was not allowed. The cot was constructed of steel tubing and was equipped with a 24 volt DC power pak with hydraulic actuator and dual lifting cylinders. The unassisted lift capacity was 318 kg (700 lb). The load capacity of the cot in the lowest position was 454 kg (1000 lb). The patient's weight 127 kg (280 lbs). The lower frame of the cot was a scissor design, which allowed for a height adjustment range of 33-104 cm (13-41 in). The maximum specified loading height was 86 cm (34 in) The specified maximum length of the cot was 211 cm (83 in). The minimum length was 61 cm (24 in) and the width was 61 cm (24 in).

Figure 10: The Ferno PowerFlex+ patient cot

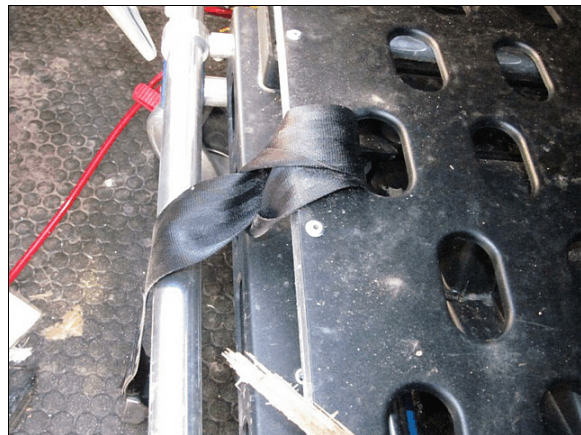
Figure 11: The leg and torso restraints were tied to the cushion support frame

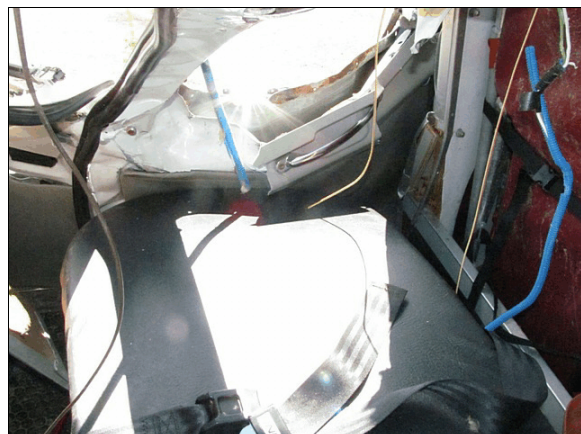
Figure 12: The intruded left patient loading door was in contact with, but did not deform the patient cot

bracket or the cot's framework. The lower portion of the back left patient loading door intruded longitudinally 41 cm (16.1 in) and was contacting the bottom end the cot (**Figure 12**). The cot was not damaged by the intruded loading door. The back rest of the patient cot was elevated 37 degrees. There was no deformation of the back rest.

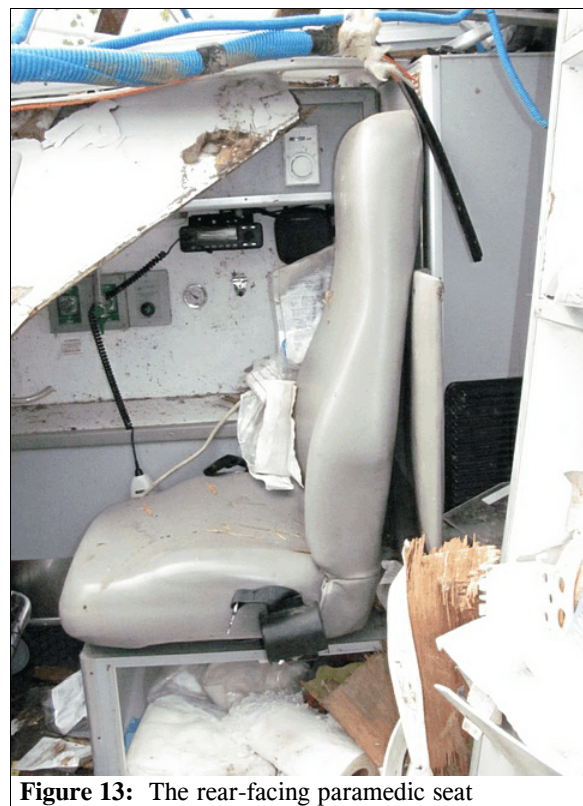
Figure 13: The rear-facing paramedic seat

the guardrail, the paramedic loaded the seat back. There was no evidence of deformation on the seat back, which was reinforced by the bulkhead behind the seat (**Figure 13**). As the vehicle rotated counterclockwise and rolled over right side leading, the paramedic was redirected to the right and toward the roof within his lap belt. He remained restrained in the seat throughout the rollover sequence. He sustained a fractured arm. The aspect and injury source are not known. Following the crash, he exited the vehicle through the open roof structure. A passerby assisted him in the removal of the patient from the cot.

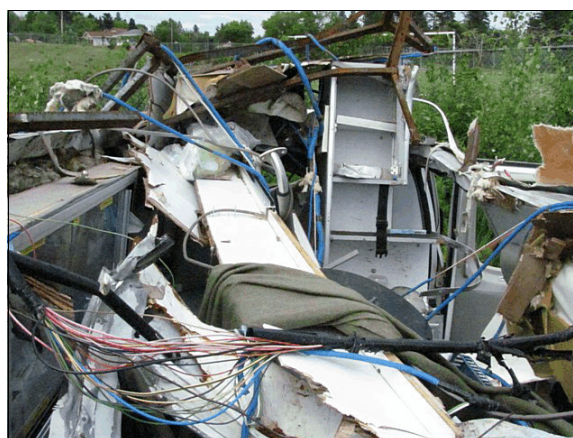
The patient loaded the restraints during the crash and remained restrained on the cot throughout the crash sequence. Displaced roof structure components (**Figure 8**) contacted him during the rollover as the roof was crushed and broken by the guardrail. He sustained bilateral rib fractures, a massive bilateral pneumothorax, a lacerated left lower lung, a contusion of the epicardium, a compound fracture of the right femur, and multiple lacerations and contusions. He was removed from the vehicle by the paramedic and passersby and attended to by responding emergency medical personnel.

Figure 8: Back to front view of the damaged patient compartment
