On-Site Potential Unintended Acceleration Investigation  
Dynamic Science, Inc. Case Number DS10024  
Office of Defects Investigation  
2008 TOYOTA CAMRY  
Utah  
November 2010

1. Report No. DS10024		2. Government Accession No.		3. Recipient Catalog No.	
4. Title and Subtitle  On Site Potential Unintended Acceleration Investigation				5. Report Date July 8, 2011

**Dynamic Science, Inc.  
Crash Investigation  
Case Number: DS10024**

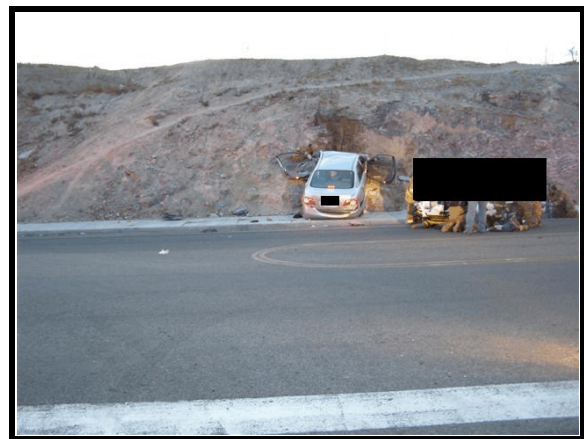
The Toyota came to rest at an upward angle with its front tires on the embankment and the rear tires on the adjacent sidewalk (**Figure 4**). On scene photos show brake lights and 4-way flashers were on at vehicle final rest.

**Figure 4.** Toyota at final rest (police photo)

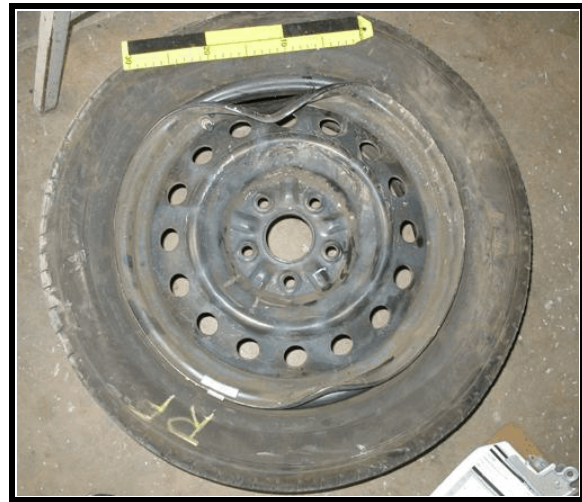
There were a total of six events in this crash. Events 1 and 2 involved front tires to curb impacts. The left front tire was de-beaded and the rim was deformed in three locations. The first deformation measured 18.0 x 5.0 cm (7.0 x 1.9 in), the second 23.0 x 5.0 cm (9.0 x 1.9 in), and the third 10.0 x 3.0 cm (3.9 x 1.2 in). The right front tire was de-beaded and the rim was deformed in two locations (**Figure 5**). The first deformation measured 18.0 x 4.0 cm (7.0 x 1.6 in) and the second 10.0 x 2.0 cm (3.9 x 0.8 in). The Collision Deformation Classifications (CDCs) for the curb impacts were 12FLWN3 and 12FRWN3, respectively.

**Figure 5.** Right front tire/rim damage

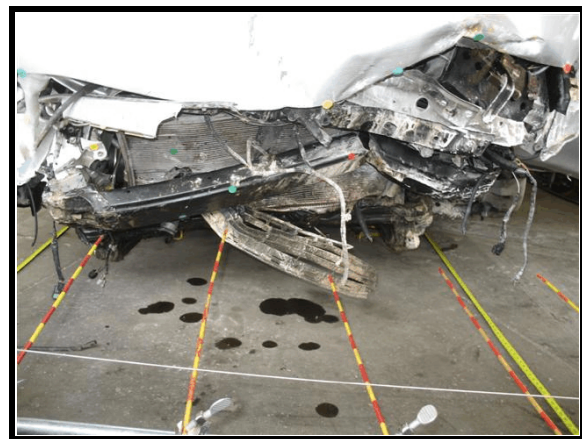
The Toyota sustained severe damage to the front plane from the impact with the embankment (Event 3). The direct damage began at the front left backing bar corner and extended 120.0 cm (47.2 in) to the right (**Figure 6**). Six crush measurements were documented at the backing bar as follows:  $C_1 = 81.0$  cm (31.8 in),  $C_2 = 79.0$  cm (31.1 in),  $C_3 = 83.0$  cm (32.7 in),  $C_4 = 74.0$  cm (29.1 in),  $C_5 = 64.0$  cm (25.1 in),  $C_6 = 60.0$  cm (23.6 in). The maximum crush was located at  $C_3$ . The CDC for the frontal impact with the embankment was 12FDEW4.

**Figure 6.** Frontal damage

Due to the frontal impacts, the wheelbase was shortened by 42.0 cm (16.5 in) on the left and 24.0 cm (9.4 in) on the right.

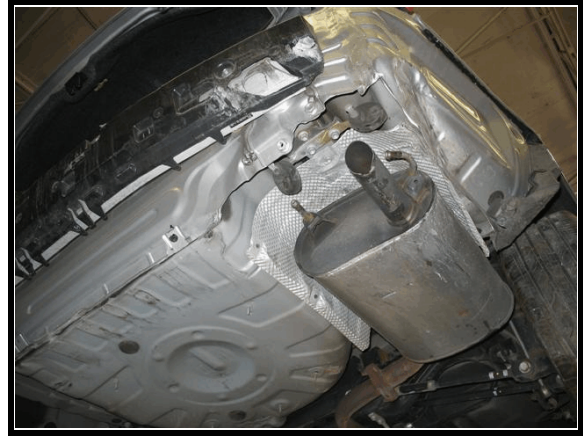
The Toyota sustained minor damage to the rear bumper and undercarriage from contact with the sidewalk as the vehicle climbed the embankment (Event 6) (**Figure 7**). The direct damage began at the right corner of the vehicle and extended laterally along the undercarriage 130.0 cm (51.1 in). The direct damage included scratches along the rear face of the rear bumper fascia. The CDC for this impact was 00UBDW2.

**Figure 7.** Undercarriage damage

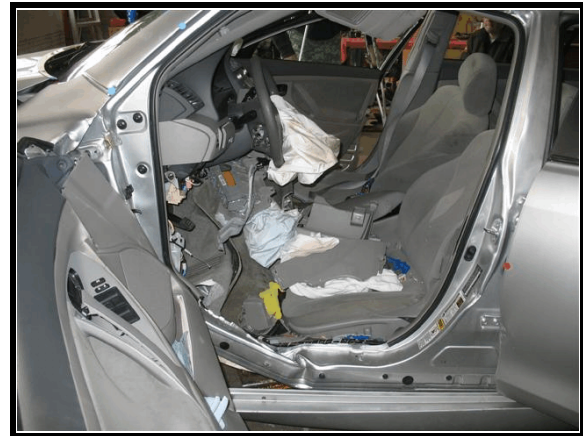
The Toyota sustained moderate interior damage as a result of passenger compartment intrusion and occupant contacts. The vehicle sustained longitudinal intrusions to the toe pan, lower A-pillar, and instrument panel and vertical intrusions to the floor. Prior to the vehicle inspection, the police and rescue personnel had used extrication tools to move vehicle components on the driver's side of the vehicle to access the foot controls. The accelerator pedal was broken and removed from the vehicle during this effort. There was also longitudinal intrusion to the rear seat due to cargo movement. The windshield was cracked but remained intact. The driver's door appeared to be jammed shut and the remaining doors remained closed and operational. The steering wheel rim was deformed forward due to occupant loading (**Figure 8**). The lower instrument panel fascia was displaced. There were scuffs and skin transfers to the roof and roof side rails. The first was located aft of the B-pillar (**Figure 9**) and measured 30.0 x 8.0 cm (11.8 x 3.1 in). The second was located 32.0 cm (12.6 in) right of the side rail and 13.0 cm (5.1 in) forward of the B-pillar and measured 7.0 x 3.0 cm (2.8 x 1.2 in).

**Figure 8.** Driver seated area and deformed steering wheel rim

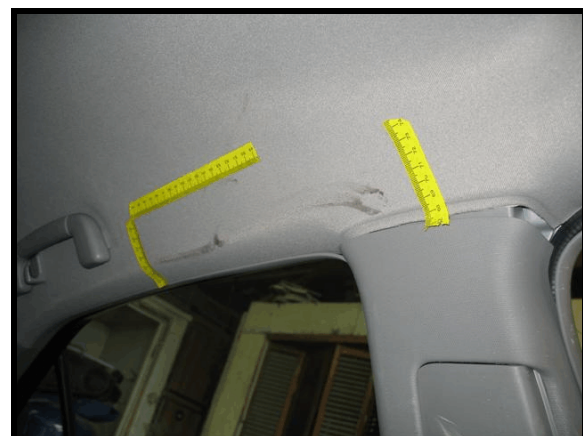
**Figure 9.** Occupant contact along left roof side rail

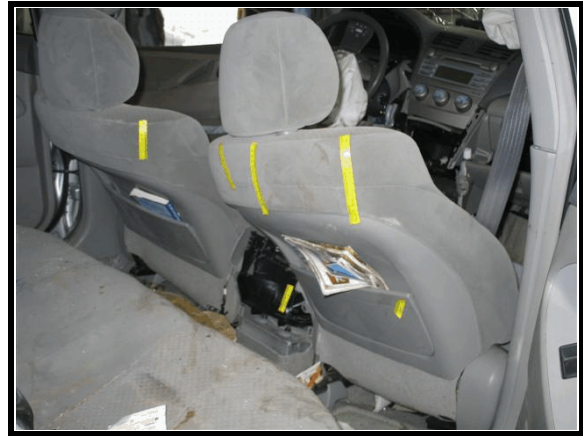
The third was located to the right of the interior roof light. There were scuffs documented to both seat backs (**Figure 10**). The first was located at the upper right corner of the driver seat back and measured 10.0 cm (3.9 in) along the side of the seat back. There was a 14.0 x 10.0 cm (5.5 x 3.9 in) scuff at the left upper passenger seat back and a 21.0 x 20.0 cm (8.3 x 7.9 in) scuff on the right upper seat back. Both front row seat backs were partially reclined at the time of the vehicle inspection. The right front seat back was deformed and the seat was loose in its mount and could be moved forward and back. The rear of the center console was deformed.

**Figure 10.** Occupant contacts to rear of front seat backs

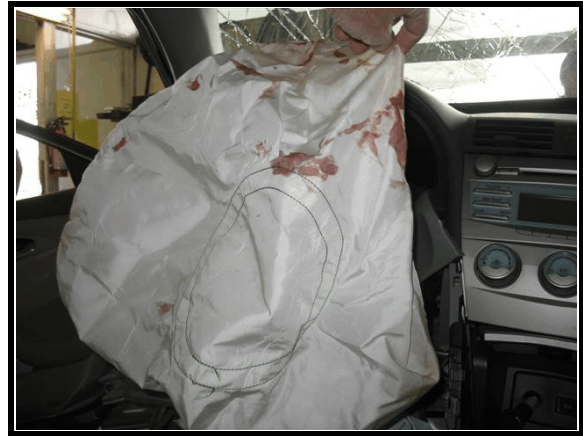
The driver’s air bag deployed from the center of the steering wheel hub through H-configuration cover flaps (**Figure 11**). The deployed air bag measured 49.0 cm (19.2 in) in diameter in its deflated state. The air bag was tethered by a single internal strap. The tether was attached to a stitched 23.0 cm (9.0 in) diameter circle in the center of the front panel. Two circular 3.0 cm (1.2 in) vent ports were located at the 11 and 1 o’clock aspects on the rear panel. The air bag and module covers were not damaged. There were areas of blood on the face of the bag, primarily in the upper half. There was a rectangular diagonal scuff mark measuring 7.0 x 3.0 cm (2.7 x 1.2 in) located at the upper left quadrant of the circular stitching. The driver’s knee air bag deployed from the lower instrument panel. The deployed air bag measured 53.0 cm (20.8 in) in width and 24.0 cm (9.4 in) height. The front right passenger’s air bag deployed from the top of the instrument panel through a rectangular module cover (**Figure 12**). The deployed air bag measured 39.0 cm (15.3 in) in width seam-to-seam, 52.0 cm (20.5 in) in height, and had a maximum excursion of 53.0 cm (20.8 in). There was no damage to either air bag.

**Figure 11.** Driver’s air bag

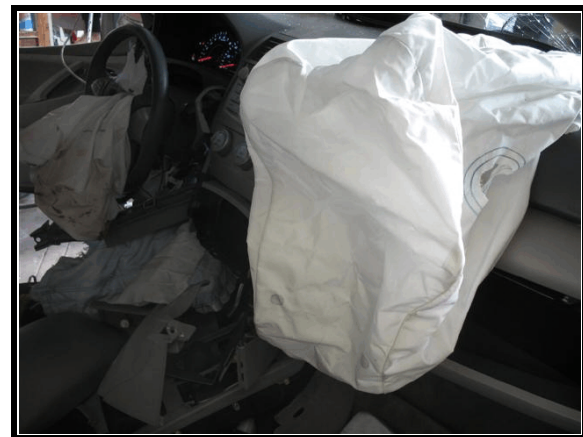
**Figure 12.** Front right passenger air bag

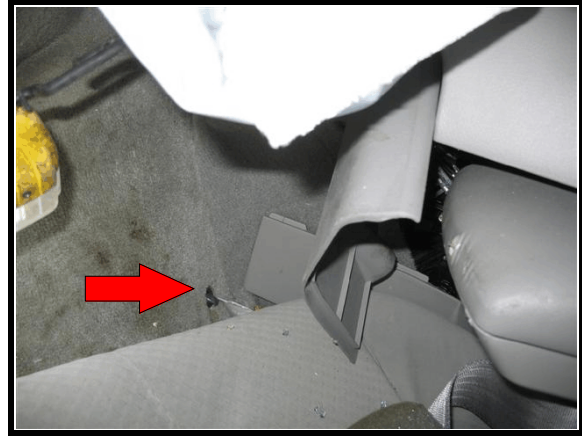
An original equipment manufacturer (OEM) floor mat was installed and was held in place by the retaining clips (**Figure 13**). The floor mat consisted of a carpeted top side and a textured rubber under side. The floor mat was contoured to fit within the left floor pan. Prior to the vehicle inspection, the forward portion of the mat had been pulled away by the police from toe pan area to access the foot controls. This vehicle was not equipped with an all-weather type mat. According to ODI the 90L recall (possible floor mat replacement) was not performed.

**Figure 13.** Floor mat retaining clip

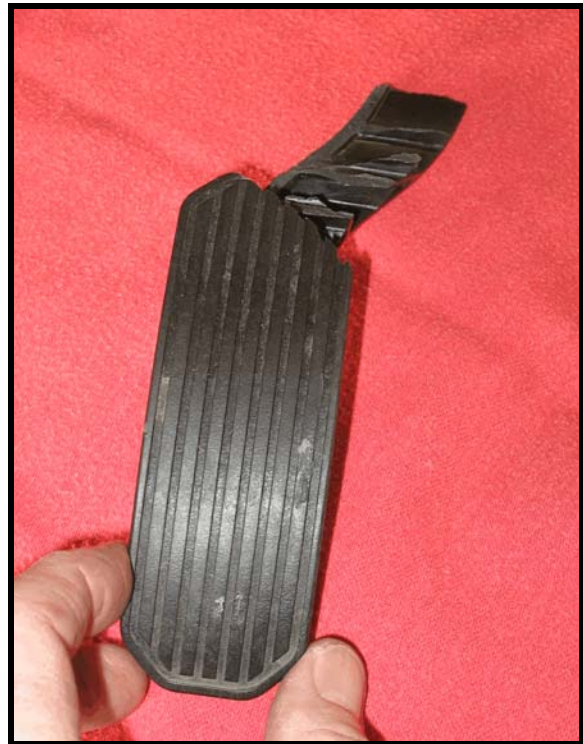
The accelerator pedal was manufactured by CTS and was inspected for damage and unusual wear patterns and none were observed (**Figure 14**). The pedal had been broken by the police during their examination effort as stated on page 6 of this report. The accelerator body had been displaced upward and to the right by the frontal and undercarriage impacts with the rock embankment (**Figure 15**). The pedal was manipulated by hand. The movement forward and back was smooth and there were no impingements. According to ODI the AOA recall (accelerator pedal steel reinforcement) was performed on February 4, 2010.

**Figure 14.** Accelerator pedal

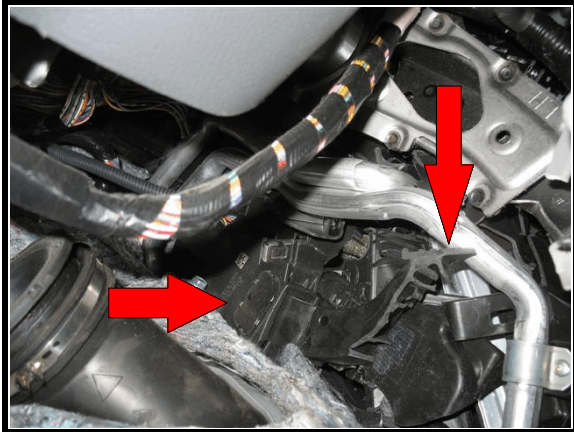
**Figure 15.** CTS accelerator pedal body. Side arrow shows metal tab associated with CTS pedal. Down arrow shows where the pedal assembly had been broken away.

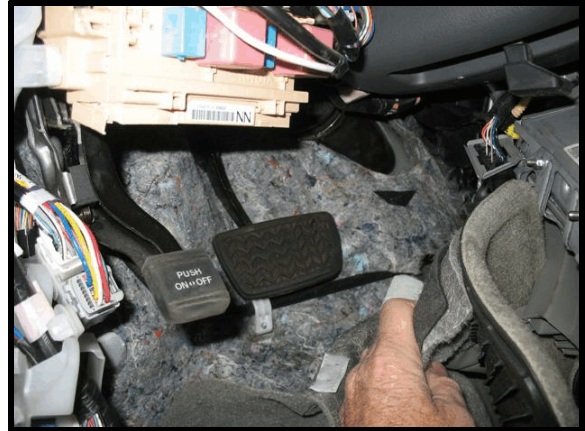
The brake pedal was restricted by the intruding toe pan and could not be operated (**Figure 16**). Mechanics were, however, able to by-pass the pedal and put pressure on the linkage behind the pedal. When pressure was applied they were able to restrict the movement of the rear tires. The front tires were not tested in this way.

**Figure 16.** Overview of floor and brake

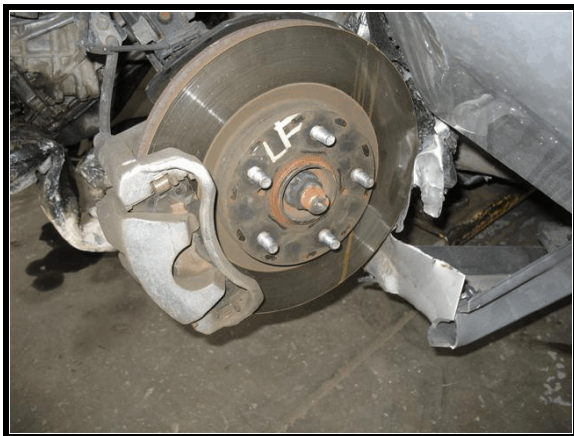
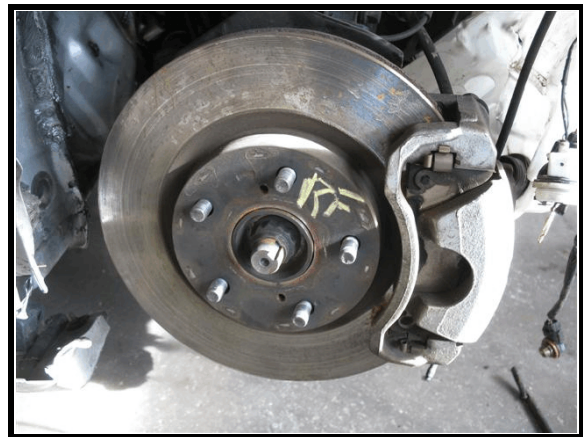
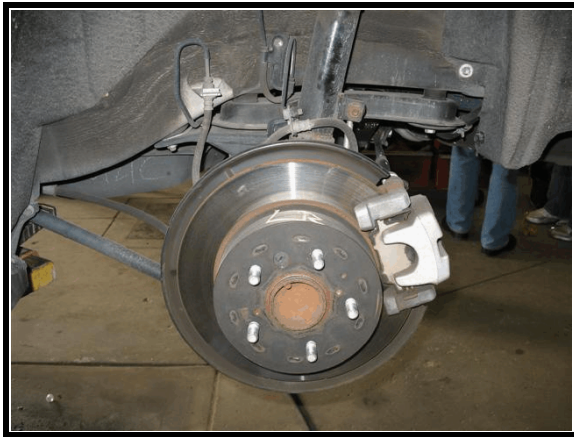
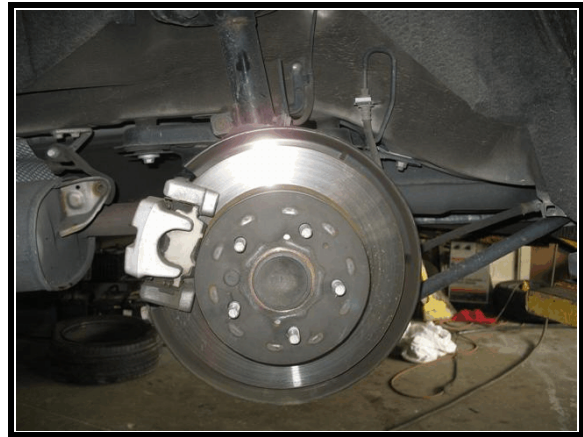
All the wheels were removed from the vehicle and the disc brakes were examined (**Figures 17-20**). The rotor wear did not appear unusual. The right front rotor did exhibit scoring and discoloration differences when compared to the left front. The police reported that the right front brake rotor appeared to have brake pad resin build-up on the outer surface as well as heat transfer indications on the top of the rib of the inside (length of pad). They stated that these may be indicators that the right front brake was heavily used at the time of the crash. Based on the EDR and scene evidence obtained during the SCI investigation, there were no indications of brake usage.

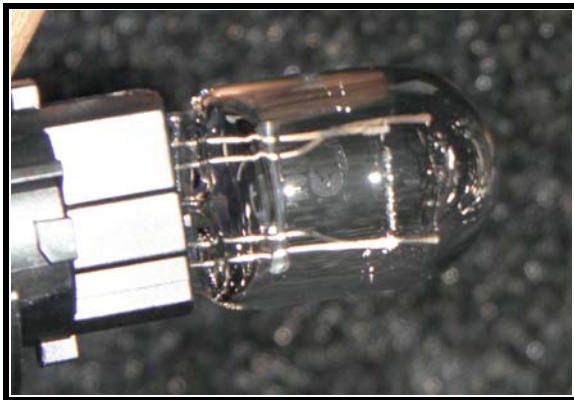
During the mechanical inspection, the police investigators removed and photographed the vehicle tail light lamps (**Figure 21**). The vehicle was equipped with two-filament lamps. The smaller of the two filaments is for the tail lights and the larger (lower) filament is for brake lights, turn signals or a combination of both. If the filaments are incandescent or hot at impact it will stretch out, uncoil, or break. The result deformation is called “hot shock”. There were no indications of hot shock when the photographed lamps were compared to an exemplar lamp (**Figure 22**).

**Figure 21.** Left rear tail light lamp from subject vehicle (police photo)
