CALSPAN ON-SITE CHILD RESTRAINT SYSTEM CRASH INVESTIGATION
SCI CASE NO.: CA10033

VEHICLE: 2010 DODGE GRAND CARAVAN

LOCATION: NORTH CAROLINA

CRASH DATE: JUNE 2010

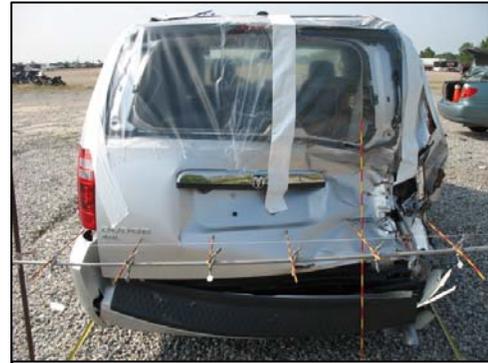
The 2010 Dodge's back plane sustained moderate damage in this offset rear-end crash (**Figure 3**). This impact was Event 1 of the crash sequence. On the back plane, the direct damage began 24 cm (9.4 in) right of the centerline, and extended 56 cm (22 in) right to the bumper corner. The maximum bumper level crush was located at C5, 39 cm (15.4 in) right of the centerline and measured 21 cm (8.3 in). Above the bumper elevation, the maximum crush was at the same location and measured 27 cm (10.6 in). The combined width of the direct and induced damage extended across the entire end-width of the rear plane. A residual crush profile was documented at bumper and above bumper height of the Dodge. The averaged profile was as follows: C1 = 2 cm (0.8 in), C2 = 10 cm (3.9 in), C3 = 15 cm (5.9 in), C4 = 19 cm (7.5 in), C5 = 21 cm (8.3 in), C6 = 17 cm (6.7 in). The front doors and left rear door were fully operational post-crash. The right rear door latch was operational but the door would only open 22 cm (8.7 in) on its track. The rear hatch was jammed shut as a result of the crash damage. The right wheelbase was shortened by 3 cm (1.2 in) as the right rear wheel was displaced forward. The backlight and right rear glazing adjacent to the third row disintegrated as a result of impact forces. All other glazing was undamaged. The Collision Deformation Classification (CDC) assigned for this impact was 06BZEW2.

Figure 3: Initial impact damage to the rear of the 2010 Dodge.

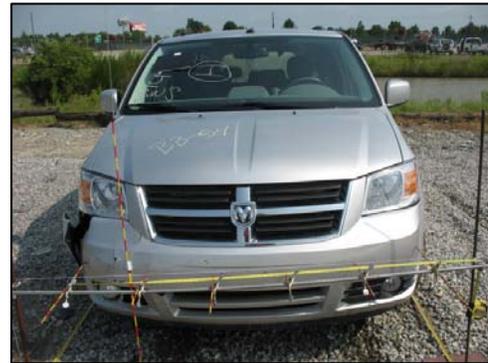
In Event 2 of this crash sequence, the right aspect of the 2010 Dodge's front plane impacted the left aspect of the Nissan's back plane in an offset impact. The direct damage to the 2010 Dodge began 14 cm (5.5 in) right of the vehicle centerline and extended right 62 cm (24.4 in) to the bumper corner. The maximum crush was located at C6, the front right bumper corner, and measured 7 cm (2.8 in). The Event 2 damage to the 2010 Dodge is depicted in **Figure 4**. The combined direct and induced damage width extended along the entire end-plane. A residual crush profile was documented at the bumper elevation and was as follows: C1 = 0 cm, C2 = 0 cm, C3 = 0 cm, C4 = 1 cm (0.4 in), C5 = 4 cm (1.6 in), C6 = 7 cm (2.8 in). This damage was measured to the bumper reinforcement bar. The CDC assigned to the secondary impact was 12FZEW1.

Figure 4: Event 2 damage to the front plane of the 2010 Dodge.

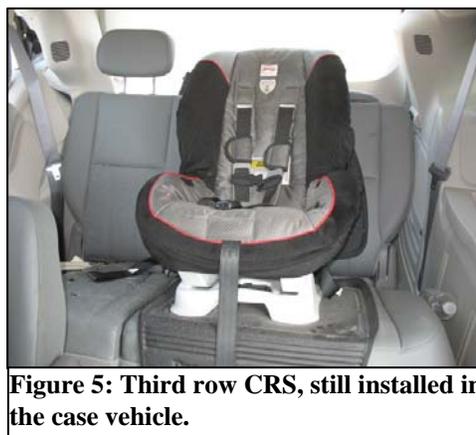
The Britax CRS was installed using the lower LATCH anchors and the top tether strap, and was still installed in the 2010 Dodge at the time of the SCI inspection (**Figure 5**). A Prince Lionheart two-piece seat protector pad was installed on the vehicle seat below the Britax CRS. The Britax seat was installed tightly to the third row bench, with no movement at the belt path in any direction. The length of the LATCH strap between the left lower anchor and the left side of the CRS belt path measured 25 cm (9.8 in). The length of the LATCH strap between the right lower anchor and right side of the CRS Belt path measured 22 cm (8.7 in).

Figure 5: Third row CRS, still installed in the case vehicle.

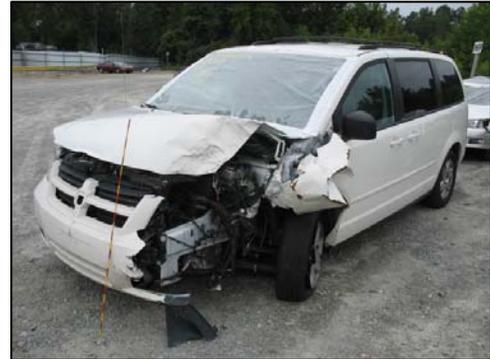
The left aspect of the 2009 Dodge's front plane sustained moderate severity damage as a result of the impact with the back right of the 2010 Dodge (Event 1). Refer to **Figure 6**. The direct contact damage began 37 cm (14.6 in) left of the vehicle centerline and extended 40 cm (15.7 in) to the left corner. The combined direct and induced damage extended along the full width of the front bumper. A residual crush profile was documented along the full width of the front bumper reinforcement and was as follows: C1 = 5 cm (2 in), C2 = 2 cm (0.8 in), C3 = 0 cm, C4 = 0 cm, C5 = 0 cm, C6 = 0 cm. The maximum crush was located at the left end of the reinforcement and measured 5 cm (2 in). As a result of the impact configuration, the direct contact wrapped around the corner and extended rearward along the left side plane 70 cm (27.6 in). The left front suspension was displaced rearward shortening the left wheelbase by 30 cm (11.8 in). The CDC assigned for this initial impact was 12FLEE4.

Figure 6: Event 1 damage to the front of the 2009 Dodge.

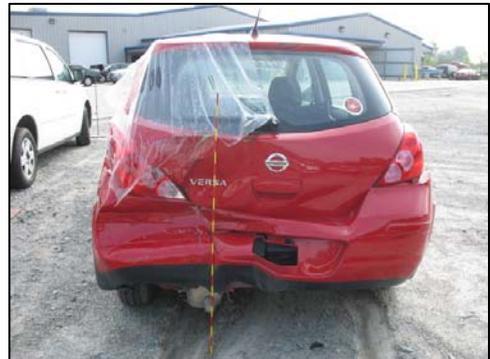
The back plane of the Nissan sustained moderate severity damage in the secondary impact from the front of the 2010 Dodge (**Figure 7**). The direct contact damage began 14 cm (5.5 in) left of the vehicle centerline and extended left 52 cm (20.5 in). The maximum crush was located at C2, 45 cm (17.7 in) left of the vehicle centerline. The maximum crush measured 31 cm (12.2 in). The combined direct and induced damage extended from the left rear bumper corner to the right rear bumper corner of the Nissan, a distance of 144 cm (56.7 in). A residual crush profile was documented along the full width of the Nissan's rear bumper and was as follows: C1 = 18 cm (7.1 in), C2 = 31 cm (12.2 in), C3 = 21 cm (8.3 in), C4 = 8 cm (3.1 in), C5 = 1 cm (0.4 in), C6 = 0 cm. The CDC assigned for the Event 2 impact was 06BYEW2.

Figure 7: Secondary event damage to the rear of the Nissan.

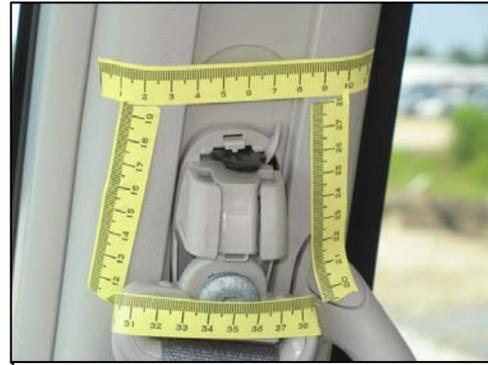
The 2010 Dodge sustained minor severity interior damage that was attributed to passenger compartment intrusion and occupant contact. The D-ring height adjustment control located on the B-pillar for the front right safety belt was fractured at the time of the SCI inspection. The control had been impacted by the front right passenger's forehead causing a laceration. The displaced knob contained body fluid consistent with a forehead laceration. Body fluid was also present on the front right safety belt webbing which was in use at the time of the crash. The rear hatch and right D-pillar structures had intruded forward into the passenger compartment. The right D-pillar was in contact with and had compressed the third row right seat back 4 cm (1.6 in). The intrusion to the vehicle is listed on the following table:

Figure 8: Damage to the front right safety belt height adjustment.
