ON-SITE AMBULANCE CRASH INVESTIGATION

CASE NUMBER - IN11001
LOCATION - INDIANA
VEHICLE - 2009 FORD E350 TYPE II AMBULANCE
CRASH DATE - December 2010

INDIANA UNIVERSITY
TRANSPORTATION RESEARCH CENTER
ON-SITE AMBULANCE CRASH INVESTIGATION
CASE NUMBER - IN11001
LOCATION - INDIANA
VEHICLE - 2009 FORD E350 TYPE II AMBULANCE
CRASH DATE - December 2010

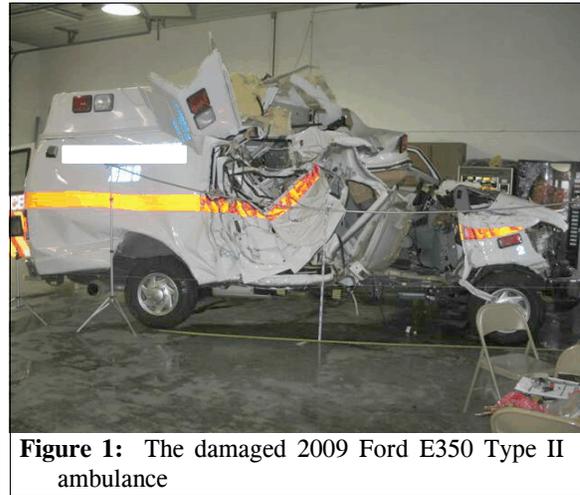
The focus of this on-site investigation was the structural damage sustained by a 2009 Ford E350 Type II ambulance (**Figure 1**), which departed the road and impacted a tree. Additional focus was on the ejection of the front right passenger and the sources of his injuries. This crash was brought to our attention by the National Highway Traffic Safety Administration (NHTSA) on December 14, 2010 through NHTSA's Emergency Medical Services (EMS) Division. The crash occurred in December, 2010, at 1445 hours, in Indiana and was investigated by the county sheriff's department. This investigation was assigned on January 11, 2011. The ambulance and crash scene were inspected on January 14 and 26, 2011. The director of operations of the ambulance company was interviewed on January 11, 2011. The driver of the ambulance would not respond to our request for an interview.

Figure 1: The damaged 2009 Ford E350 Type II ambulance

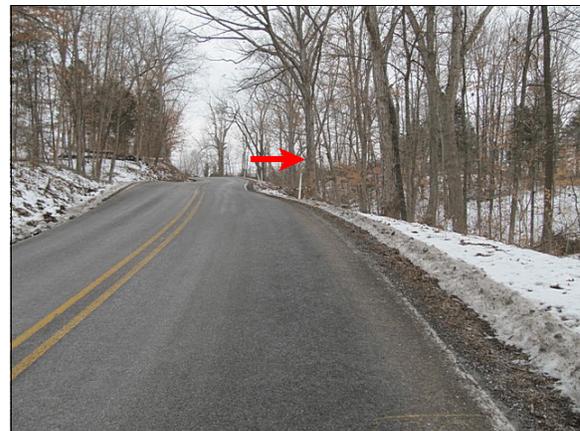
Figure 2: Southeast approach of the ambulance to area of roadway departure; arrow shows impacted tree

Pre-Crash: The ambulance was traveling southeast (**Figure 2**) and the driver was negotiating a left curve. The vehicle departed the right side of the roadway in the curve. The vehicle’s Event Data Recorder (EDR) recorded 5 seconds of pre-crash data. The EDR reported the vehicle’s speed as 78.0 km/h (48.5 mph) at 5 sec prior to Algorithm Enable (AE) decelerating to 71 km/h (44.1 mph) at 0 sec. The brakes were reported as “Off” from 5 sec to 0 sec.

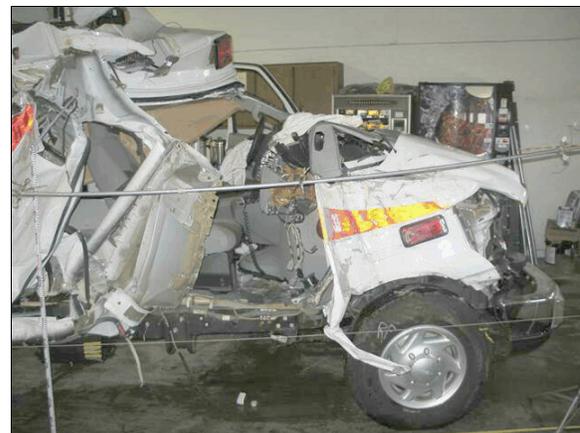
Figure 3: Initial contact with the tree began on the right fender of the ambulance

and the right side plane (**Figure 3**) impacted a 64 cm (15.2 in) diameter tree (**Figure 4**). As the impact progressed down the right side of the vehicle, the tree engaged the right A-pillar and right front door. The integral structure of the A-pillar and door frame separated from their mountings and were displaced rearward approximately 110 cm (43.3 in) opening an avenue of ejection where the unrestrained front right passenger was ejected from the vehicle. The force direction on the vehicle was within the 1 o'clock sector and the impact force triggered a deployment of the driver's and front right passenger's frontal air bags. The vehicle's EDR reported a maximum velocity change of -35.99 km/h (-22.36 mph).

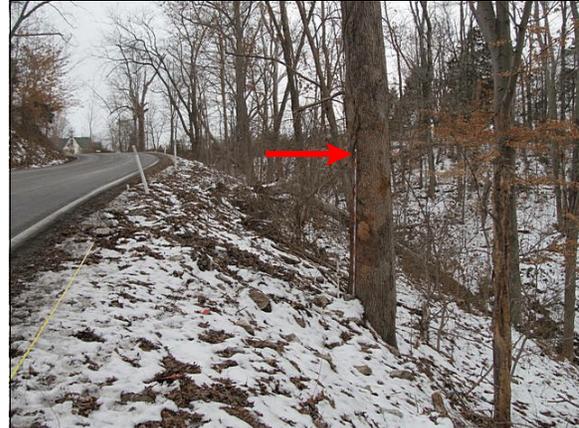
Figure 4: Southeast approach of the ambulance to the impact with the tree

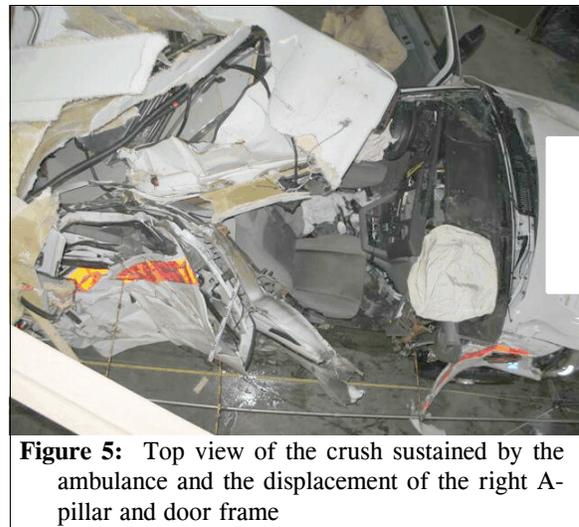
The ambulance sustained right side plane damage during the impact with the tree. The direct damage began 53 cm (20.9 in) forward of the right front axle and extended 350 cm (137.8 in) rearward. Since the right A-pillar and door frame were displaced from their attachments points (**Figure 5**) by the crash, one set of crush measurements was taken at the upper door level and a second set taken at the sill level in compliance with the crush measurement protocol. The maximum residual crush at the upper door level was 41 cm (16.1 in) and was located 56 cm (22 in) forward of C₃. The maximum residual crush at the sill level was 9 cm (3.5 in) at C₅. The maximum depth of the crush pocket occurred at the roof side rail (**Figure 6**) and was 70 cm (27.6 in). The height of the sill was 44 cm (17.3 in). The height of the maximum crush on the right front door was 120 cm (47.2 in). The door sill differential was 20 cm (7.9 in).

Figure 5: Top view of the crush sustained by the ambulance and the displacement of the right A-pillar and door frame

The Collision Deformation Classification (CDC) was 01RYAW4 (20 degrees). The Damage algorithm of the WinSMASH program calculated the total Delta V as 18 km/h (11.2 mph). The longitudinal and lateral velocity changes were -17 km/h (-10.6 mph) and -6 km/h (-3.7 mph), respectively. Based on the damage, the results appeared low and should be considered borderline.

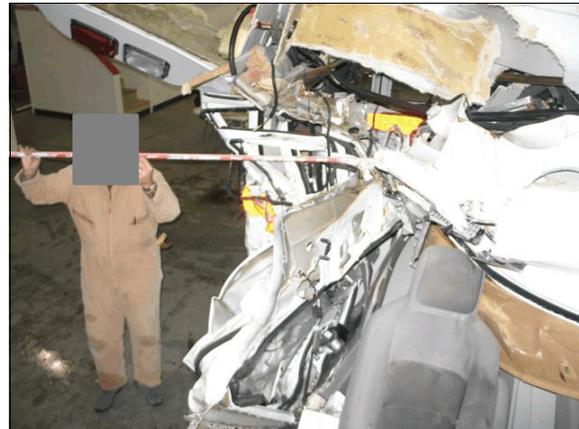
Figure 6: Front to rear view of the crush at the ambulance's right roof side rail

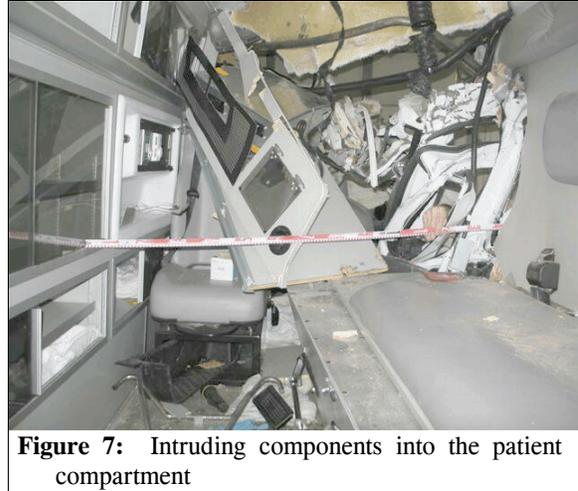
Figure 7: Intruding components into the patient compartment

The patient compartment sustained 13 intrusions. The most severe intrusions involved the right B-pillar and the air conditioning unit compartment (**Figure 7**), which intruded longitudinally 131 cm (51.6 in) and 91 cm (35.8 in), respectively.
