**CALSPAN ON-SITE ELECTRIC VEHICLE CRASH INVESTIGATION**

**SCI CASE NO.: CA11015**

**VEHICLE: 2011 CHEVROLET VOLT**

**CRASH DATE: APRIL 2011**

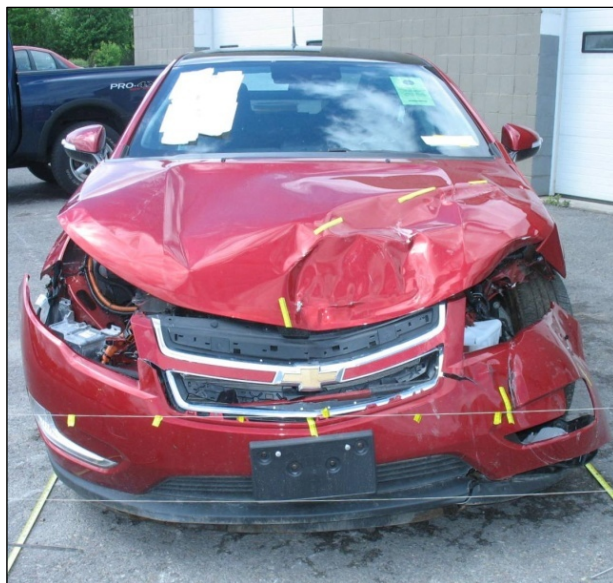
The front of the Chevrolet Volt sustained moderate damage as a result of the frontal impact with the Chevrolet K2500. Direct damage began at the front left bumper corner and extended 86 cm (33.8 in) to the right, while the induced damage extended the full 168 cm (66.3 in) undeformed end width from bumper corner-to-bumper corner. Direct damage included a 43 cm (17 in) diameter circular imprint of the Chevrolet K2500's right front wheel on the front left corner of the front bumper fascia. The front bumper was crushed rearward and displaced right laterally. Both headlamp assemblies were disintegrated. The hood displayed an arching area of deformation biased to the front left aspect, as depicted in **Figure 4**. Frontal components were

**Figure 4:** Front impact damage to the Chevrolet Volt.

crushed longitudinally and laterally, resulting in the induced displacement to underhood components. The front bumper reinforcement bar and frame mounts were displaced right laterally 8 cm (3 in). A residual crush profile with Field-L width of 112 cm (44 in) documented at the bumper reinforcement bar and the radiator support beam produced the following averaged measurements: C1 = 19 cm (7.5 in), C2 = 17 cm (6.8 in), C3 = 21 cm (8.3 in), C4 = 15 cm (6 in), C5 = 7 cm (2.8 in), and C6 = 10 cm (4 in). The Collision Deformation Classification (CDC) associated with the damage pattern to the Chevrolet Volt from Event 1 was 11FYEW1.

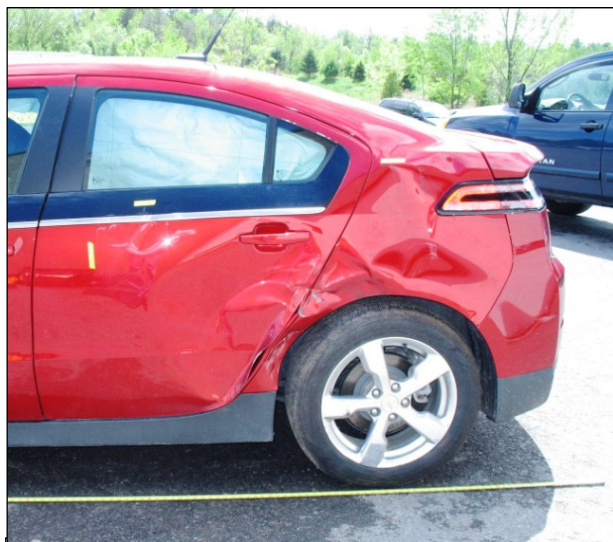
Damage from the second event was located on the left side aft of the B-pillar (**Figure 5**). The direct damage extended 130 cm (51 in) forward from the left rear bumper corner and consisted of minor surface scratches, abrasions, and body deformation. The exterior lens of the left rear taillight assembly was fractured, and there was slight crush to the lower aspect of the exterior skin of the left rear door. The induced damage length measured 170 cm (67 in) from the left rear bumper corner forward to the B-pillar. The CDC corresponding to the damage from Event 2 was 09LZAW1.

**Figure 5:** Side-slap damage to the Chevrolet Volt.

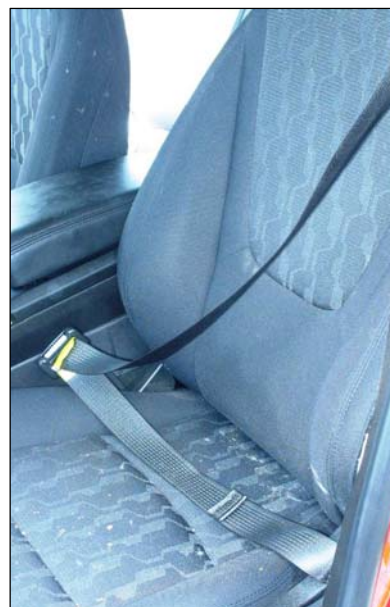
Loading abrasions were identified on the driver's seat belt webbing during the SCI inspection. These were located 80 cm (31.5 in) from the D-ring anchor point, and 58 cm (23 in) above the lower anchor (**Figure 6**). Both the retractor pretensioner and the lower anchor pretensioner were actuated. The lower anchor pretensioner was compressed 8 cm (3.1 in), based on an exemplar comparison. The front right safety belt was retracted taut against the B-pillar by the actuation of the retractor and lower anchor pretensioners, which indicated that the belt was not utilized at the time of the crash. Both rear belts were loosely retracted and neither displayed evidence of loading or historical wear.

**Figure 6:** Driver's safety belt.

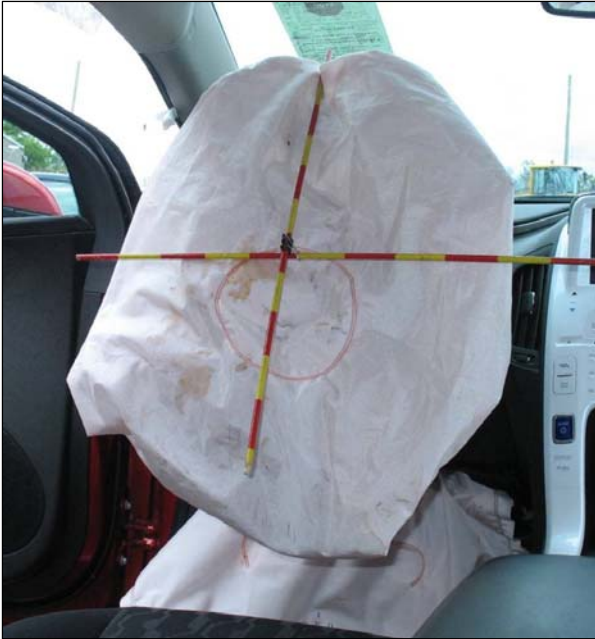
The steering wheel hub-mounted air bag deployed through the I-configuration cover flaps of the module without damage. It was circular in shape with an overall diameter of 66 cm (26 in), and had a 15 cm (6 in) diameter double seam stitched in a circular fashion around the center (**Figure 7**). An area of vomit extended from the center stitching toward the lower left quadrant on the face of the bag. There were two vents on the rear of the bag, evenly spaced on either side of the following alphanumeric nomenclature at the upper aspect of the bag:

**Figure 7:** Deployed CAC driver air bag.

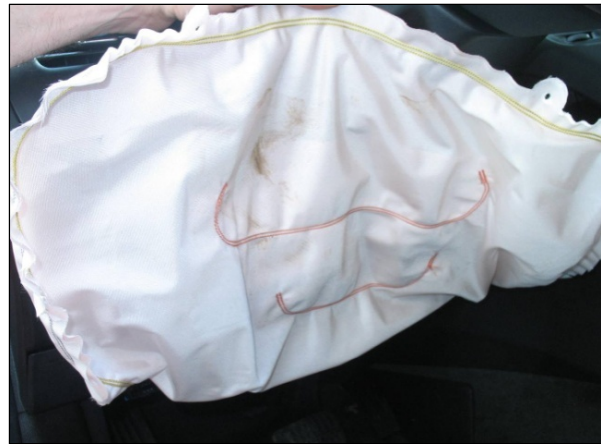
**Figure 8:** Deployed driver knee bolster air bag.

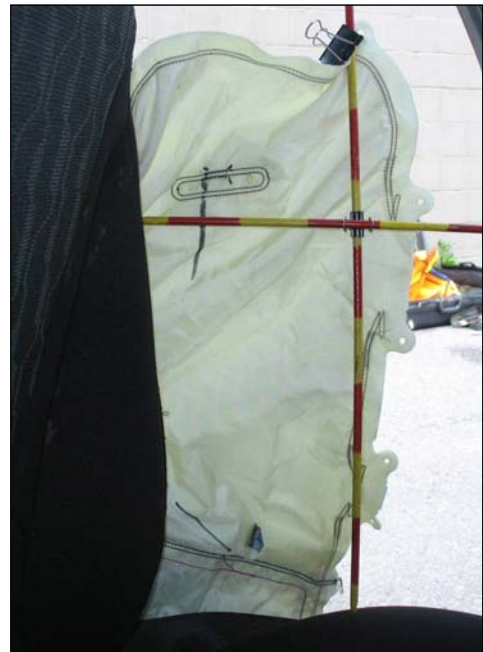
Side-impact protection within the Chevrolet Volt incorporated IC air bags and front seatback-mounted side air bags. Both IC air bags deployed during the crash, along with the left seatback-mounted side air bag. The left seatback air bag deployed from the module through 20 cm (8 in) of the outboard stitching of the seatback. The distance from the seat bight to the top of the air bag module measured 40 cm (15.8 in). In its deployed state, the air bag was rectangular in shape with an overall height of 65 cm (25.6 in) and an overall width of 26 cm (10.2 in). There were two vents on the forward aspect of the air bag. The upper vent was 8 cm (3.2 in) in height and began 15 cm (5.9 in) from the top of the air bag. The second vent was 3 cm (1.1 in) in height and began 16 cm (6.3 in) below the first vent. There was no alphanumeric nomenclature found on the air bag, nor was any contact evidence or damage present.

**Figure 9:** Deployed left seatback air bag.

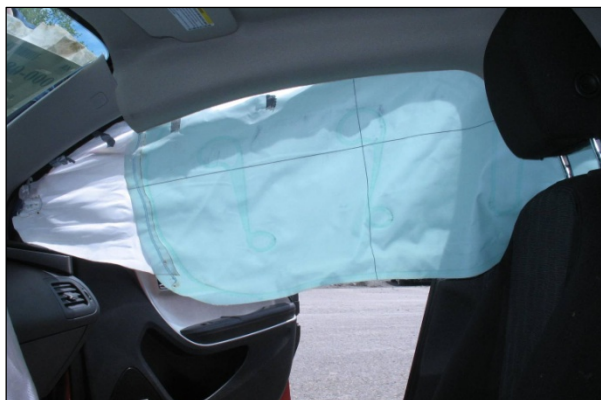
The left and right IC air bags deployed through the headliner from the module mounted to the roof side rail. Mirror images of each other, the air bags were oval in shape with a respective overall length and height of 194 cm (76.4 in) and 40 cm (15.8 in). The air bags provided 75 cm (29.5 in) of coverage from the B-pillar forward for the front row occupants, with a 29 cm (11.4 in) sail panel that incorporated an A-pillar tether anchor. There was 90 cm (35.5 in) of coverage between the B- and C-pillars, with a ribbed pattern of non-fill seams in the center aspect of the coverage.

**Figure 10:** Front row coverage of the deployed right IC air bag.

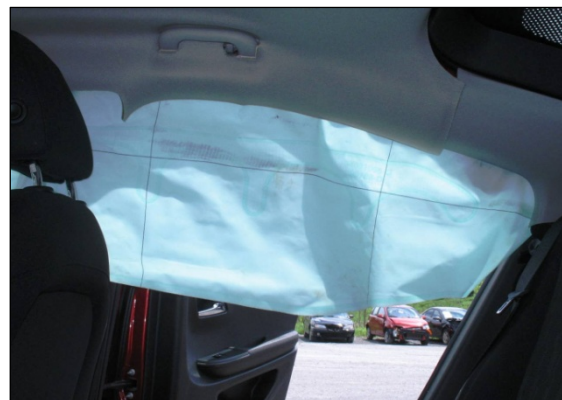
**Figure 11:** Rear row coverage of the deployed right IC air bag.

It should be noted that the forward aspect of the left IC and the forward tether of the right IC were cut by emergency response personnel post-crash. However, both bags were devoid of contact evidence or crash-related damage. **Figure 10** and **Figure 11** provide views of the front and rear row coverage of the IC air bags. The IC air bags were stamped with the following alphanumeric nomenclature: 34081665 3 90789 D

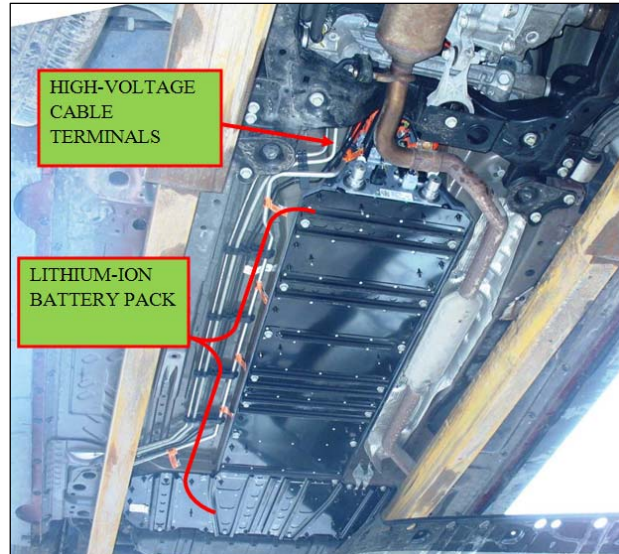
The Chevrolet Volt was visually inspected for compliance with FMVSS No. 305. A forklift operator employed at the vehicle salvage facility where the Chevrolet Volt was held utilized a forklift to raise the vehicle and enable an SCI inspection of the high-voltage battery pack and system components. The SCI team removed the skid plate and paneling protecting the vehicle's undercarriage to expose the lithium-ion battery pack, high-voltage cables, and high-voltage connection components (**Figure 16**). The high-voltage battery and surrounding system components were not displaced or damaged as a result of the crash. There was no leakage from the battery pack. There was no intrusion or damage to the battery pack or battery cover.

**Figure 16:** Undercarriage view of the Chevrolet Volt's undamaged high-voltage lithium-ion battery pack (*skid plate removed*).

There was also no intrusion of the battery pack or other high-voltage system components into the passenger compartment. Through this visual inspection, the SCI team determined that the integrity of the vehicle's high-voltage battery pack and surrounding system components was not compromised by the crash.
