REMOTE AIR BAG REPORT

CASE NUMBER - IN97-003

VEHICLE - 1991 MERCURY GRAND MARQUIS GS

CRASH DATE - May, 1992

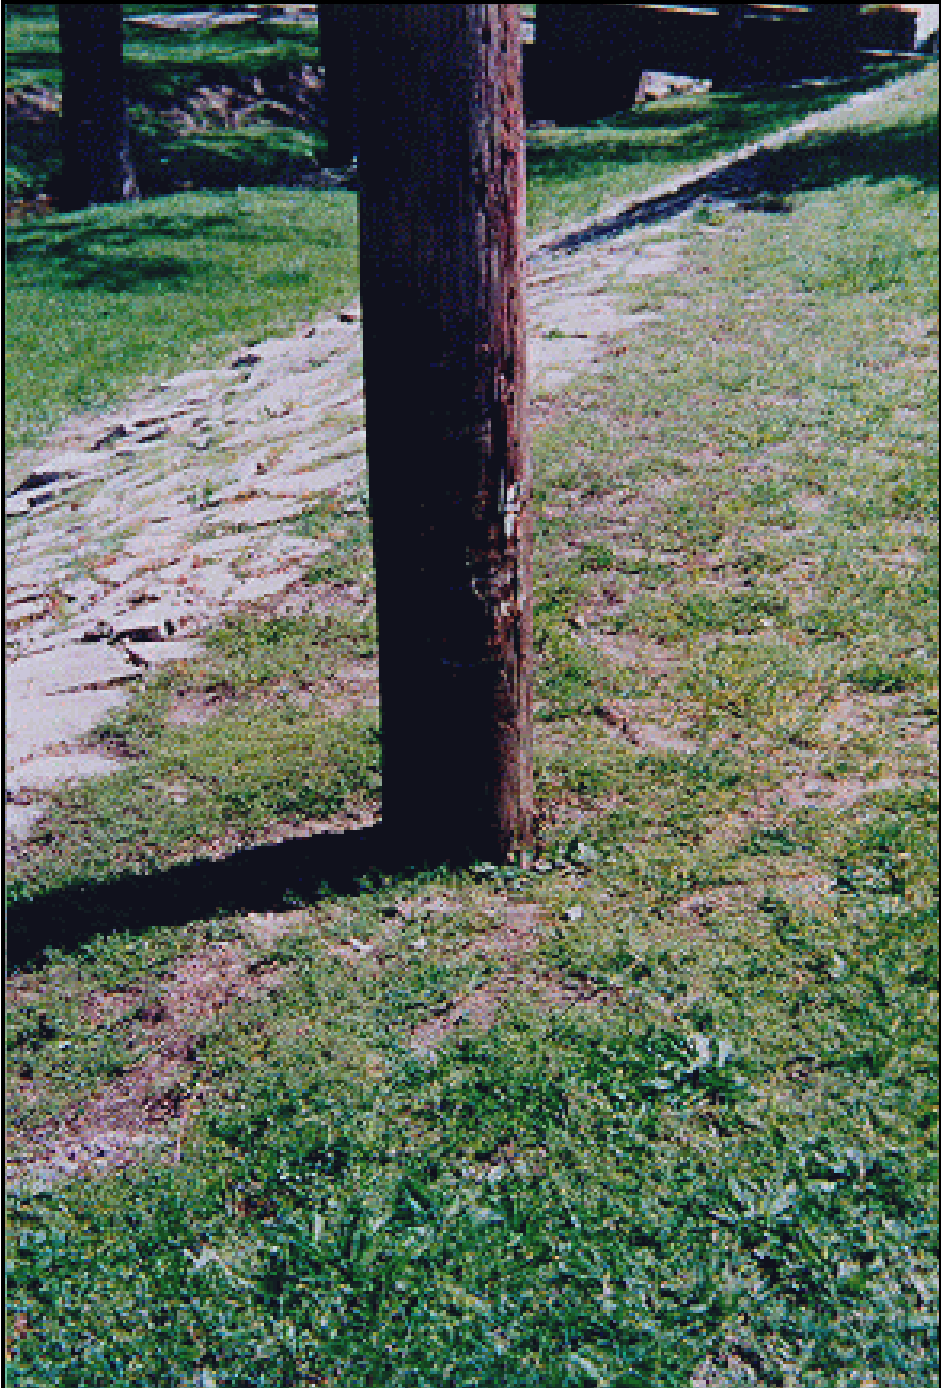
the case vehicle impacted a wooden utility pole (**Figure 1** below).

Figure 1: Eastward view of wooden utility pole impacted by case vehicle; Note: pole was located 2.4 meters (8 feet) north of north road edge (case photo #01)

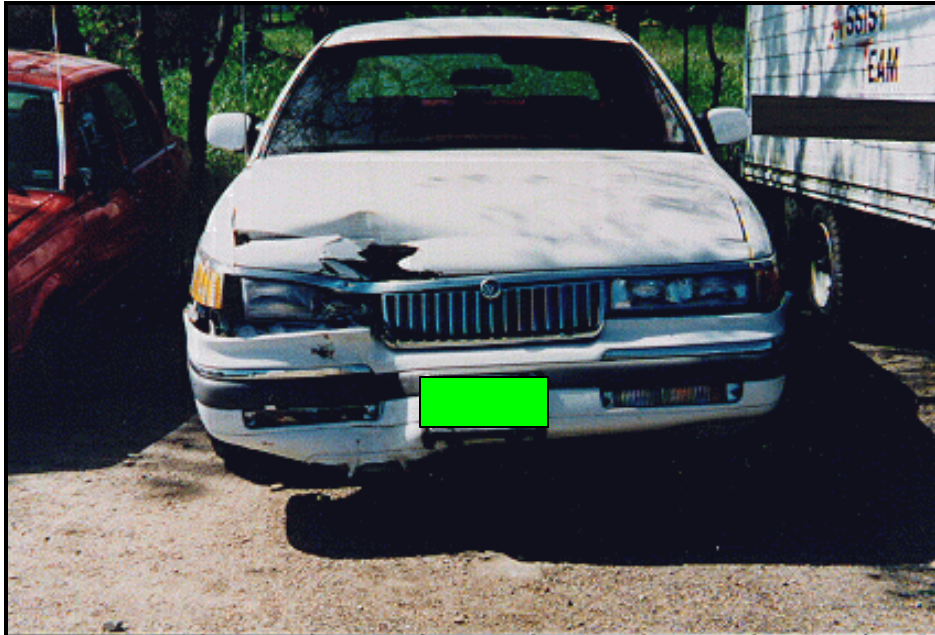
Location:	C ₄
CDC:	12-FZEN-1 (360)
Damaged Components:	Front bumper and splash pan, right front headlight and turn signal assemblies, hood edge, and grille
Repair estimate:	Unknown, vehicle was repaired and sold
Interior damage:	Driver air bag module per photographs

CRASH: The front right of the case vehicle (**Figures 2 and 3** below) impacted the wooden utility pole causing the driver side supplemental restraint system (air bag) to deploy. The post-impact trajectory, if any, and the vehicle's final rest position are unknown; however, based on the police diagram, the case vehicle was located against or near the wooden utility pole at final rest with little or no rotation.

Figure 2#: Case vehicle's frontal damage from impact with wooden utility pole (case photo #02)

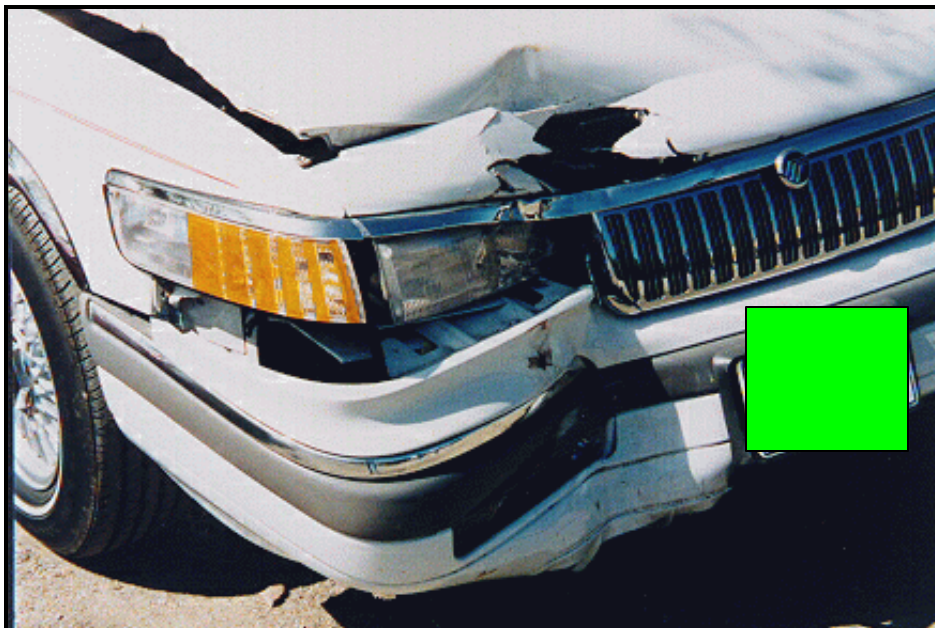
Figure 3: Close-up of case vehicle's frontal damage viewed from right of front (case photo #03)

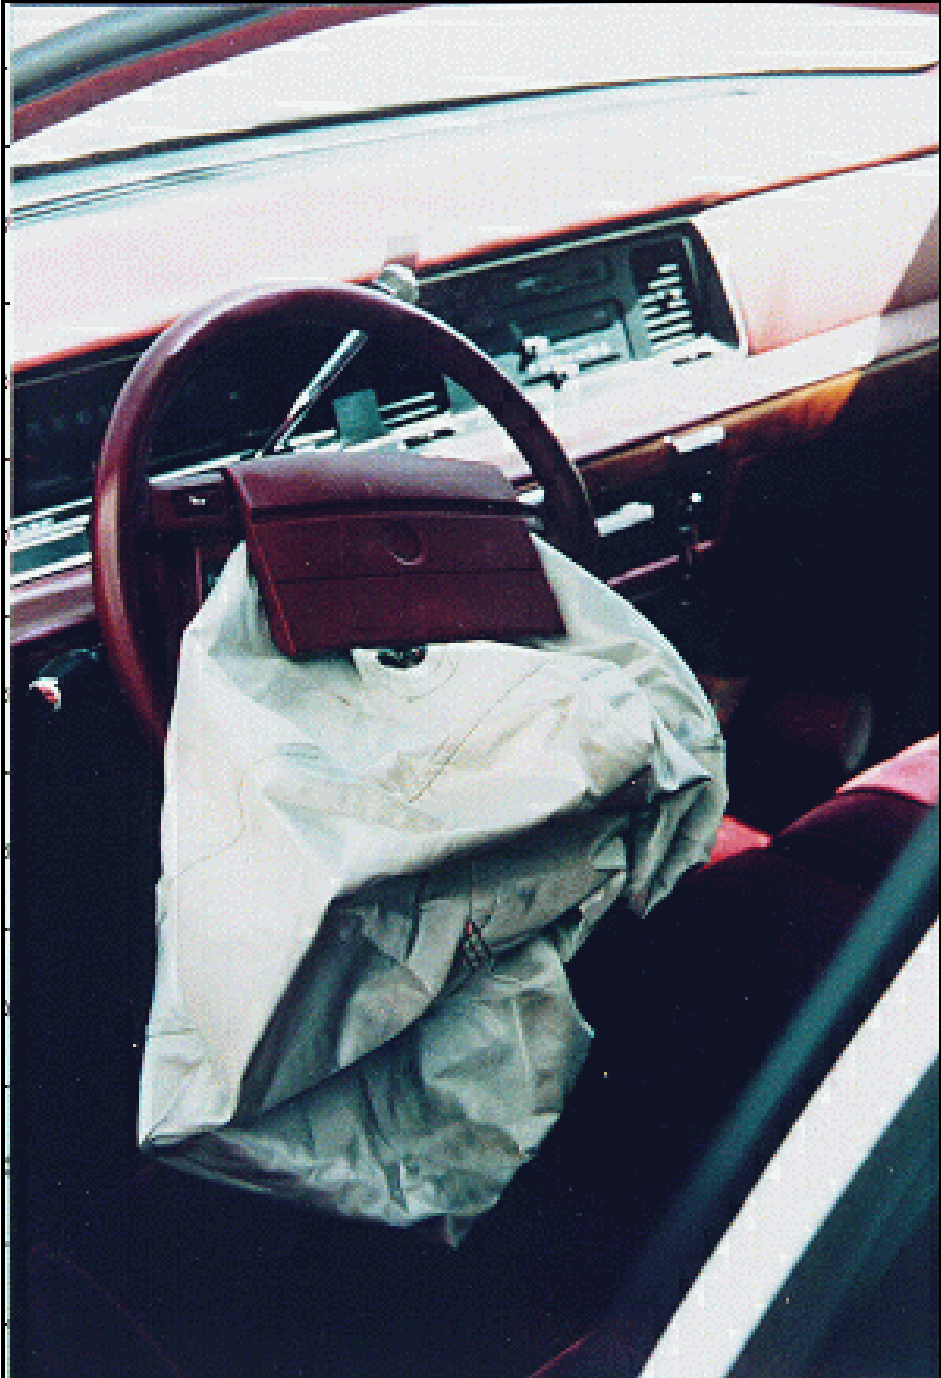
Figure 4: Case vehicle's driver seating area and deployed driver air bag; Note: no obvious contact evidence to air bag module's top cover flap (case photo #04)

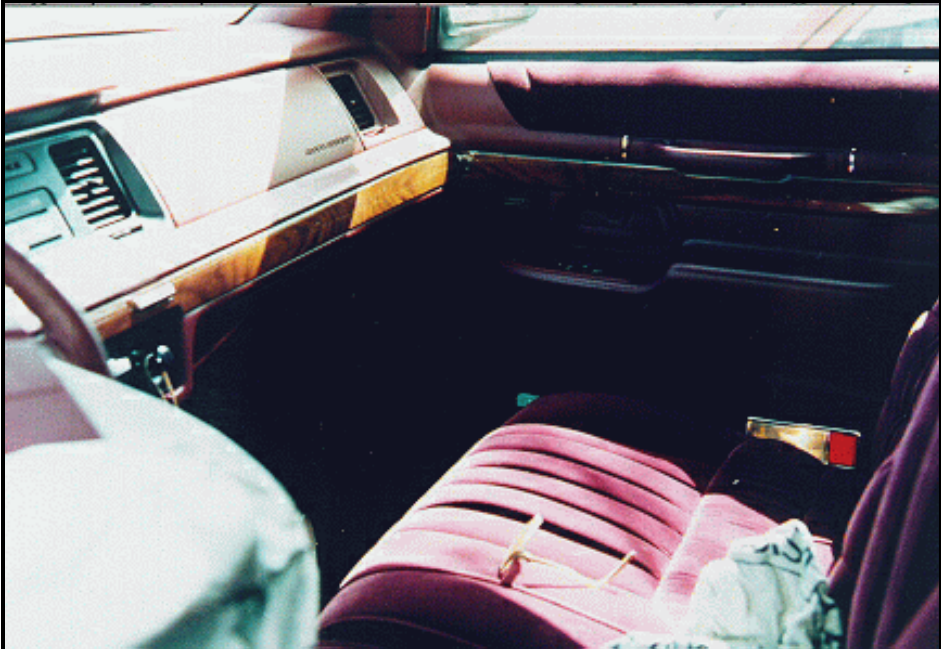
Figure 5 Case vehicle's front right seating area; Note: no evidence of occupant contact to front dash (case photo #05)
