CALSPAN AIR BAG DEPLOYMENT INVESTIGATION

CALSPAN CASE NO. CA97-006

**VEHICLE #1 - 1994 DODGE CARAVAN
VEHICLE #2 - 1989 GMC JIMMY**

CRASH DATE - JANUARY, 1997

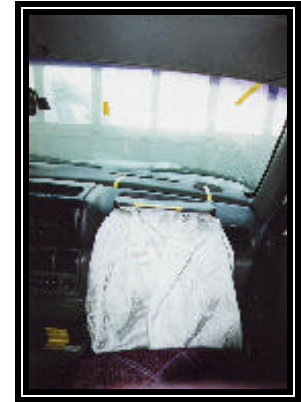
The windshield glazing was in place, but was cracked from impact forces. Two air bag transfer marks were located on the upper right surface of the windshield (refer to **Figure 1**). One transfer mark was 3.2 cm (1.25") long and was located 16.5 cm (6.5") right of center and 19.1 cm (7.5") below the windshield header. A second vertically orientated transfer mark was 6.4 cm (2.5") long and located 56.5 cm (22.25") right of the vehicle centerline and 1.3 cm (0.5") below the windshield header. The windshield had a 40 degree rake angle.

Figure 1. Deployed passenger air bag and resulting damage to the windshield.

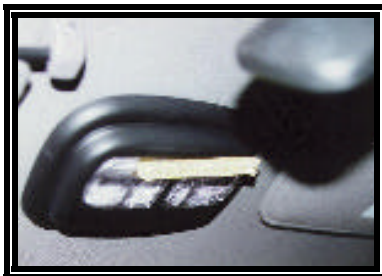
The leading edge of the center front courtesy light bracket exhibited a 10.2 cm (4.0") smudge mark (refer to **Figure 2**). This contact was not attributed to the crash event.

Figure 2. Courtesy light smudge mark.

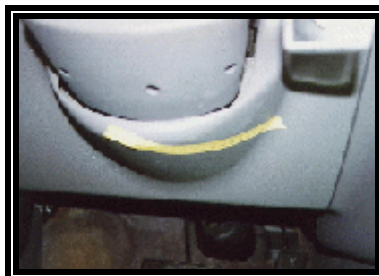
A 6.4 cm (2.5") scuff from the right knee of the driver was noted on the protruding area of the knee bolster which conformed to the curved surface of the steering column. This contact was located 30.5 cm (12.0") left of the vehicle centerline (refer to **Figure 3**).

Figure 3. Driver's right knee contact to the bolster.

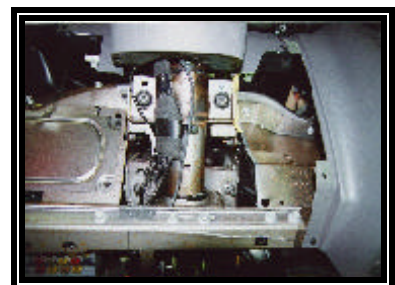
Figure 4. Shear plate displacement.

The steering column shear plate was displaced as a result of driver loading during the crash (refer to **Figure 4**). The displacement at the left shear capsule measured 6.4 mm (0.25") and 12.7 mm (0.5") at the right shear capsule.

Driver #1 was only wearing the lap portion of the manual three point lap and shoulder belt with the shoulder belt placed behind her back. She moved forward and contacted the knee bolster with her right knee which was noted by a scuff mark. She contacted the deployed driver air bag and displaced the steering column 6.4 mm (0.25") and 12.7 mm (0.5") at the left and right shear capsules, respectively.

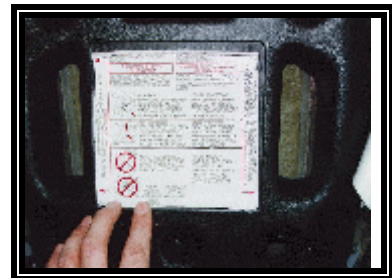
Figure 5. Child safety seat warning label.

When used in this configuration, the five point belt safety seat harness was required to properly restrain the child to the booster seat. The second method required only the use of the vehicle's lap and torso belt to restrain the child to the booster seat which in turn secured the booster seat to the vehicle. Following the two methods of installation was a warning (refer to **Figure 5**) which read:
