On-Scene / Vehicle to Vehicle  
Dynamic Science, Inc. / Case Number: DS97016  
1995 Jeep Grand Cherokee Limited  
California  
July/1997

1. Report No. DS97016		2. Government Accession No.		3. Recipient Catalog No.	
4. Title and Subtitle In-Depth Accident Investigation				5. Report Date September, 1998

**Dynamic Science, Inc.**  
**Accident Investigation**  
**Case Number: DS97016**

Description: This case was initiated in response to a report of a non-deployment of the air bag in Vehicle 1.

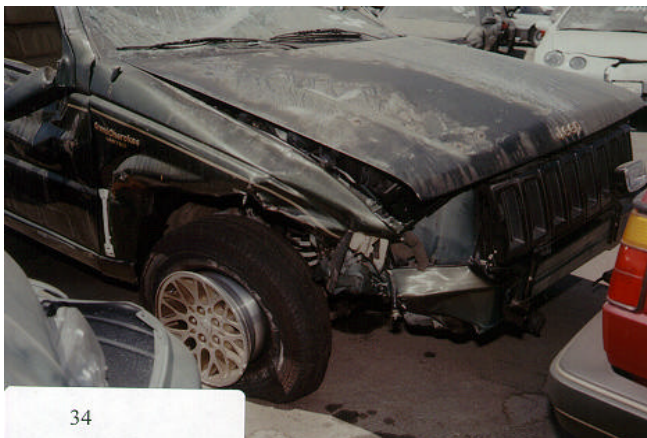
The front right corner damage to Vehicle 1 was assigned a CDC of 01FREW1. Maximum crush measured a total of 18.5 cm (7.3 in) at C6. The damage to Vehicle 2 was assigned a CDC of 10LFEW4, and maximum crush measured 67.4 cm (26.5 in) at C6. Delta V was computed using the damage routine of WinSmash, and it produced the following results:

CDC Impact # 1 Vehicle 1 vs Vehicle 2: 01FREW1

**Figure 1.** Right front bumper corner damage to V1.

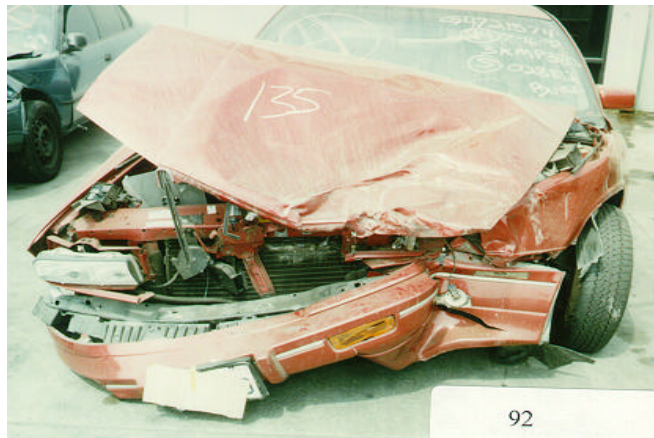
Description:	1994 Buick Regal 4-door
VIN:	2G4WB5518R1XXXXXX
Odometer:	46,367 km (28,812 miles)
Engine:	Unknown
Reported Defects:	None noted
Cargo:	None visible
Damage Description:	Major damage to the front right Q-panel, hood, front bumper, grille area, and the windshield. The vehicle was towed from the scene and later totaled by the insurance company.
CDC Impact # 1, Vehicle 1 vs Vehicle 2:	10LFEW4

**Figure 2.** Exterior damage to V2.
