ON-SITE AIR BAG INVESTIGATION

CASE NUMBER - IN97-017

VEHICLE - 1992 FORD TAURUS GL

CRASH DATE - June, 1997

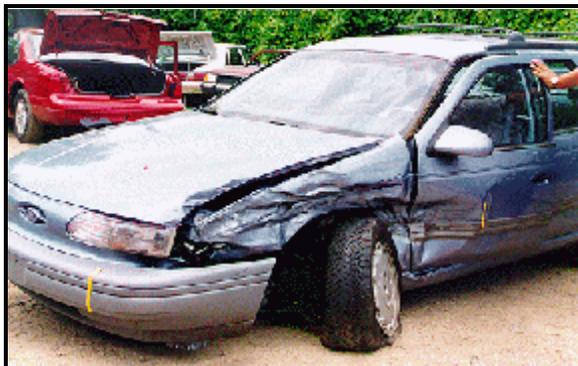
Figure 2: Case vehicle's front left corner damage from impact with vehicle #2; Note: damage extends down left side to driver's door, and vertical yellow tape indicates direct damage length (case photo #20)

The initial contact involved the front left bumper corner (**Figures 2** above) of the case vehicle against the front left bumper of vehicle #2 (**Figure 4** above). The direct contact damage consisted of a longitudinal abrasive pattern that began 54 centimeters (21.3 inches) left of the center and extended 19 centimeters (7.5 inches) to the front left bumper corner (**Figure 3** above). The corner impact was primarily a narrow end engagement that continued down the left side of the case vehicle snagging the left front wheel. The snagging action separated the left lower ball joint from the steering spindle and displaced the left lower control arm rearwards; in addition, the snagging deployed the case vehicle's driver air bag. The residual deformation to the bumper reinforcement bar was nonexistent except for scratches and abrading to the bumper fascia. Direct damage continued down the left side a distance of 185 centimeters (72.8 inches) and ended just past the left "A"-pillar. The left fender, hood, bumper fascia, left wheel assembly, and left front door were deformed. The case vehicle's left front tire was deflated or physically restricted. There was no evidence of intrusion to the case vehicle's interior.

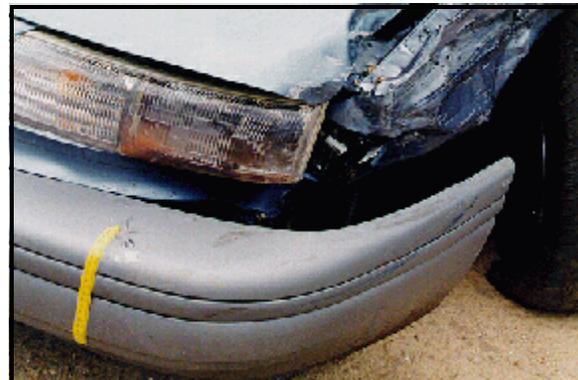
Figure 3: Close-up of direct damage width to case vehicle's front left bumper corner (case photo #23)

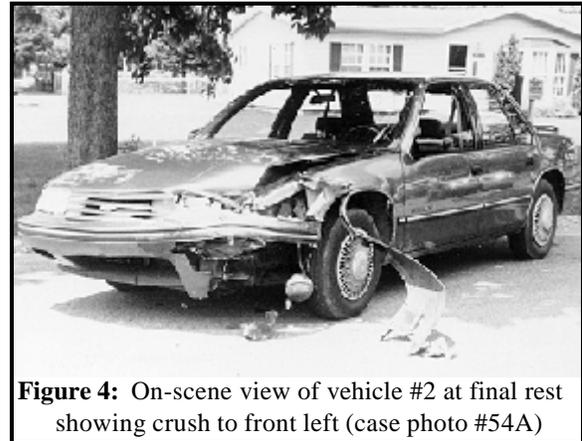
Figure 4: On-scene view of vehicle #2 at final rest showing crush to front left (case photo #54A)

Vehicle #2's direct damage started 21 centimeters (8.3 inches) left of center and extended to the left front bumper corner. The left half of the grille and left headlight assembly were broken out. The bumper fascia was abraded with the bumper reinforcement bar deformed on the left corner only. The hood and left front fender were damaged as well. The CDC was determined to be: **11-FLEW-1 (+30)** [maximum crush was 13 centimeters (5.2 inches)]. No reconstruction program was used on this crash because neither the case vehicle nor vehicle #2 reached a common velocity due to the impact configuration. Vehicle #2 was towed due to damage.

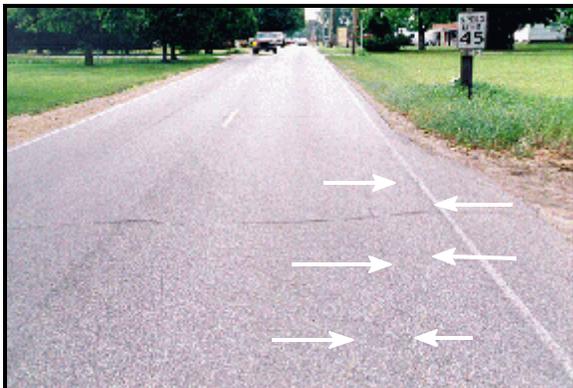
Figure 5: Case vehicle's path of travel after impacting vehicles #2 and #3 showing scuff marks from left front tire (highlighted by arrows) and replaced SPEED LIMIT sign struck before coming to rest (case photo #05)

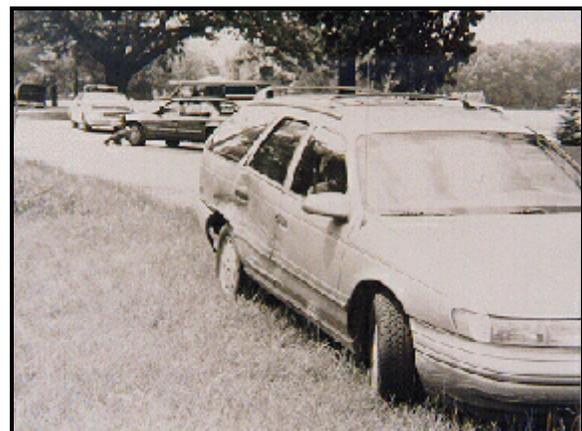
Figure 8: On-scene view of case vehicle's right side damage from end swipe with vehicle #3; Note: vehicle #2 at final rest in background (case photo #16)

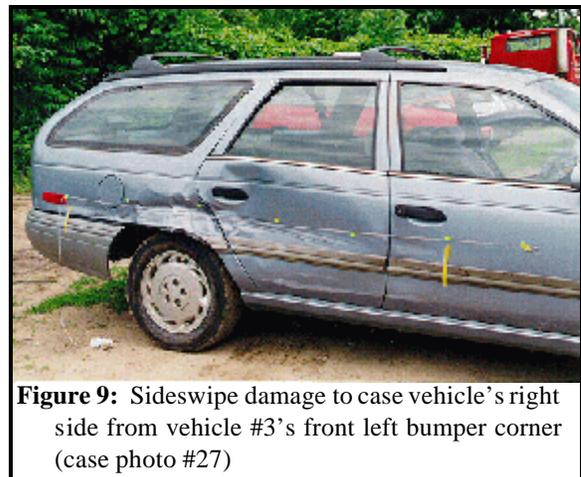
The case vehicle's right side impact with vehicle #3 began on the right front door (**Figure 9**), and the sideswiping type damage extended to the right quarter panel. The direct damage length was 205 centimeters (80.7 inches). The right front door, right rear door, and right quarter panel were deformed; maximum crush was 5 centimeters (2.0 inches) and occurred to

Figure 9: Sideswipe damage to case vehicle's right side from vehicle #3's front left bumper corner (case photo #27)

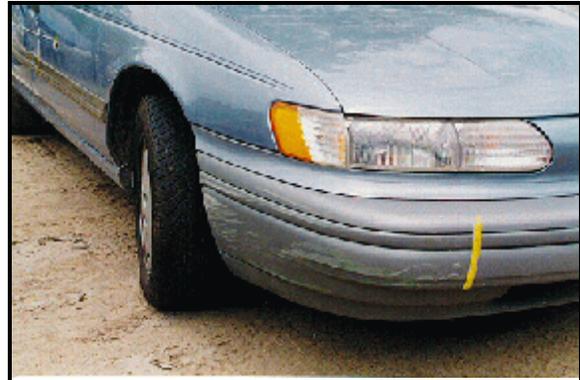
the right rear door panel. The case vehicle's front right impact with the regulatory SPEED LIMIT sign (**Figure 10**) resulted in 19 centimeters (7.5 inches) of direct damage (i.e., scrapes and scratches) along the front right bumper.

Figure 10: Scraping to the case vehicle's front right bumper corner from contacting regulatory SPEED LIMIT sign (3rd event) prior to coming to rest (case photo #30)

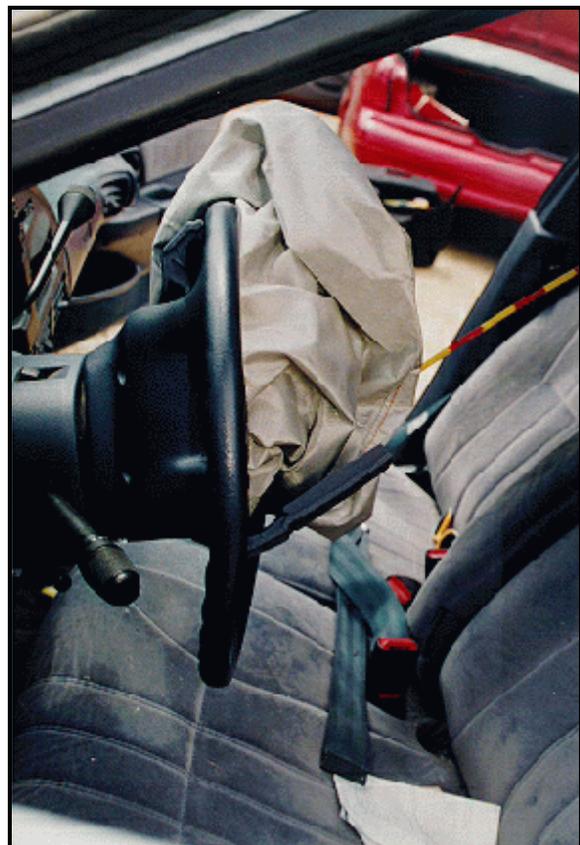
Figure 11: Deformation to top of case vehicle's steering wheel rim which resulted when the driver loaded the deploying air bag causing the air bag to expand backwards into the rim; Note: steering wheel inverted (case photo #34)

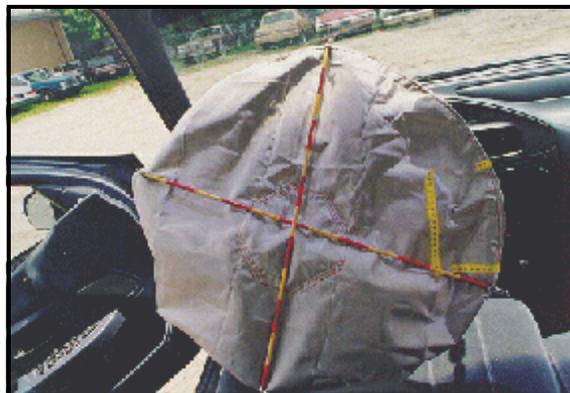
Figure 12: Case vehicle's driver air bag with steering wheel in upright position; Note: yellow tape highlights area of contact (i.e., skin transfer) by front center passenger (case photo #37)

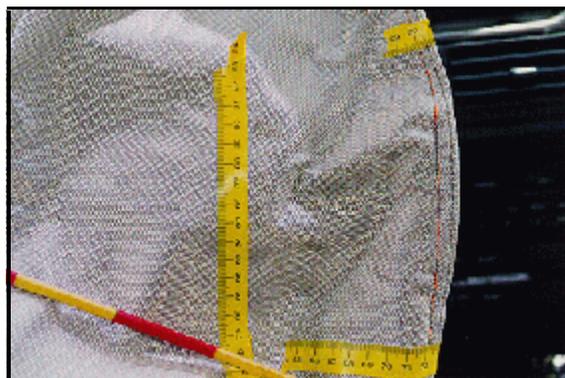
Figure 13: Close-up of skin transfer to right side of case vehicle's driver air bag from contact with the left side of the front center passenger's face (case photo #38)

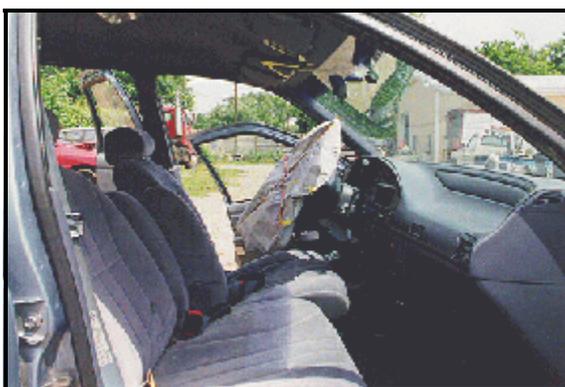
Figure 14: Case vehicle's front seating area; Note: difference in seat track placement between driver and passenger seats, and ceiling tape indicates air bag exhaust residue (case photo #50)

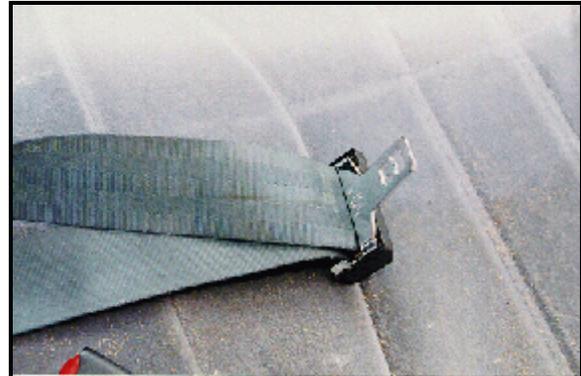
The case vehicle's front center passenger [4-year-old, White (non-Hispanic) male] was restrained by his available, active, two-point, lap belt. An inspection of the front center passenger's seat belt webbing and latch plate showed no conclusive evidence of loading, but there was blood evidence on the webbing near the latch plate (**Figure 15** below) where this occupant would have had the seat belt latched as well as heavier than normal wear marks on the latch plate's webbing guides.

Figure 15: Seat belt for case vehicle's front center passenger showing blood streak on backside of belt webbing, near latch plate (case photo #48)

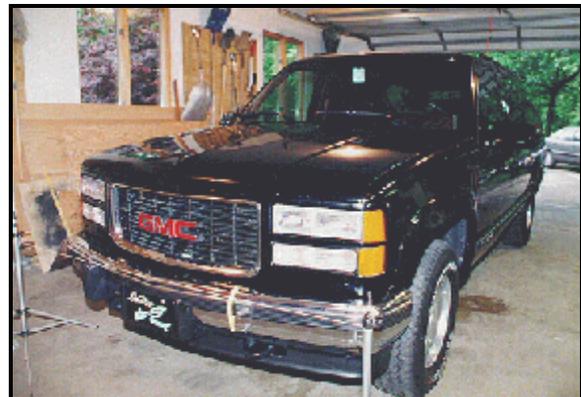
Direct damage to vehicle #3's front bumper began 39 centimeters (15.4 inches) left of center and extended out to the left front bumper corner. The only damage to the bumper, besides abrading of the rubber bumper trim, involved the left bumper guard

Figure 16: Vehicle #3's frontal damage viewed from left of front; Note: direct damage to front left bumper corner and missing bumper guard; also, tape indicates direct and induced damage (case photo #62)

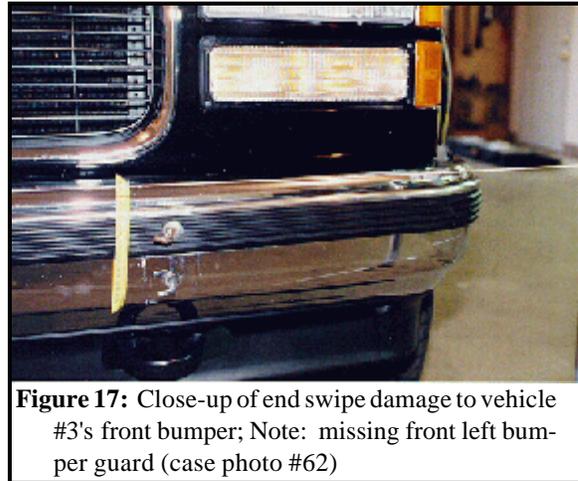
being torn away during the end swiping type impact with the case vehicle (**Figure 16** above and **Figure 17**). The CDC was determined to be: **09-FYLS-1 (-90)** with no measurable deformation. Vehicle #3 was driven from the scene.

Figure 17: Close-up of end swipe damage to vehicle #3's front bumper; Note: missing front left bumper guard (case photo #62)
